# Inspection Report Home Buyer

7243 E Monte Vista Rd 456 Yellow Brick Rd. AZ 85257

**Liberty Inspection Service**

<b>Date:</b> 9/10/2018	<b>Time:</b> 12:00 PM	Report ID: Sample Report 2
Property: 7243 E Monte Vista Rd 456 Yellow Brick Rd. AZ 85257	Customer: Home Buyer	Real Estate Professional: Sample Agent

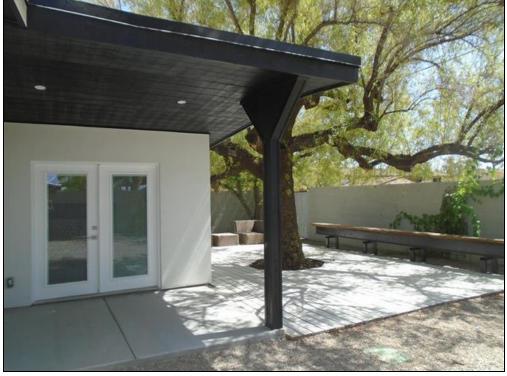
1.3 Item 1(Picture)

(1) The visible portions of the posts/columns are in satisfactory condition.

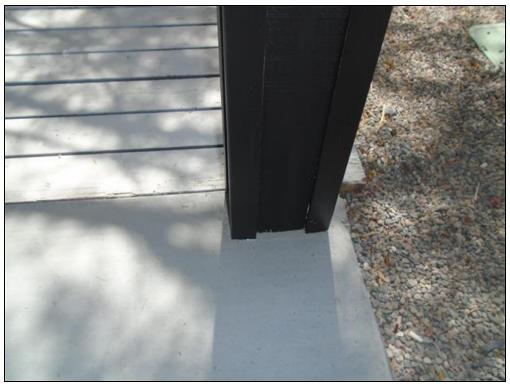
1.3 Item 2(Picture)

(2) The post base is in contact with the ground and concrete, this is conducive to water and insect damage. I recommend the installation of raised post bases to prevent damage to the post.

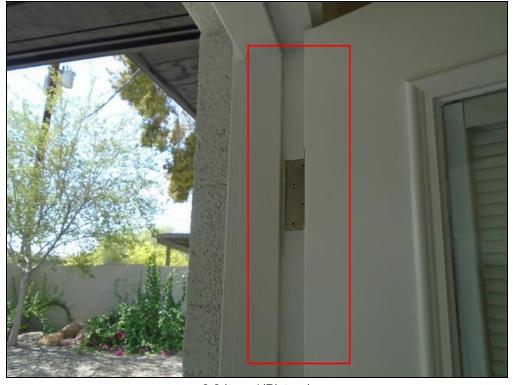
2.2 Item 1(Picture)

(1) The master bedroom and dining room exterior doors weather stripping have been removed. I recommend the addition of weather stripping.

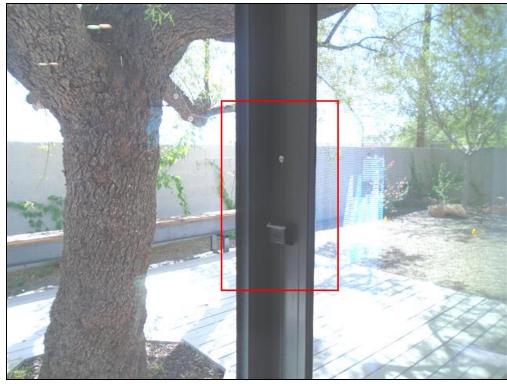
2.3 Item 1(Picture)

- (1) A representative number of windows were operated and found to be in satisfactory condition and operational.
- (2) The master bedroom rear window lock has been removed and the window does not open. I recommend replacement of the lock and adjustment of the window to operate as intended.

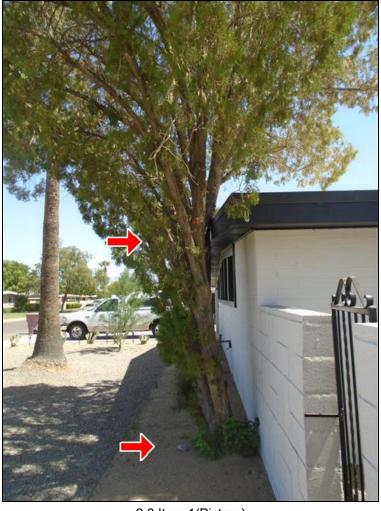
2.8 Item 1(Picture)

There is a large tree growing in close proximity to the house. This could damage the foundation. Also, tree limbs/ vegetation in contact with the exterior and roof can cause damage to the roof and wall cladding, as well as provide access for rodents. I recommend removal of the tree to prevent damage to the foundation, house, and roof.

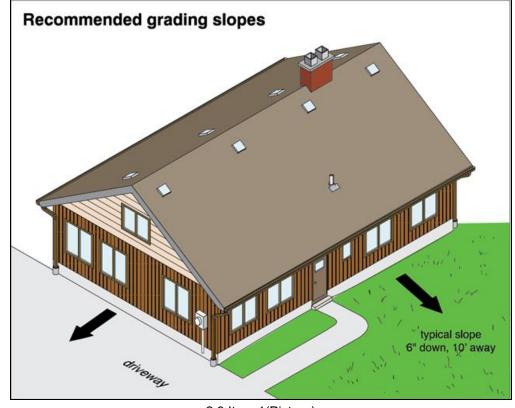
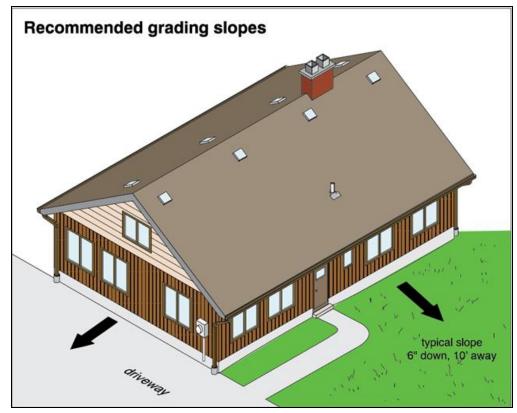
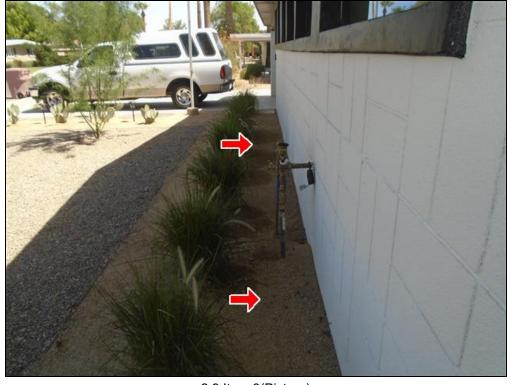
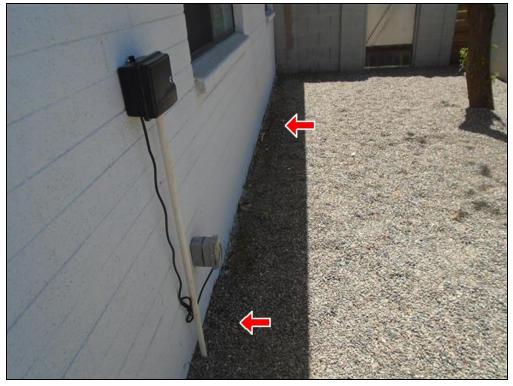
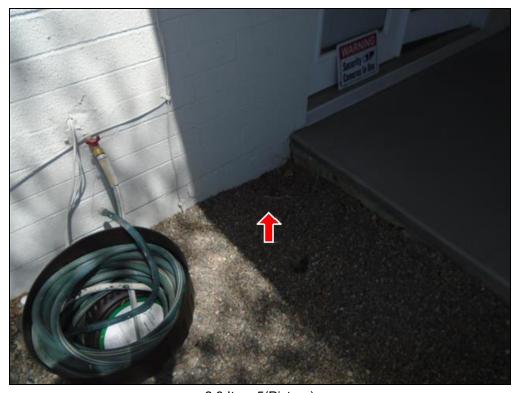
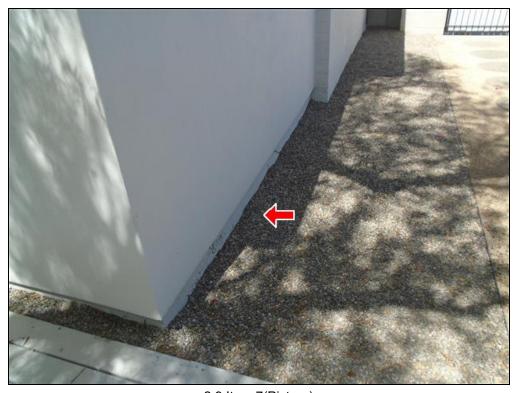
(1) The grade is sloped toward the house on all sides of the house. This will direct surface water into the soil adjacent to the foundation and cause water damage to the foundation concrete. Adjust the grade to direct surface water away from the foundation to prevent water damage.

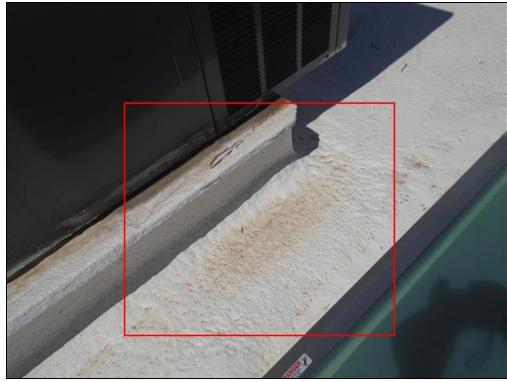
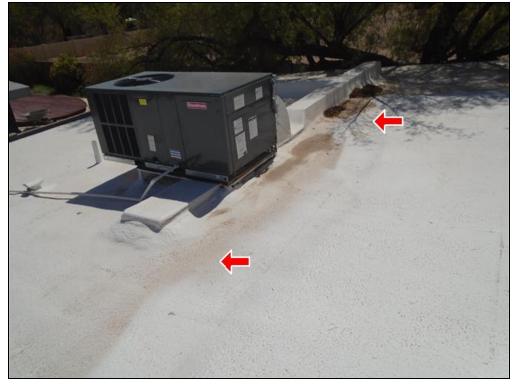
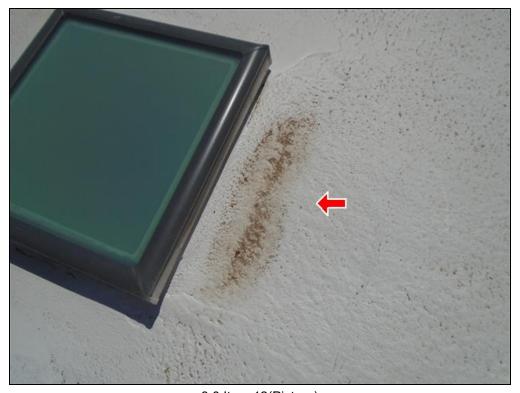
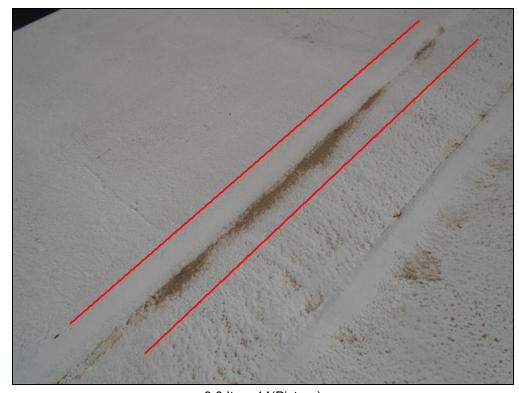
(2) There is evidence of ponding in low places on the roof. The roof sealant is a water based product that will rehydrate and fail to protect the foam if wet for too long. If the water does not evaporate in 48 hours I recommend evaluation by a licensed roofer and remedy as needed.

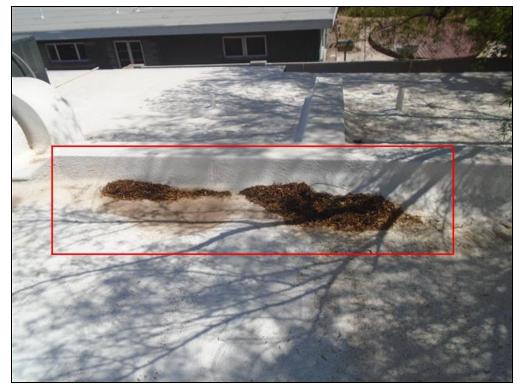
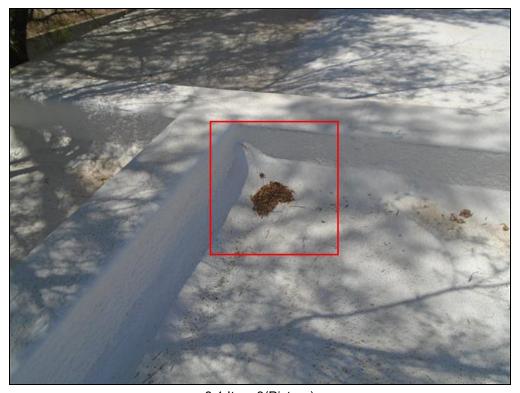
- (1) Overall the roof drainage system is in satisfactory condition.
- (2) Remove the leaf litter from the flat roof surfaces to improve water flow.

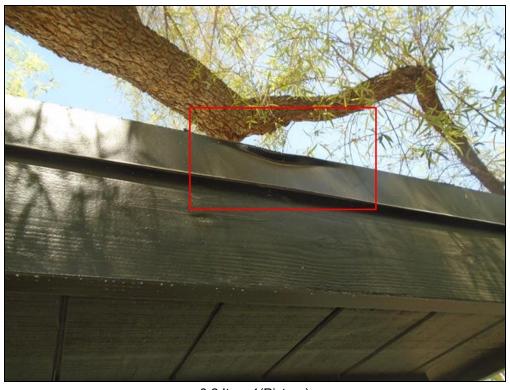
3.2 Item 1(Picture)

(2) The rear left drip edge flashing is damaged, repair or replace as needed.

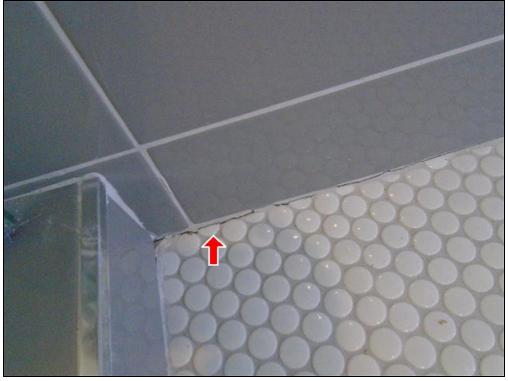
4.2 Item 1(Picture)

(1) Seal all cracks in grout and tile to prevent water intrusion.

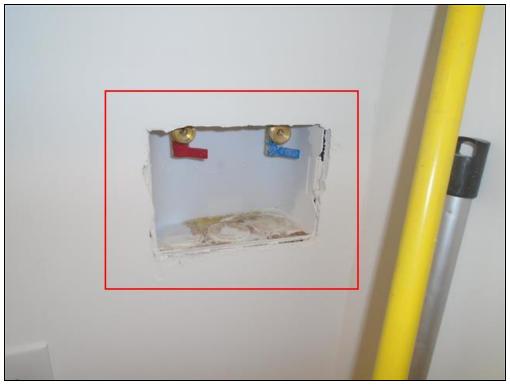
4.2 Item 3(Picture)

(2) The laundry room supply valve box trim has been removed, I recommend replacement.

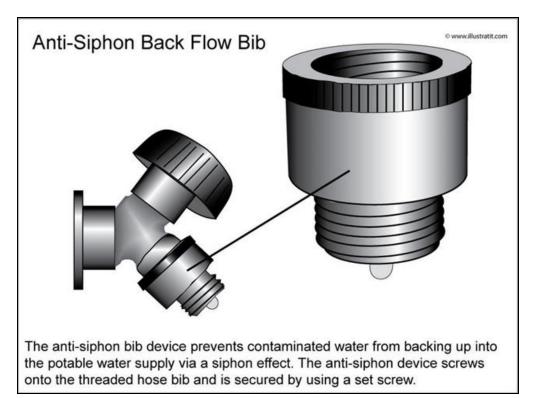
4.5 Item 1(Picture)

Exterior hose bibs require anti-siphon devices to prevent possible contamination of the potable water supply. Consider the addition of anti-siphon devices to the exterior hose bibs.

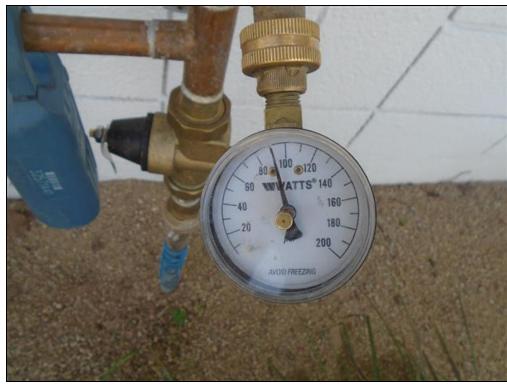
4.13 Item 1(Picture)

Water pressure above 80 psi is considered excessive by industry standards and can cause damage to plumbing fixtures. In addition, many home warranty companies will not honor a plumbing claim if the water pressure is above 80psi. The water pressure on this home is in excess of 80 psi. I recommend lowering the water pressure to within the recommended range. There is a pressure reducing valve installed.

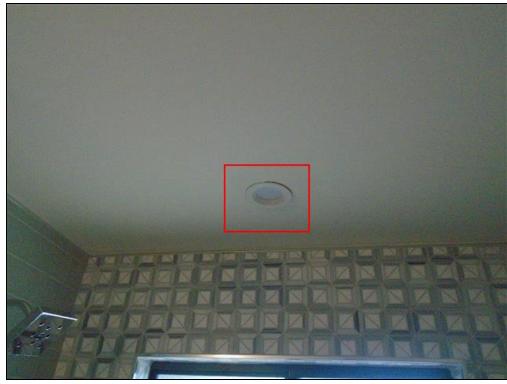
5.6 Item 1(Picture)

(2) The hallway guest bathroom recessed can light is not secured to the ceiling, remedy as needed.

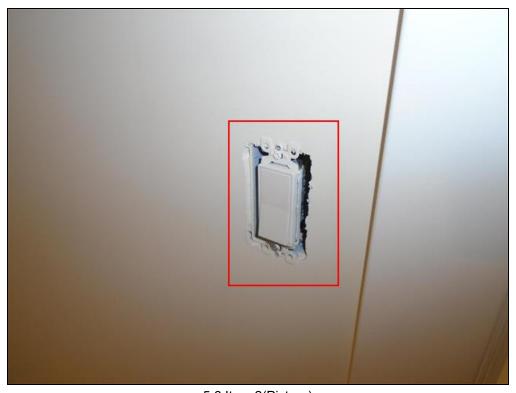
5.6 Item 2(Picture)

(3) The master closet light switch cover has been removed, I recommend replacement.

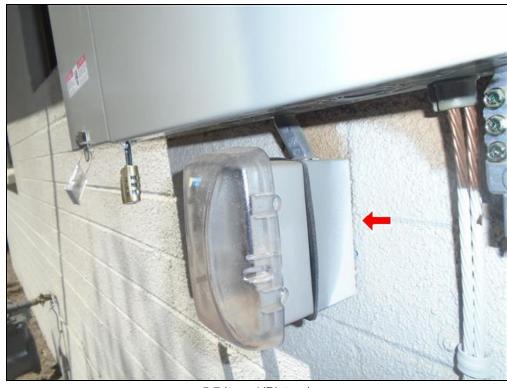
5.7 Item 1(Picture)

- (1) A representative number of receptacles were tested for polarity and ground and found to be operational and in satisfactory condition.
- (2) The outlet under the electric service panel is loose to the wall, secure as needed.

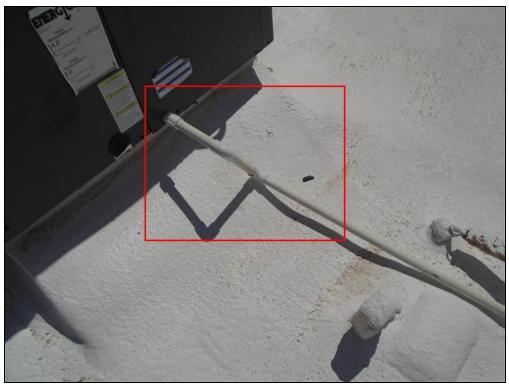
7.9 Item 1(Picture)

Condensate drains require a "P" trap and vent to prevent blockage, there are no "P" trap and vent on these drains. Remedy as needed.

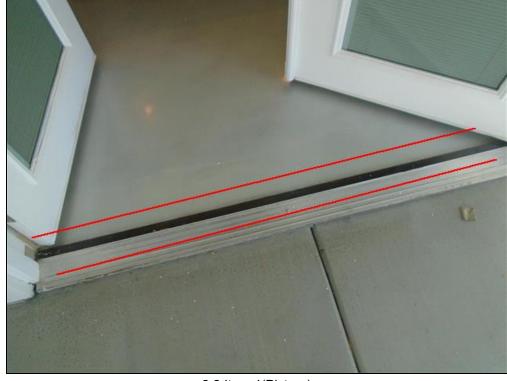
2.2 Item 4(Picture)

(3) There is daylight visible between the master bedroom exterior doors, remedy as needed.

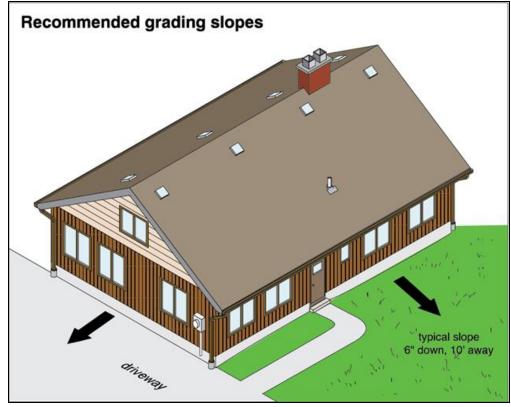
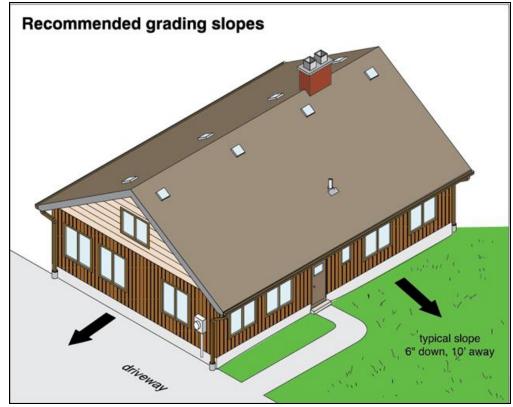
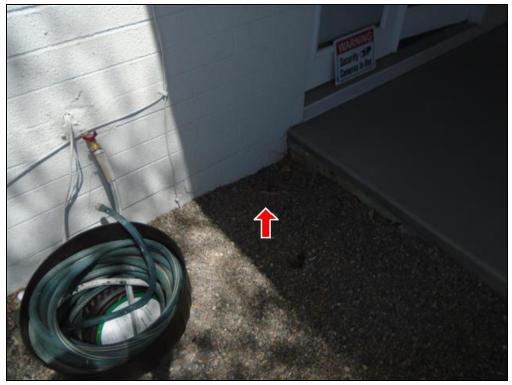
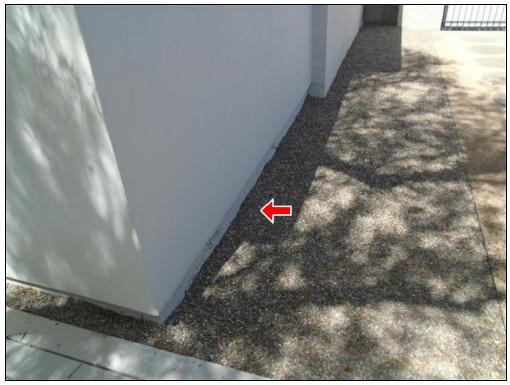
(1) The grade is sloped toward the house on all sides of the house. This will direct surface water into the soil adjacent to the foundation and cause water damage to the foundation concrete. Adjust the grade to direct surface water away from the foundation to prevent water damage.

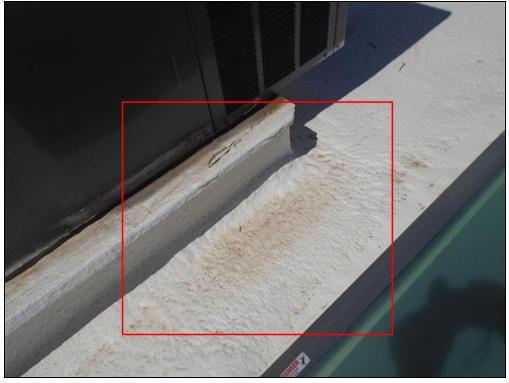
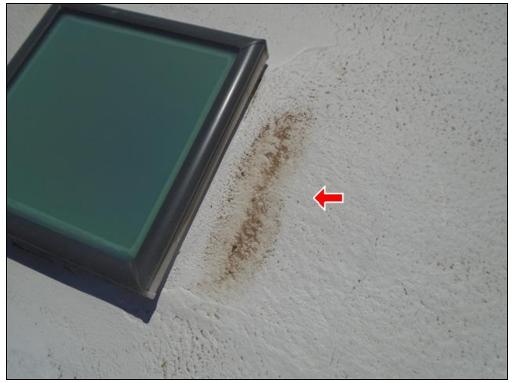
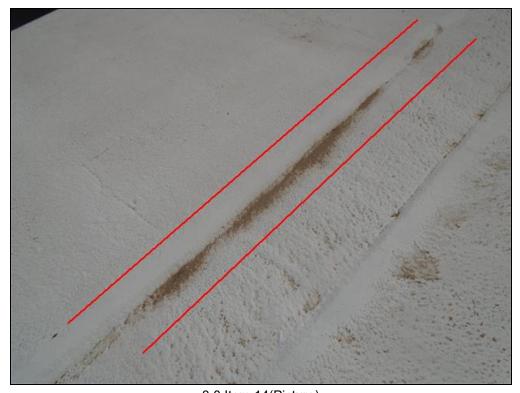
(2) There is evidence of ponding in low places on the roof. The roof sealant is a water based product that will rehydrate and fail to protect the foam if wet for too long. If the water does not evaporate in 48 hours I recommend evaluation by a licensed roofer and remedy as needed.

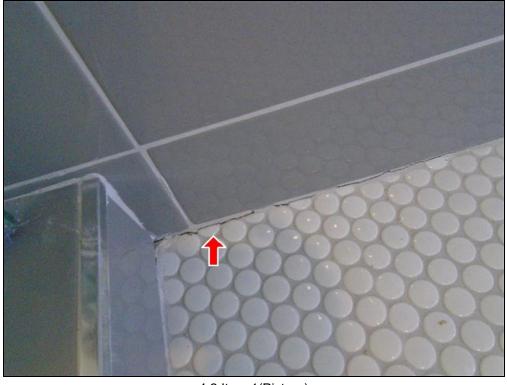
4.2 Item 1(Picture)

(1) Seal all cracks in grout and tile to prevent water intrusion.

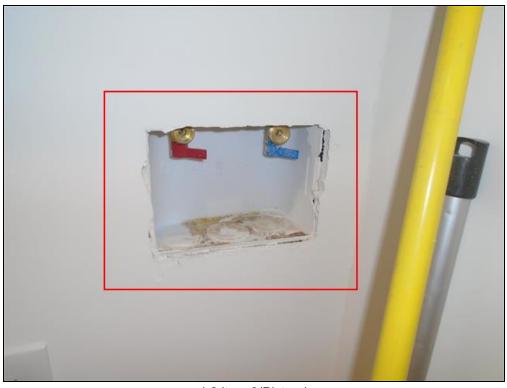
4.2 Item 3(Picture)

(2) The laundry room supply valve box trim has been removed, I recommend replacement.

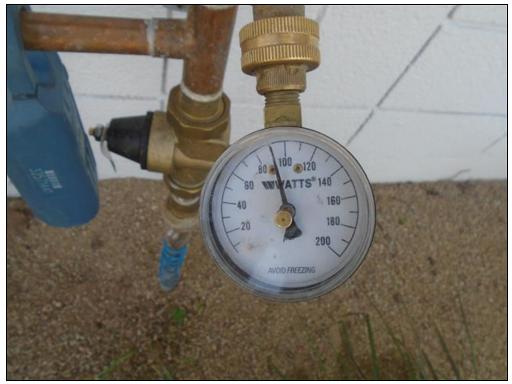
4.13 Item 1(Picture)

80psi. The water pressure on this home is in excess of 80 psi. I recommend lowering the water pressure to within the recommended range. There is a pressure reducing valve installed.

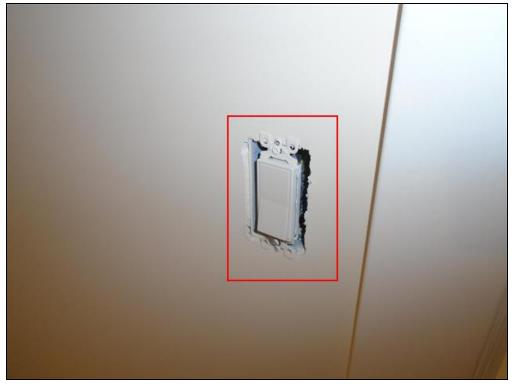
5.6 Item 2(Picture)

(3) The master closet light switch cover has been removed, I recommend replacement.
