Inspection Report

Property Address:
123 2nd Star on the Right Ln.
Scottsdale AZ 85262

Liberty Inspection Service

Date: 7/26/2018	Time: 08:00 AM	Report ID: Sample Report 1
Property: 123 2nd Star on the Right Ln. Scottsdale AZ 85262	Customer: Home Buyer	Real Estate Professional: Sample Agent

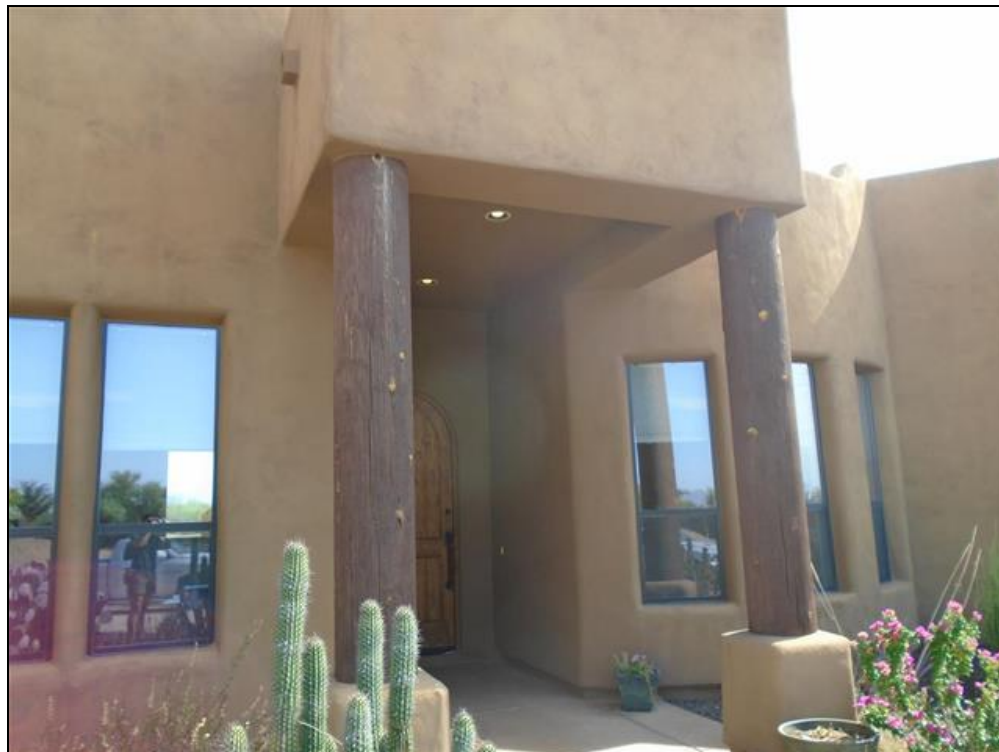
1.3 Item 1(Picture)

(1) Overall, the visible portions of the posts/columns are in satisfactory condition.

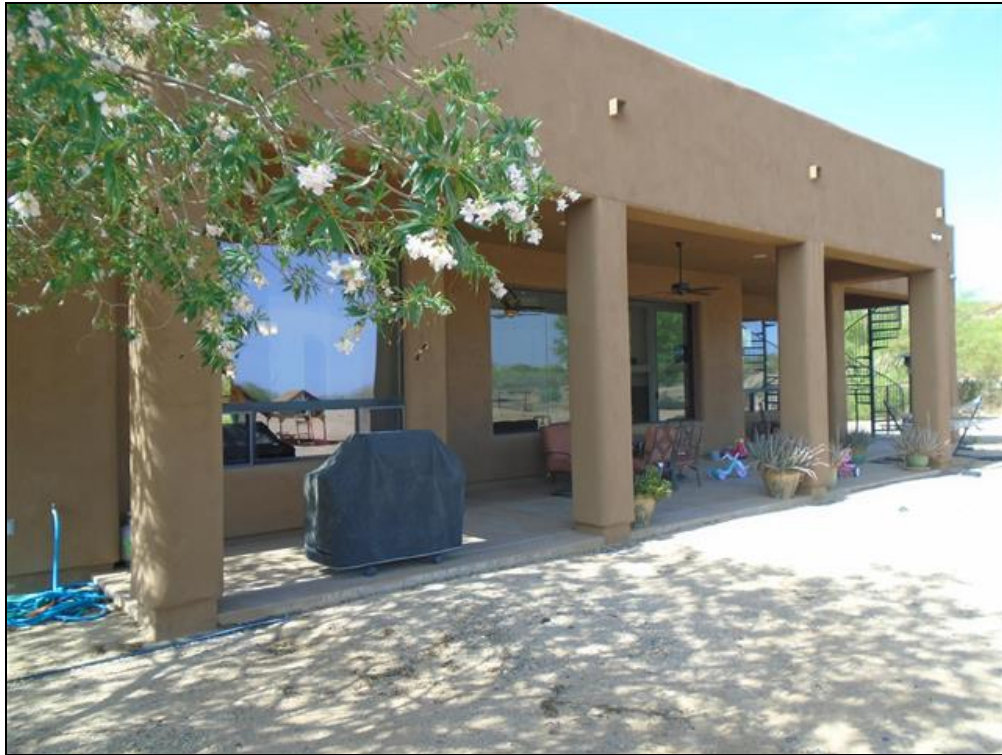
1.3 Item 2(Picture)

(2) The front porch exposed wood beams need to be re-sealed to prevent further cracking. We recommend re-sealing these beams once a year to prevent water intrusion into the cracks of the wood.

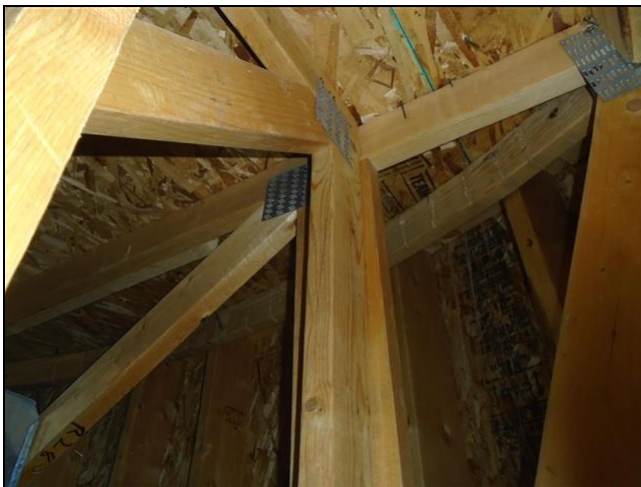
1.4 Item 1(Picture)

The visible portions of the roof and ceiling structure are in satisfactory condition.

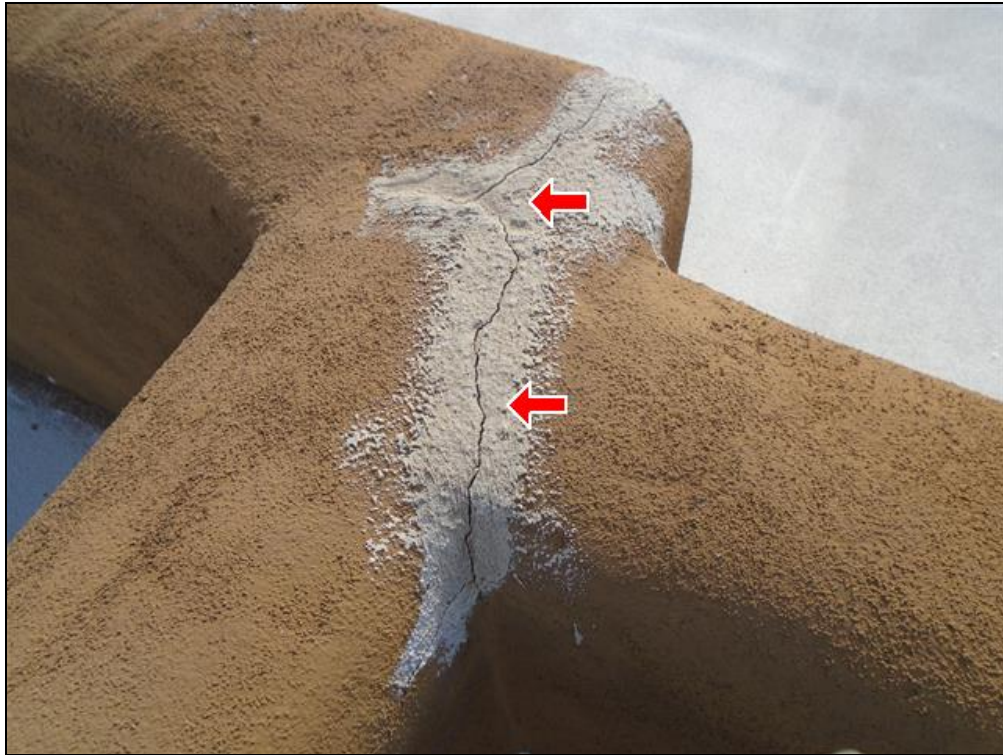
2.0 Item 1(Picture)

(2) Repair the small cracks and holes in the parapet walls and seal as needed to prevent water intrusion.

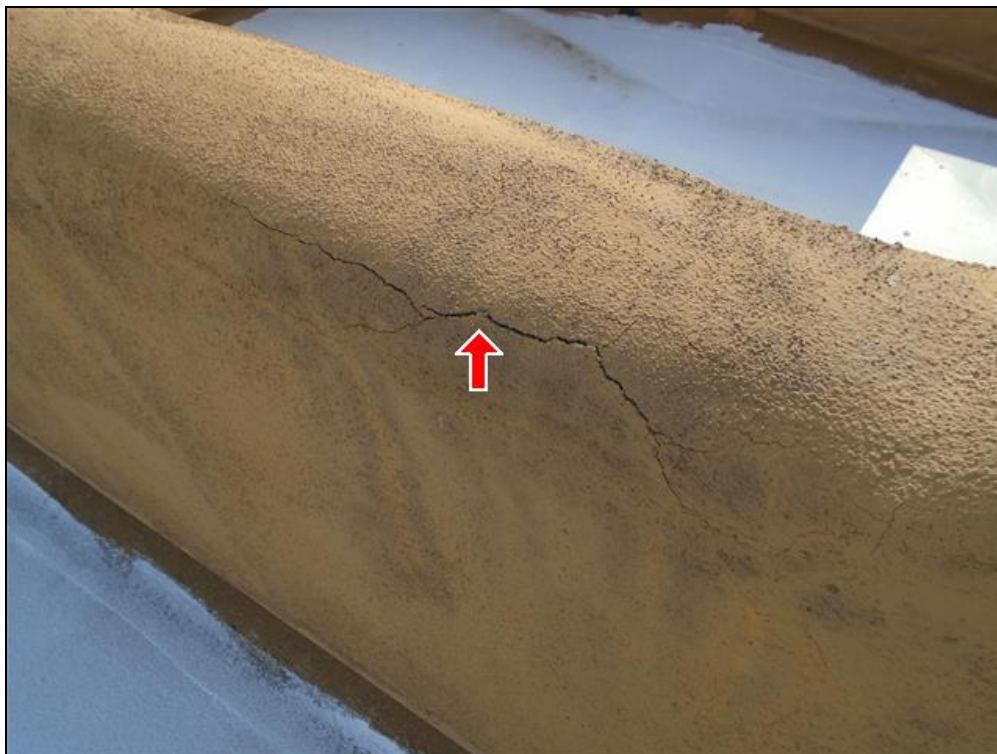
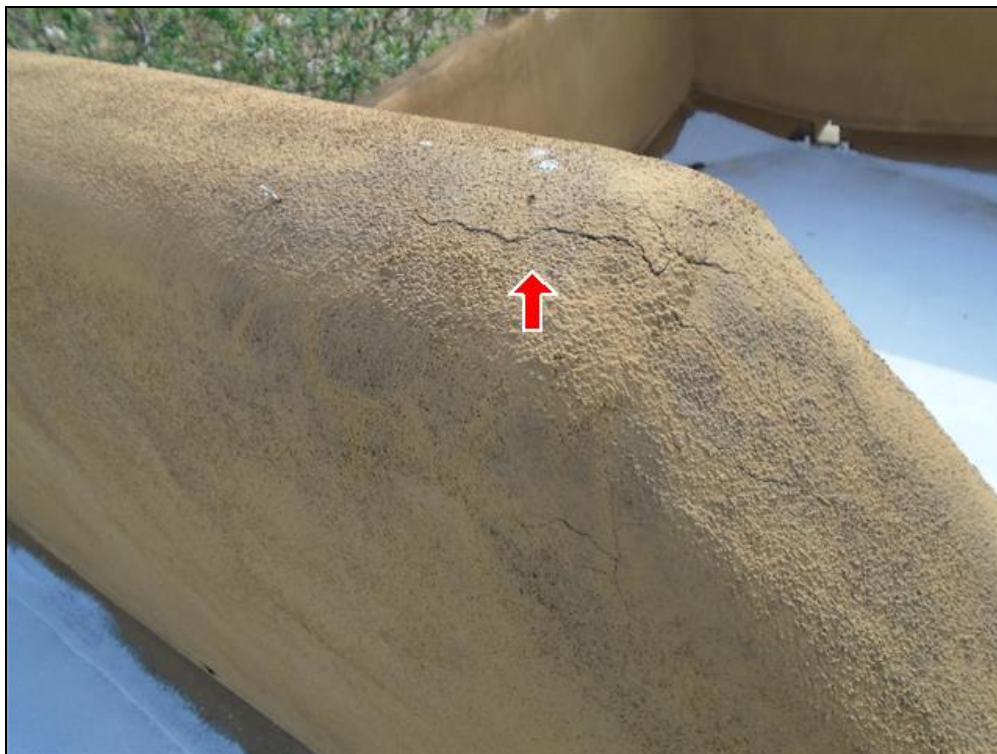
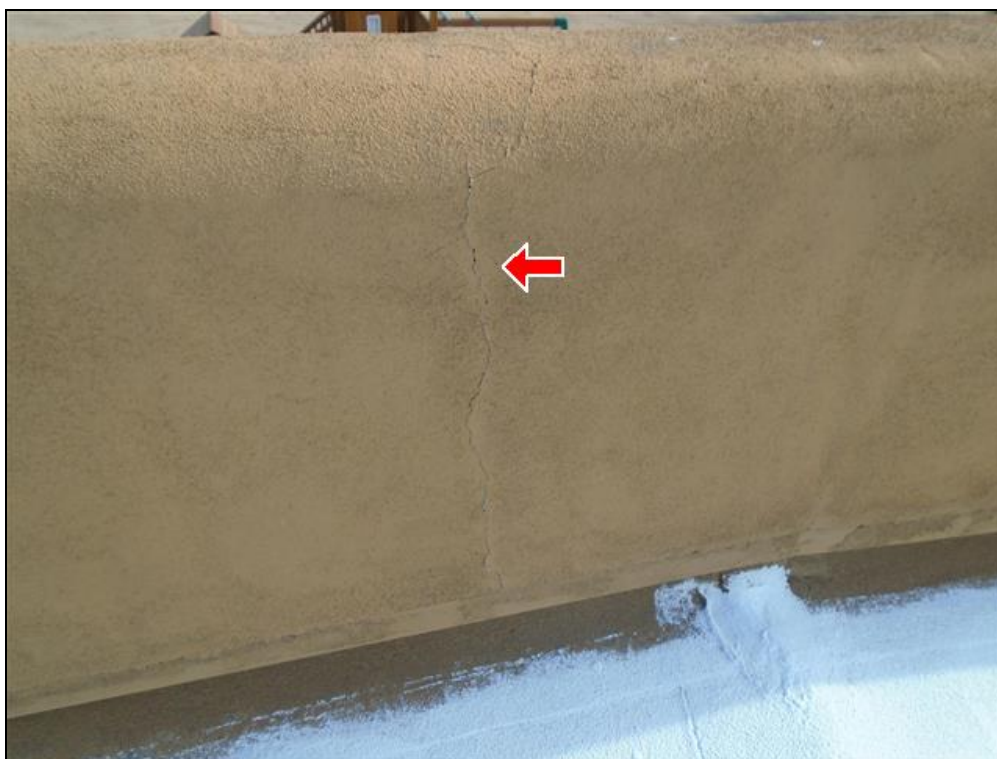
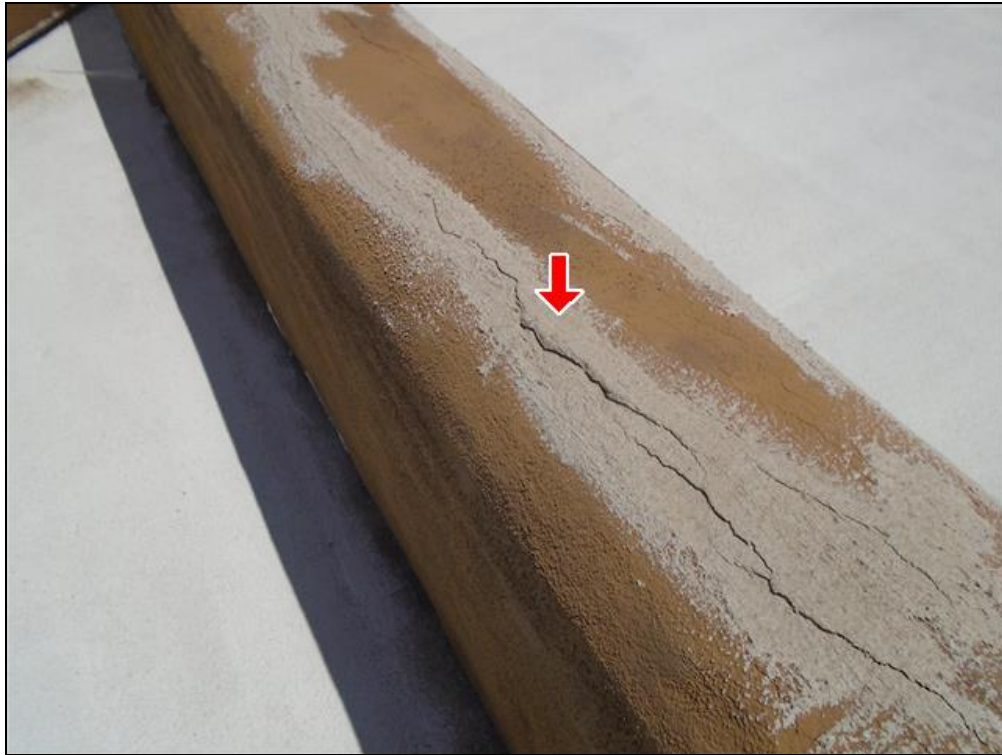
(1) Overall the visible portions of the exterior wall cladding is in satisfactory condition. Stucco has or will develop typical hairline cracks, seal all exterior penetrations as needed to prevent water and pest intrusion.

(3) The exterior paint is beginning to fade, budget for exterior re-paint in the near future.

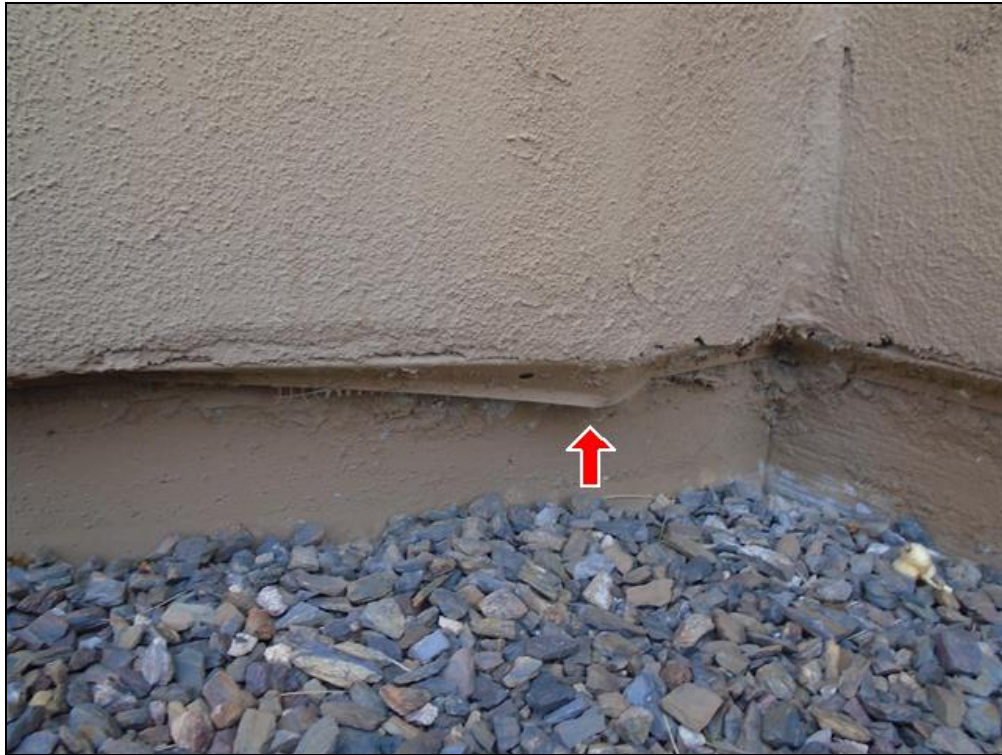
2.1 Item 1(Picture)

- (1) Overall the visible portions of the flashing and trim are in satisfactory condition.
- (2) The weep screed is loose on portions of the front of the house, secure as needed.

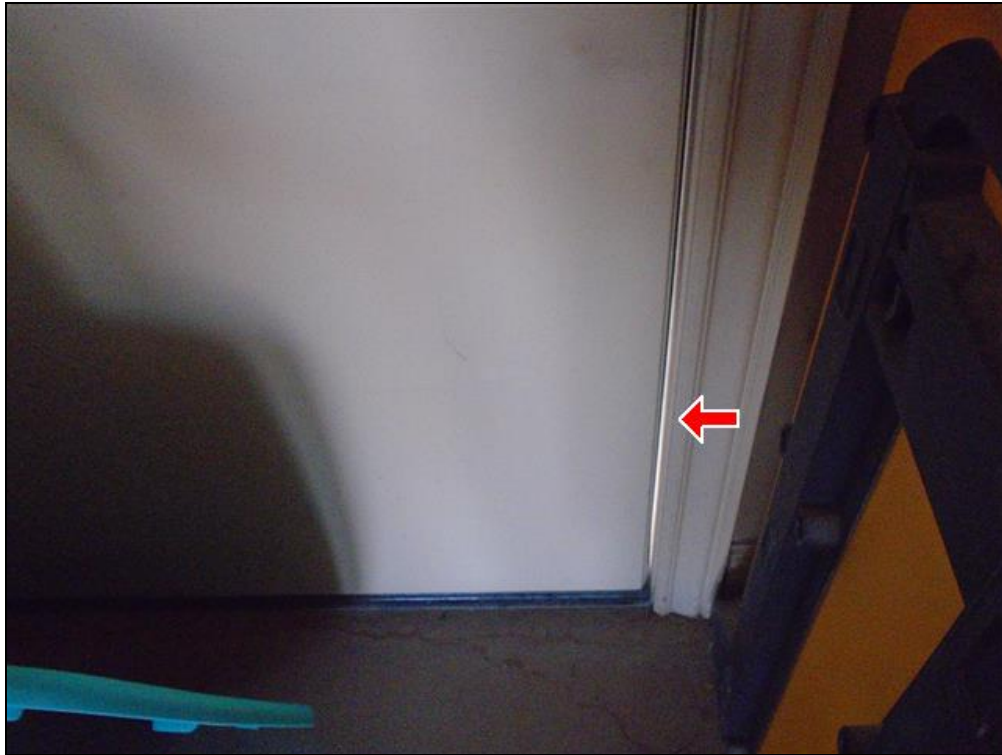
2.2 Item 1(Picture)

(2) There is daylight visible around the garage service door and there is evidence of previous water intrusion, remedy as needed.

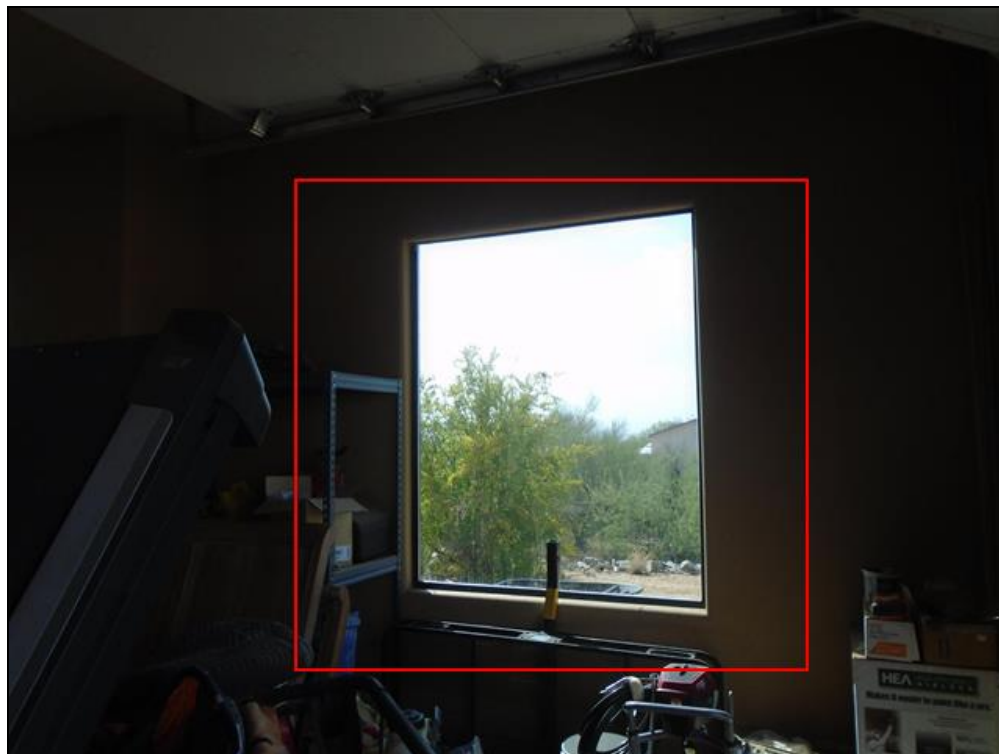
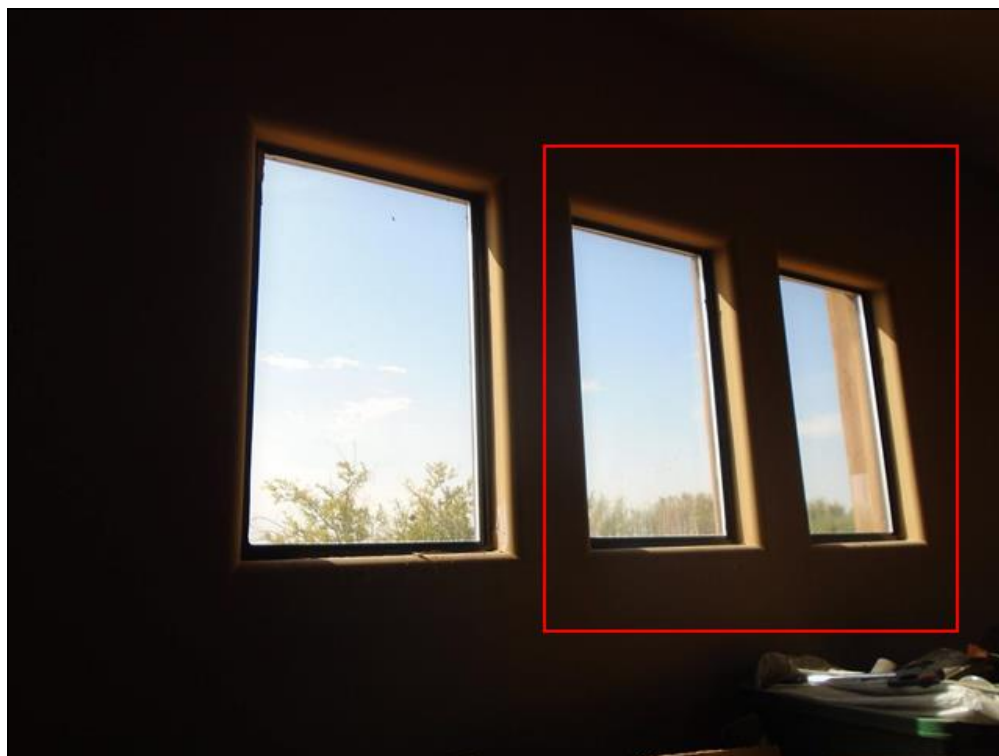
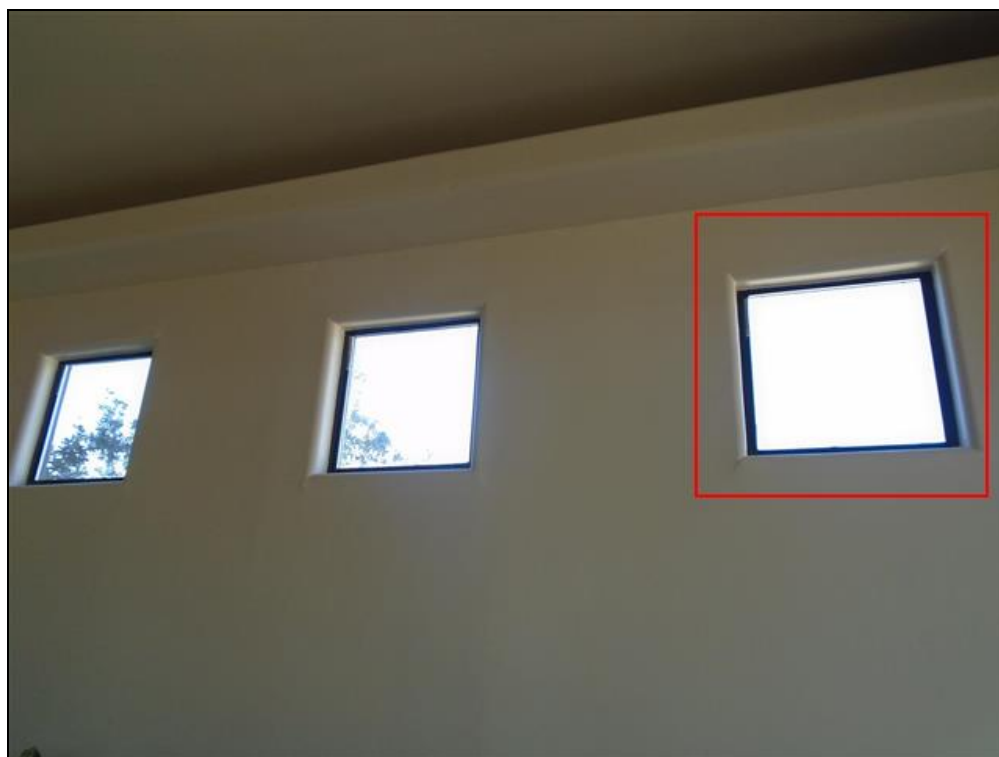
(1) Several of the windows have lost their thermal seal, the foggy appearance indicates the presence of moisture between the panes of glass. I specifically noted the following windows: garage windows, master bedroom high right window, and the right office window. I recommend a licensed window installer check all the windows and repair or replace as needed.

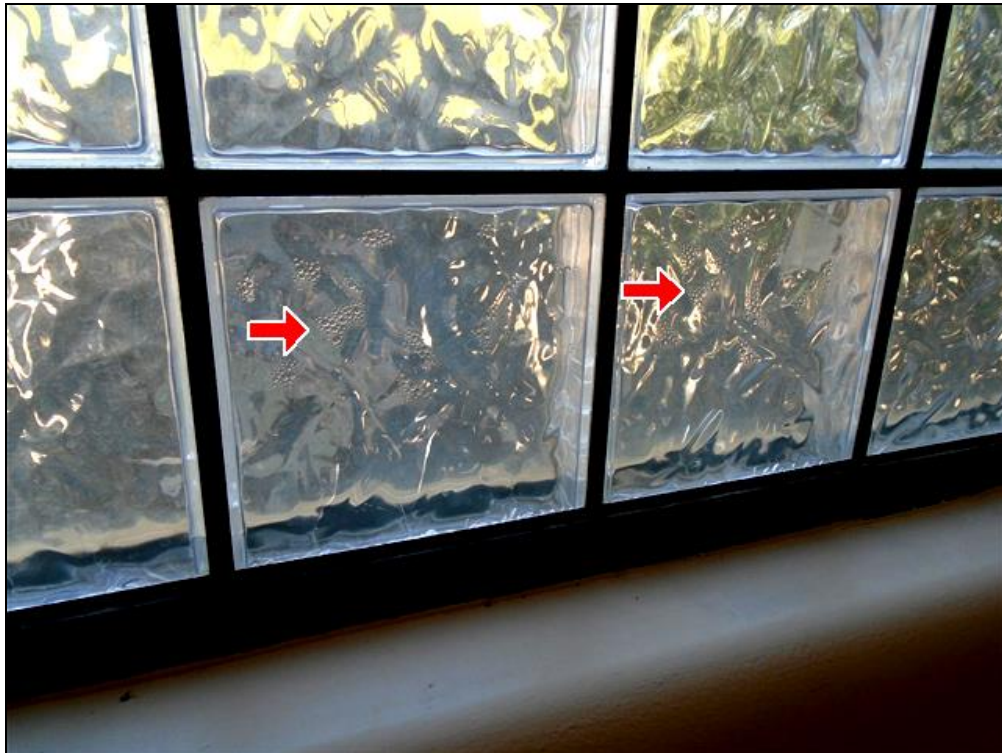
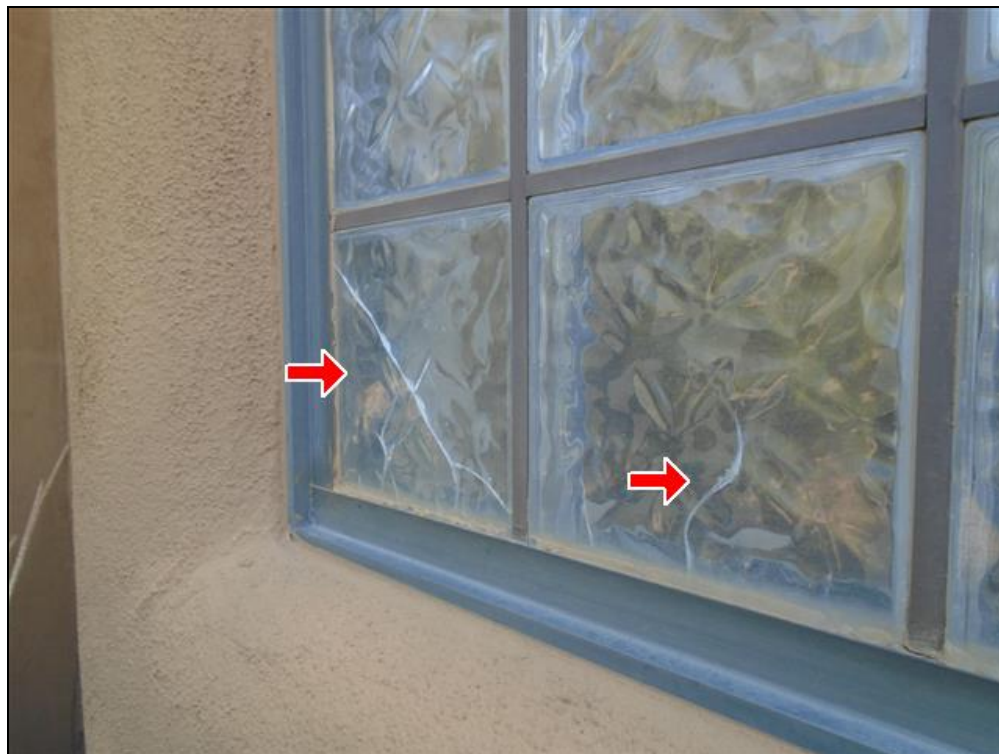
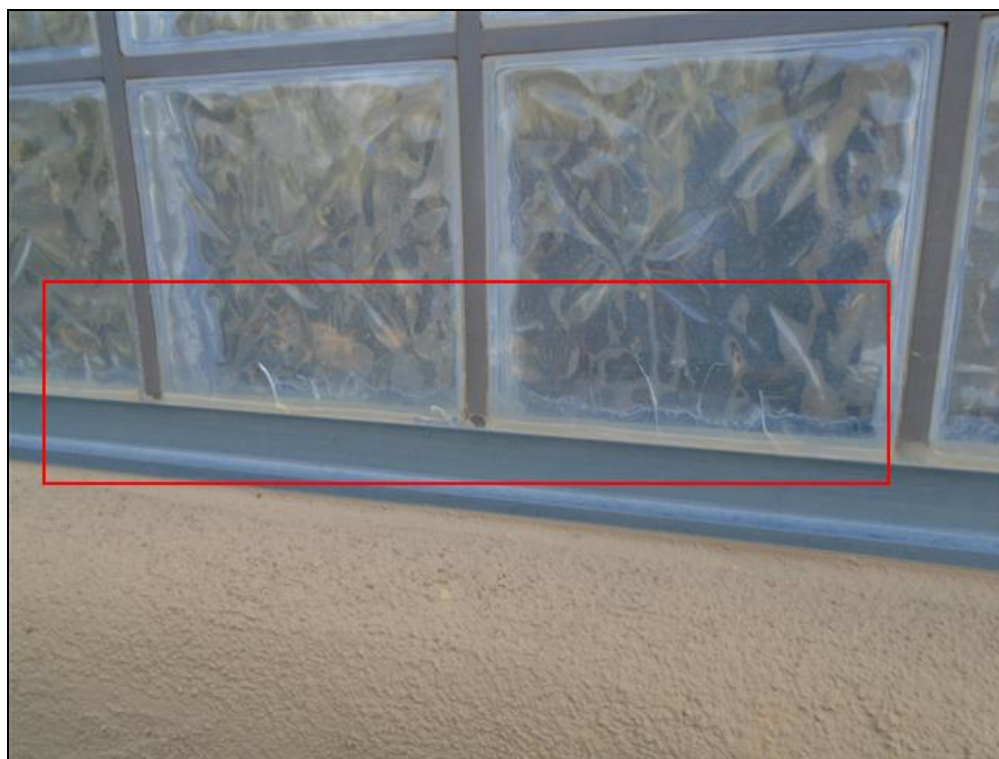
(2) The master bathroom bottom row of glass blocks are cracked and there is water inside of some of the blocks. Remedy as needed.

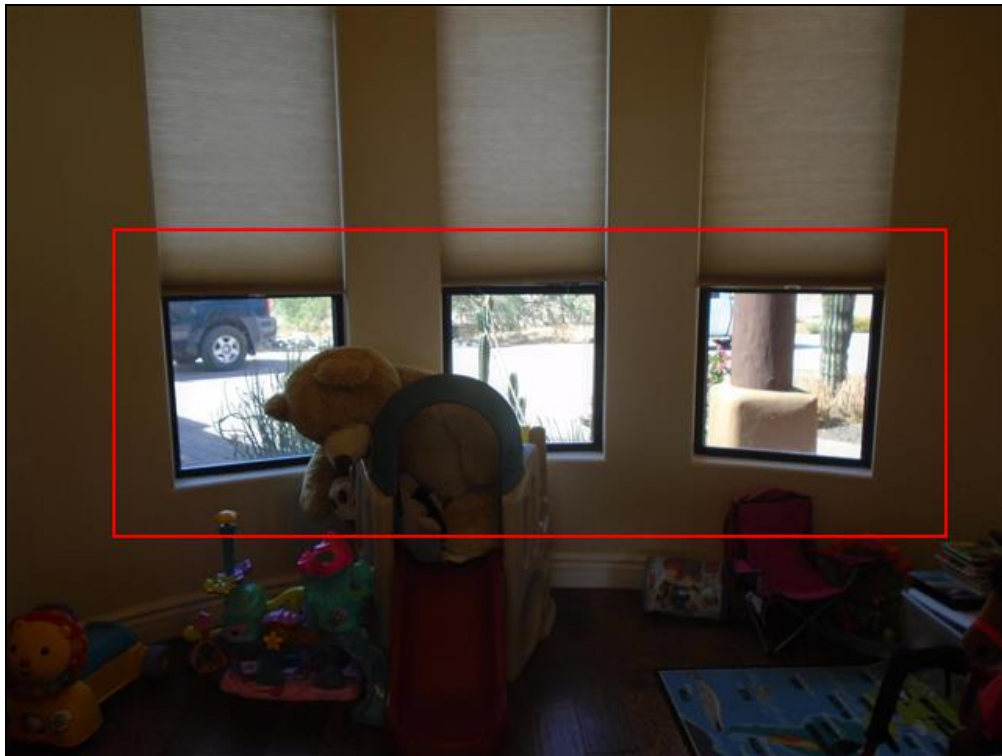
2.3 Item 9(Picture)

(3) There are numerous windows throughout the house that are difficult to operate, do not stay open, have damaged stops or springs need adjustment. I recommend evaluation of all windows by a licensed window installer with remedy as needed.

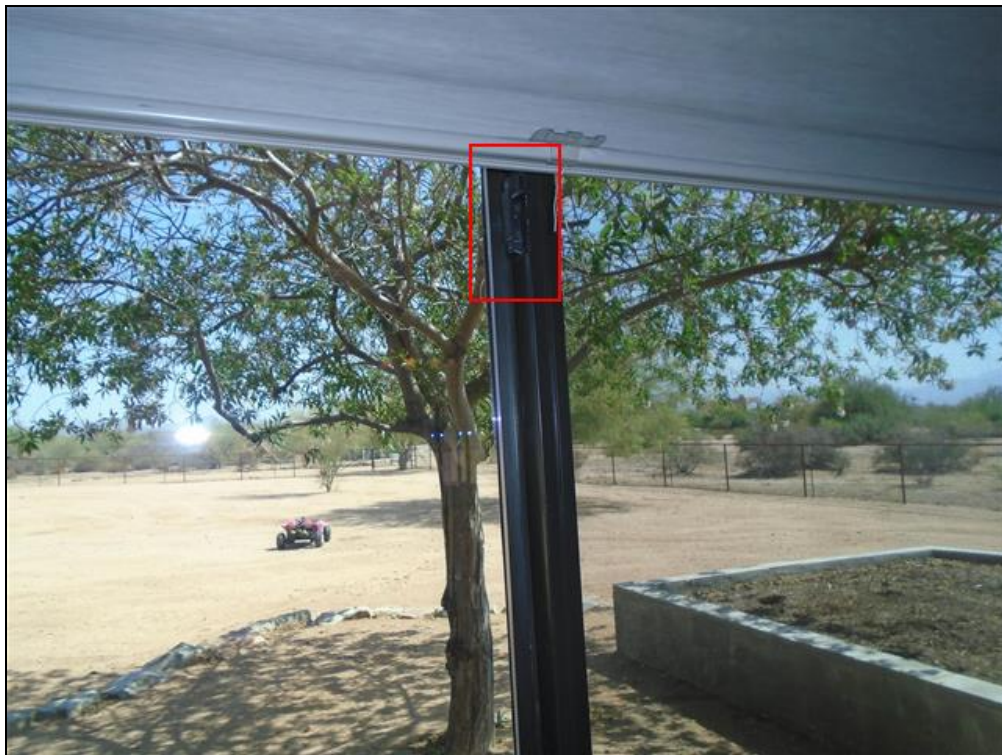
2.3 Item 11(Picture)

(4) The rear right bedroom window top lock is difficult to operate, adjust as needed.

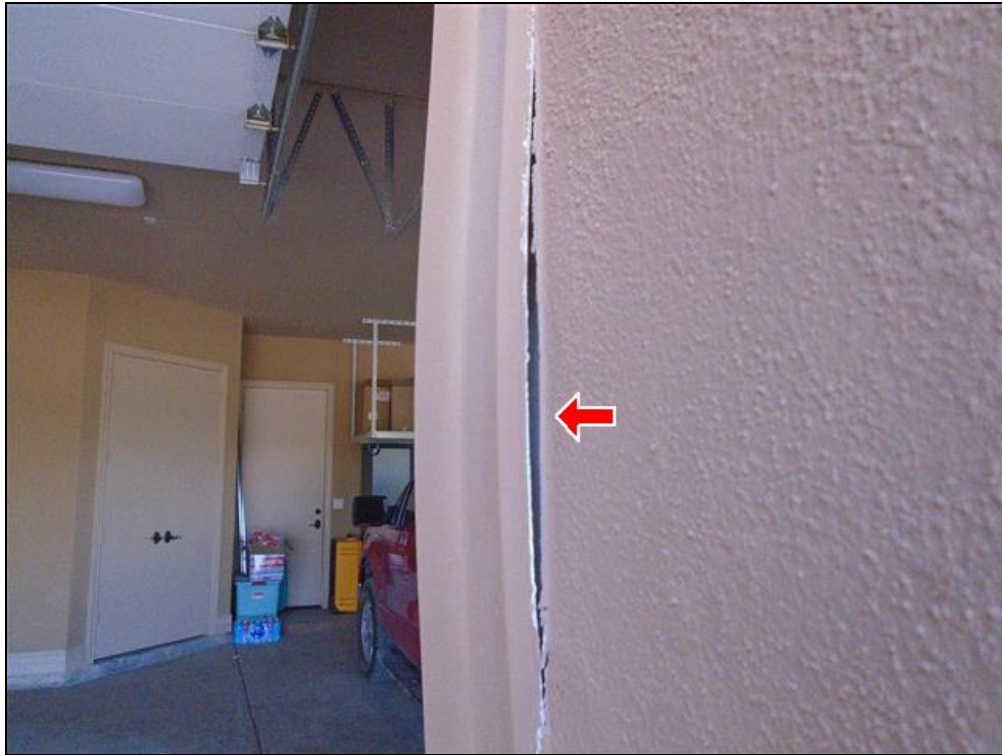
2.4 Item 1(Picture)

- (1) The garage doors and openers are in satisfactory condition and operational, including the safety reverse features.
- (2) The garage door trims are coming loose from the siding, secure as needed.

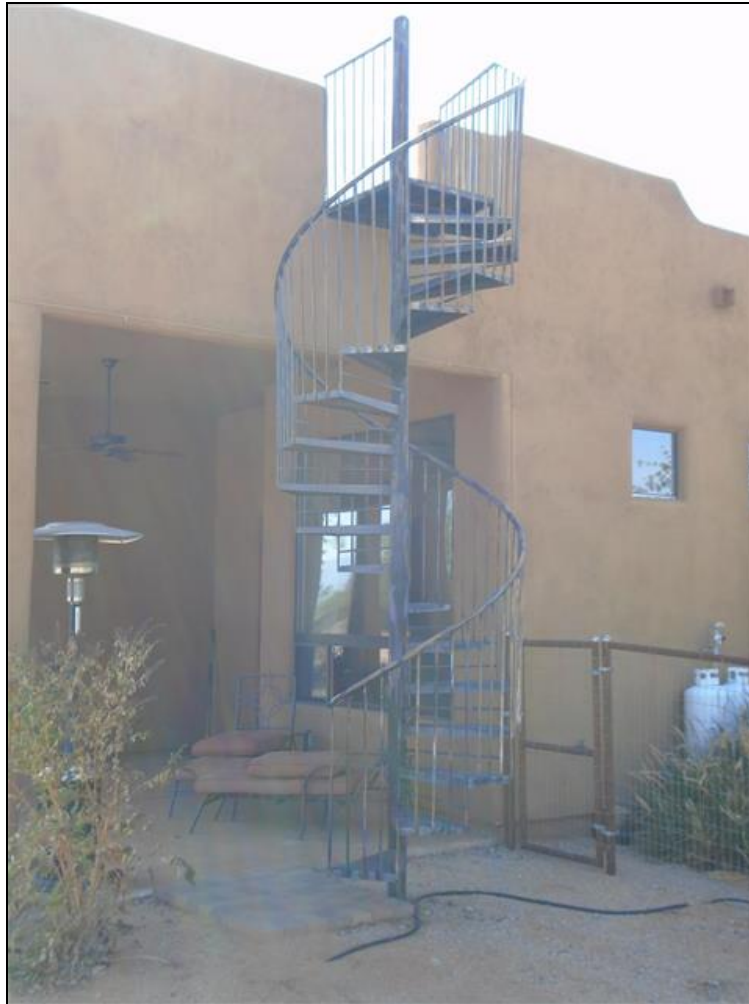
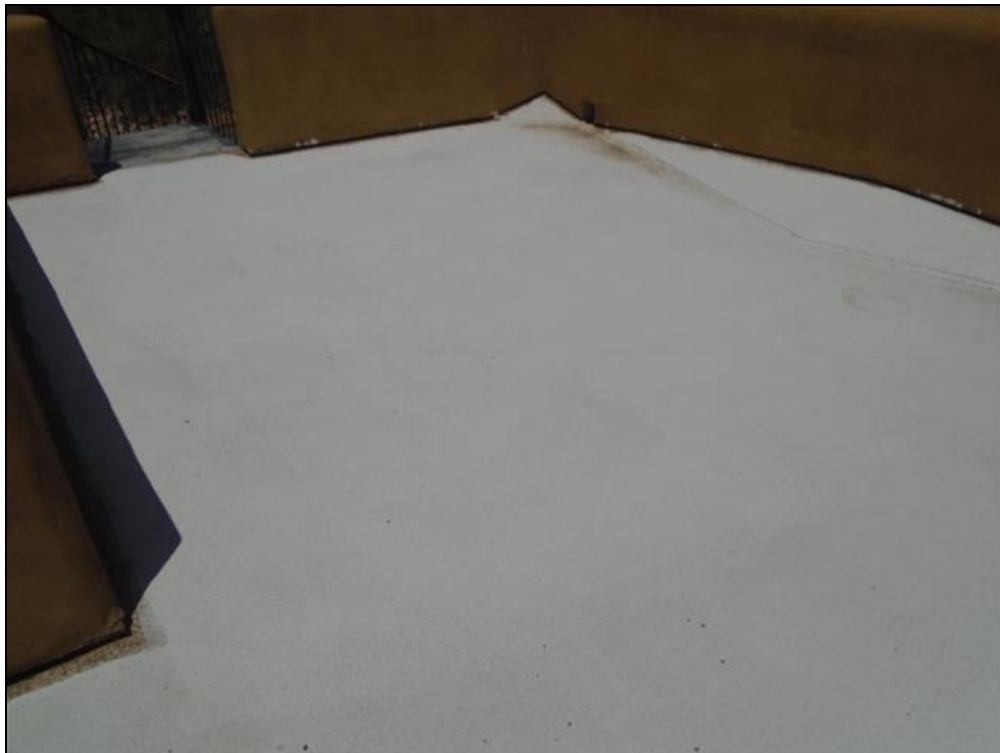
The visible portion of the decks, balconies and stairs are in satisfactory condition.

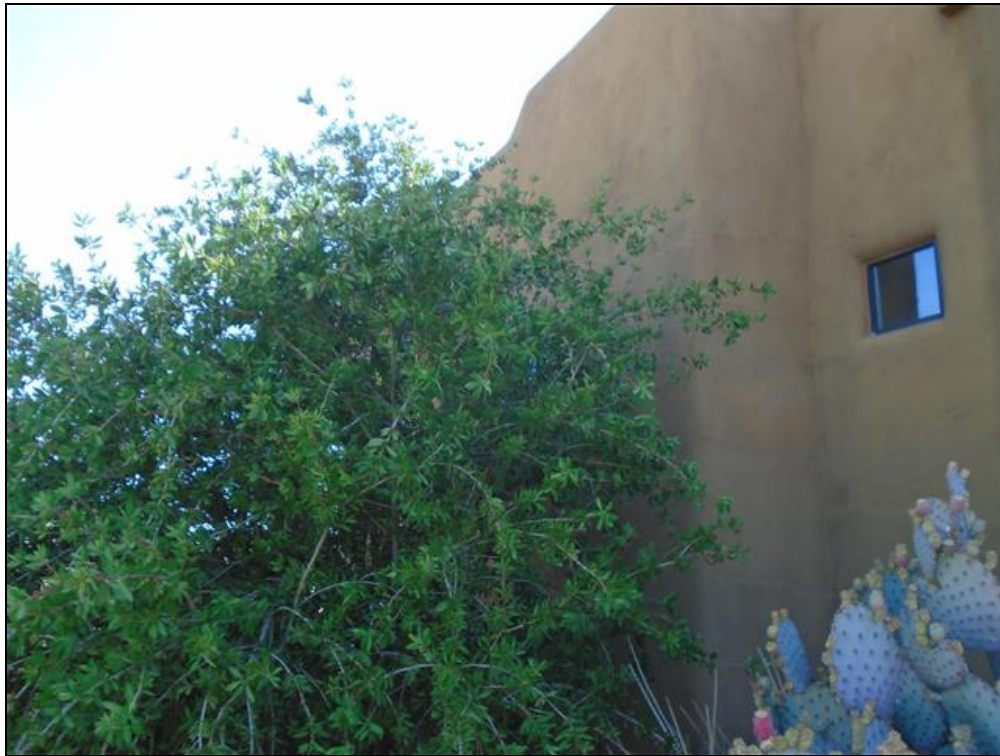
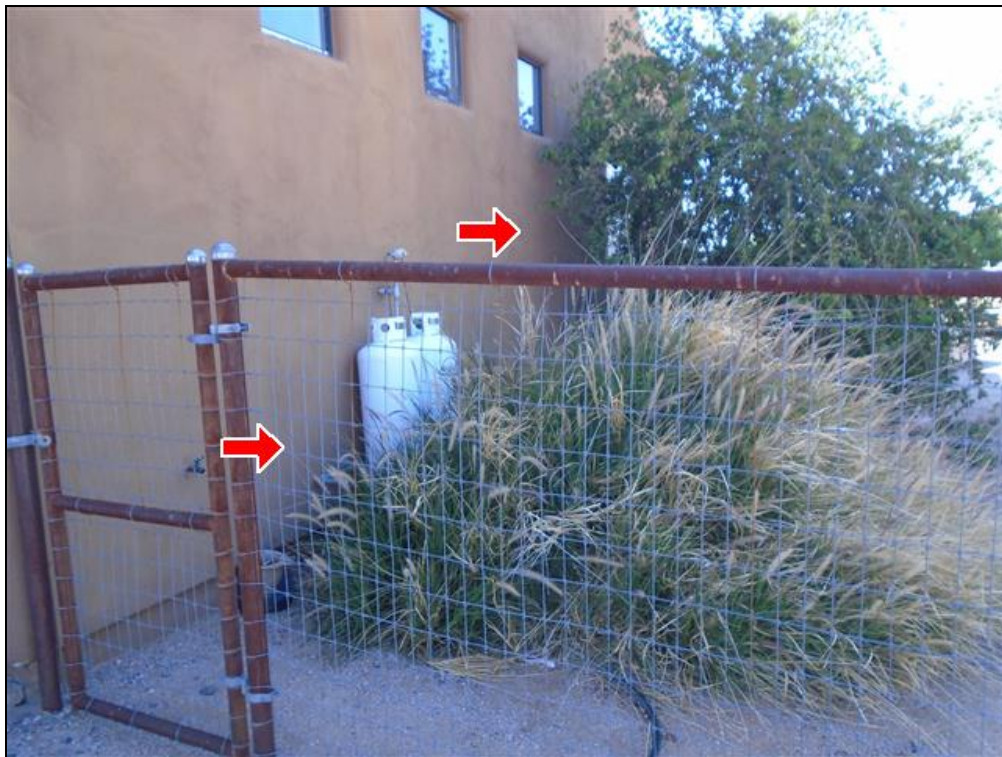
Tree limbs/vegetation in contact with the exterior can damage the finish and provide access for rodents. Trim as needed to prevent damage.

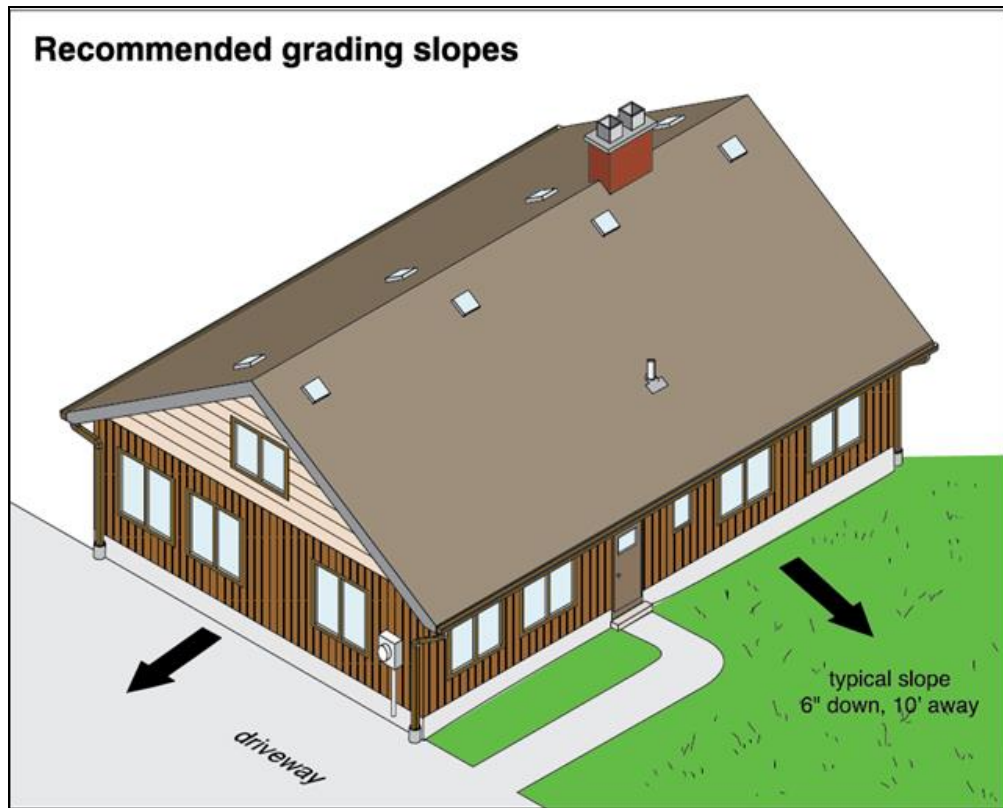
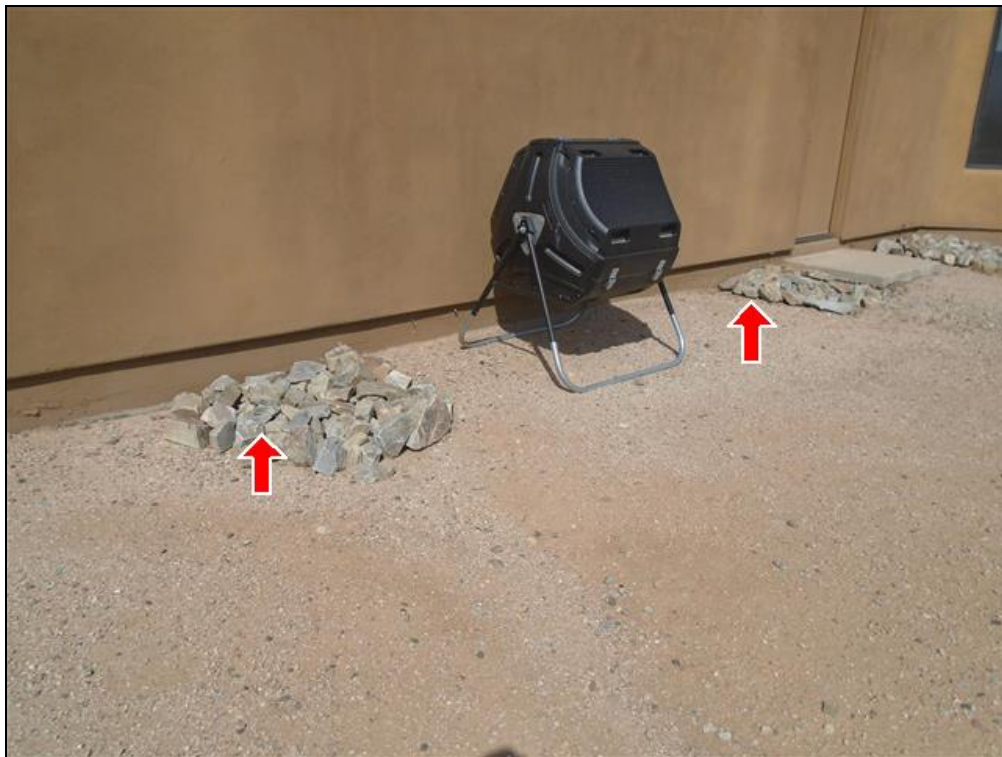
The grade is sloped toward the house on the left side, and rear. This will direct surface water into the soil adjacent to the foundation and cause water damage to the foundation concrete. Adjust the grade to direct surface water away from the foundation to prevent water damage.

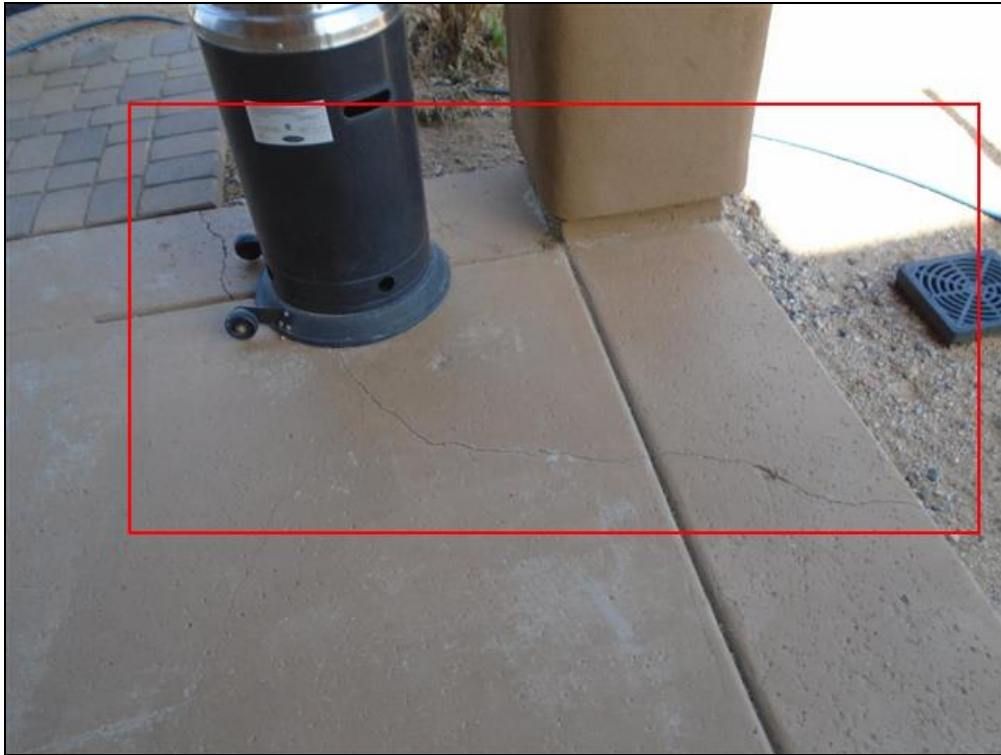
2.10 Item 1(Picture)

- (1) Overall the patios, walks and driveway are in satisfactory condition and have no adverse impact on the structure.
- (2) There is evidence of previous movement (settling) in a portion of the rear porch. Monitor for further movement with remedy as needed.

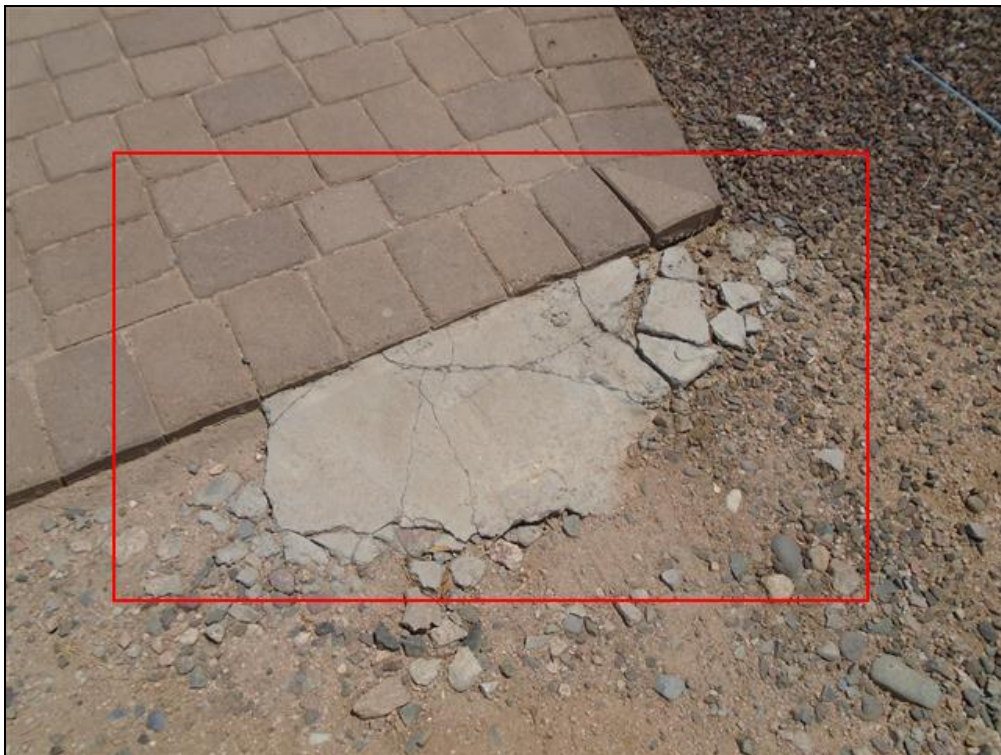
2.10 Item 2(Picture)

(3) The right driveway ramp onto the pavers is damaged, remedy as needed.

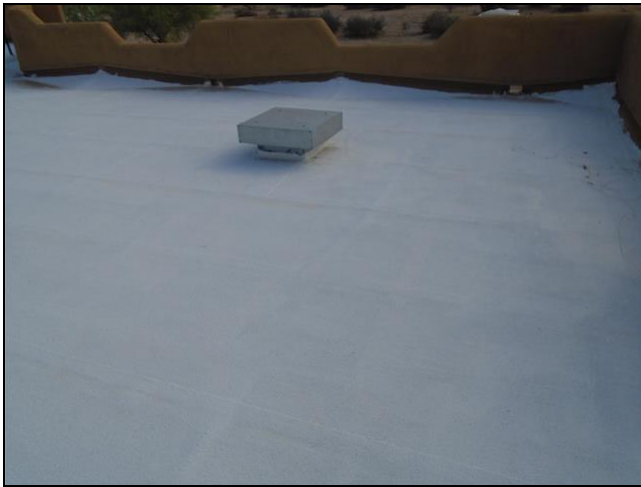
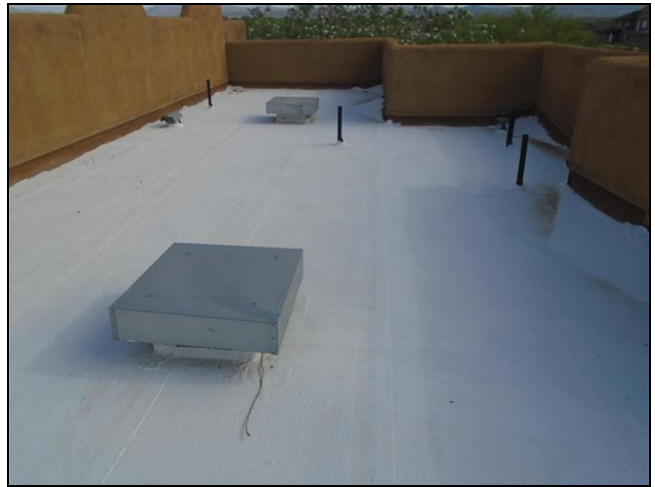
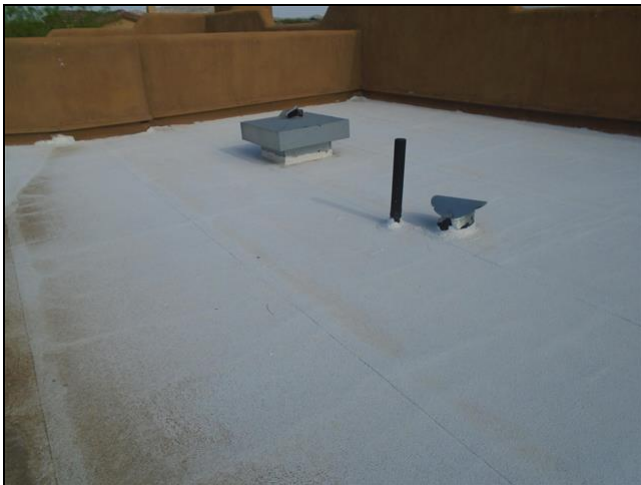
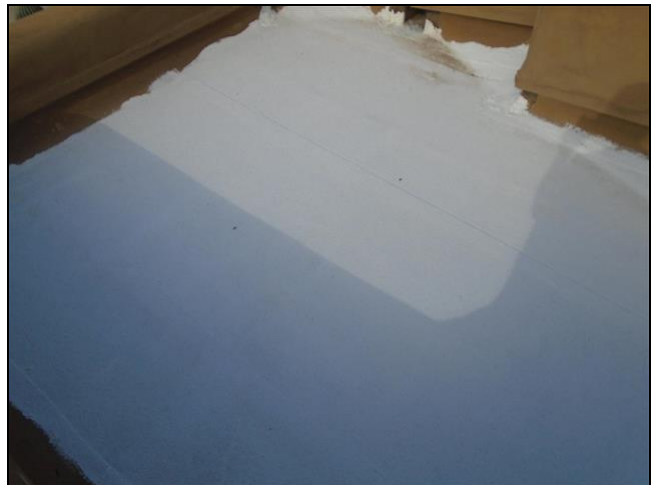
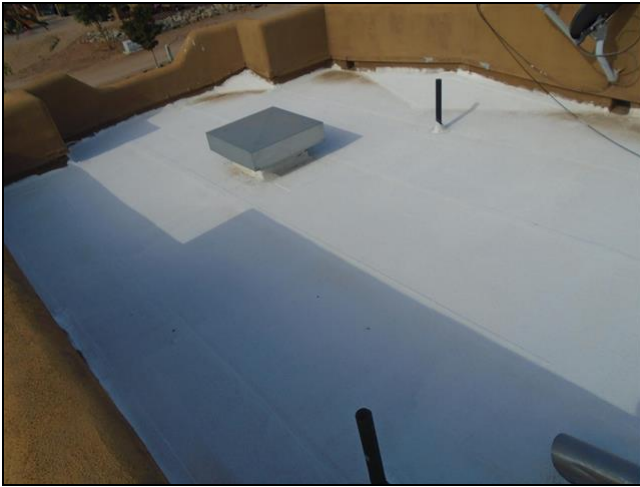
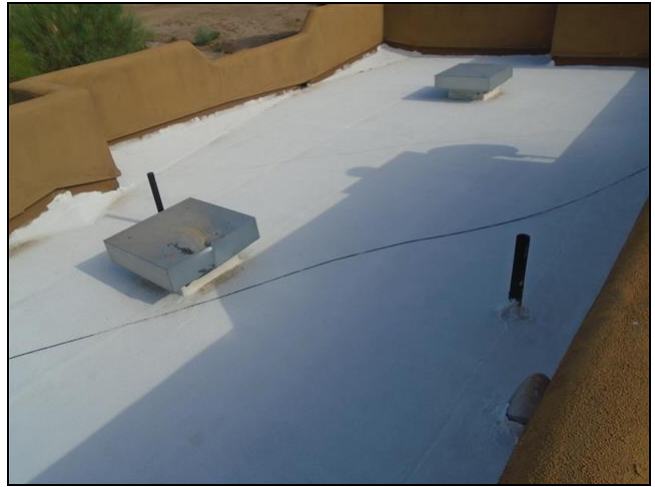
The visible portions of the roof coverings are in satisfactory condition.
