Inspection Report

Property Address:
123 2nd Star on the Right Ln.
Scottsdale AZ 85262

Liberty Inspection Service

Date: 7/26/2018	Time: 08:00 AM	Report ID: Sample Report 1
Property: 123 2nd Star on the Right Ln. Scottsdale AZ 85262	Customer: Home Buyer	Real Estate Professional: Sample Agent

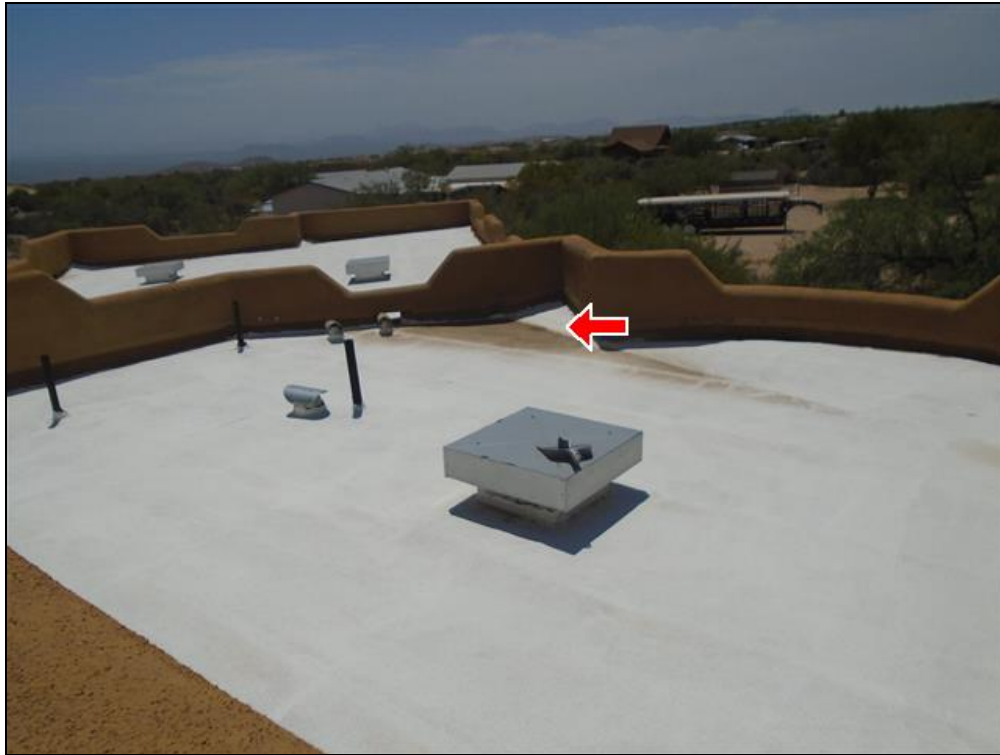
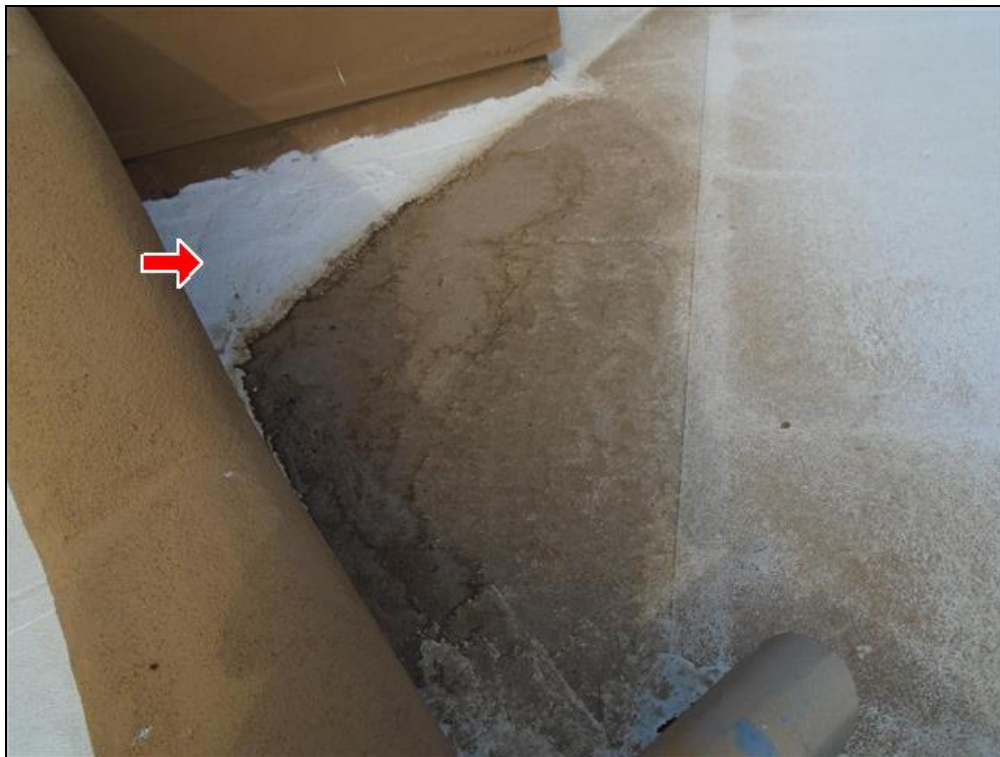
(2) There is evidence of ponding water on the front portion of the roof, adjust as needed to prevent damage to the finish and leakage.

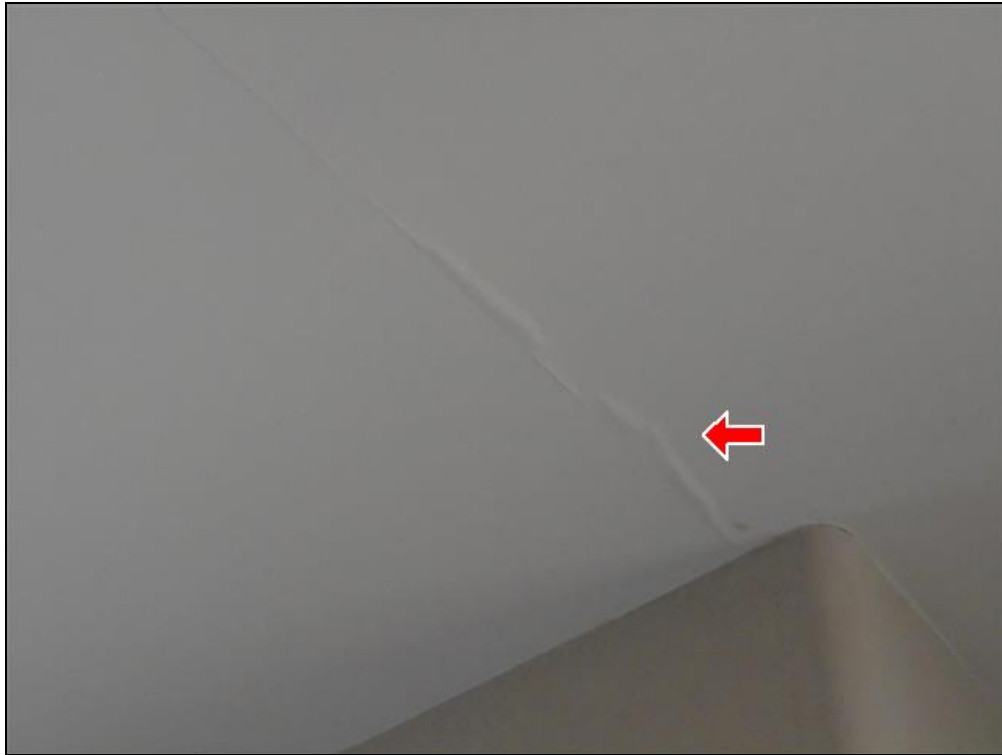
3.3 Item 1(Picture)

There are signs of previous leakage (water stains) on the rear porch decking and garage. Monitor for further leakage and repair if necessary.

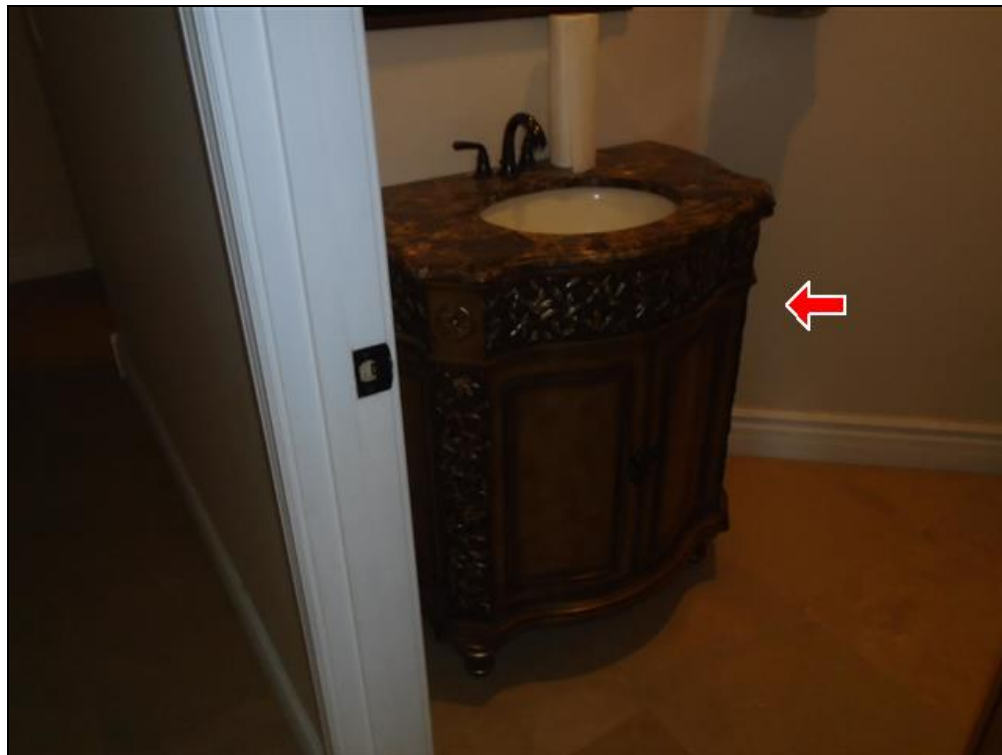
4.2 Item 1(Picture)

(2) Secure the powder bathroom vanity to the wall to prevent movement and damage to plumbing.

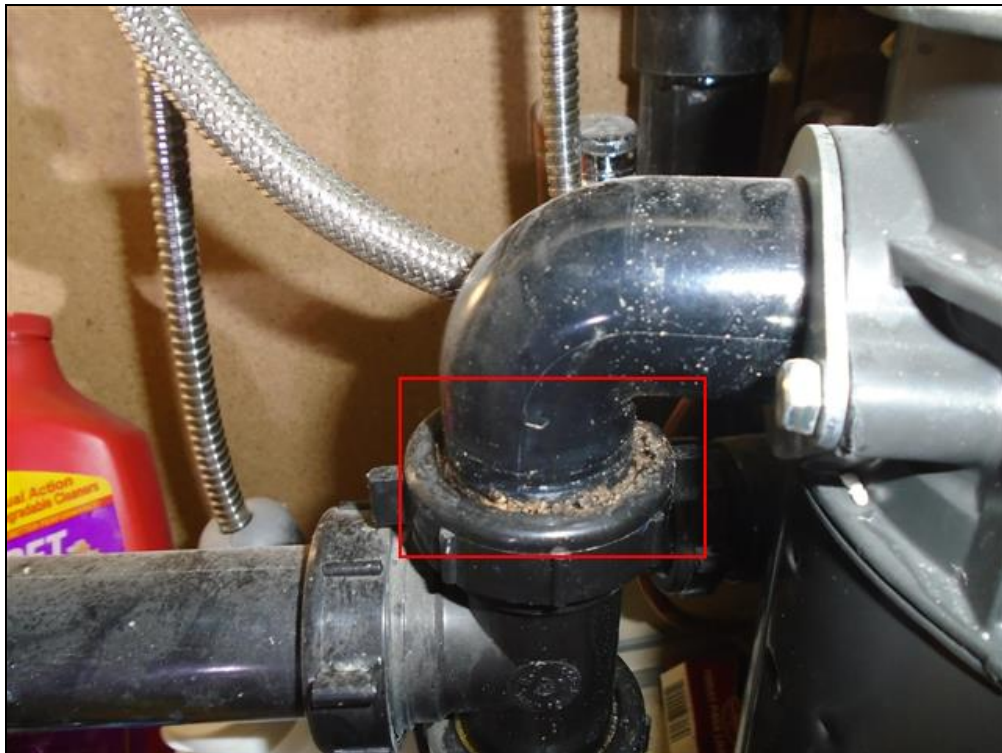
4.7 Item 1(Picture)

There is evidence of leakage at the kitchen sink drain. Repair as needed.

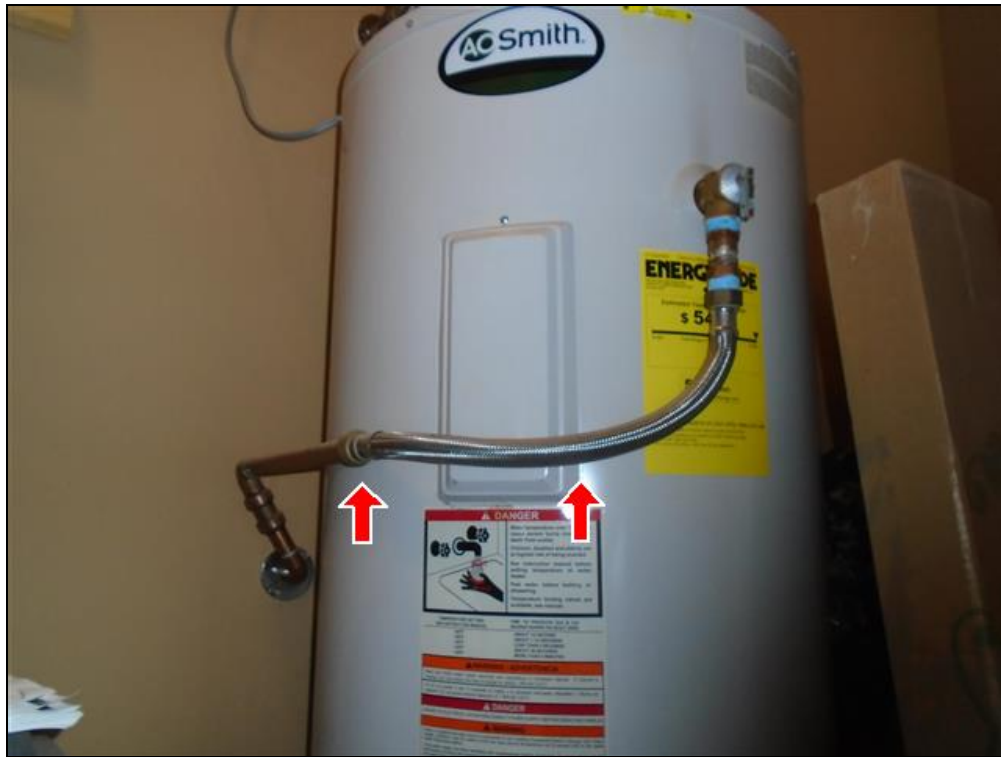
4.10 Item 1(Picture)

The TPR drain is not approved material. I recommend replacement with 3/4 inch full bore copper by a licensed professional plumber.

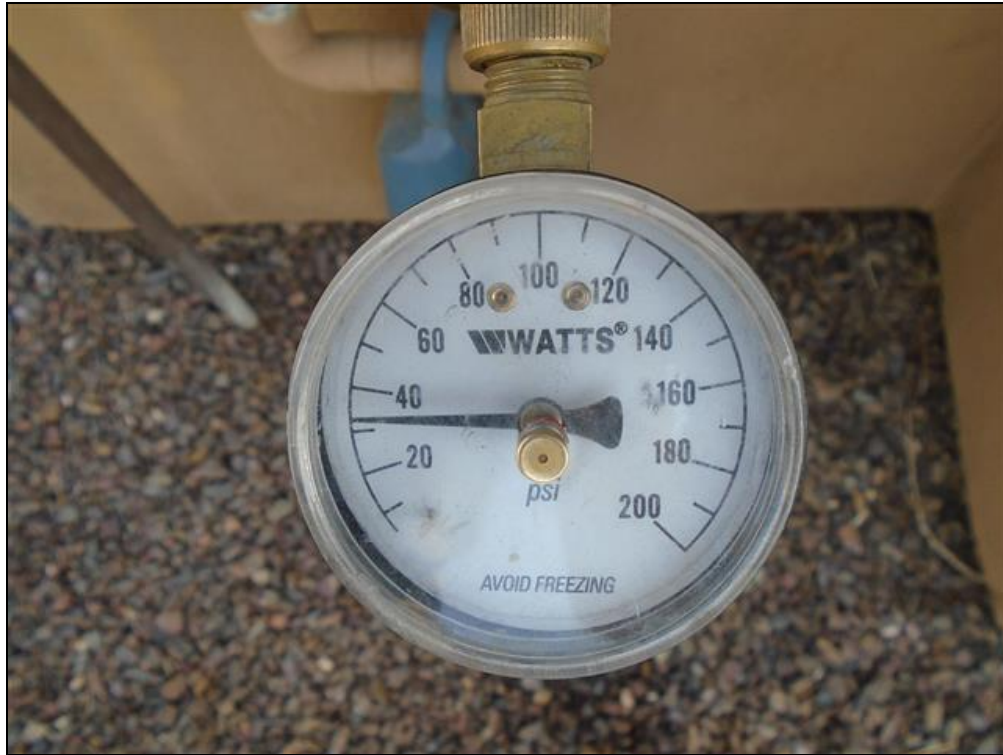
4.13 Item 1(Picture)

Water pressure below 40psi is considered low by industry standards. The water pressure on this home is below 40psi. I recommend professional evaluation and remedy as needed to increase water pressure to the recommended range of 40 - 80psi.

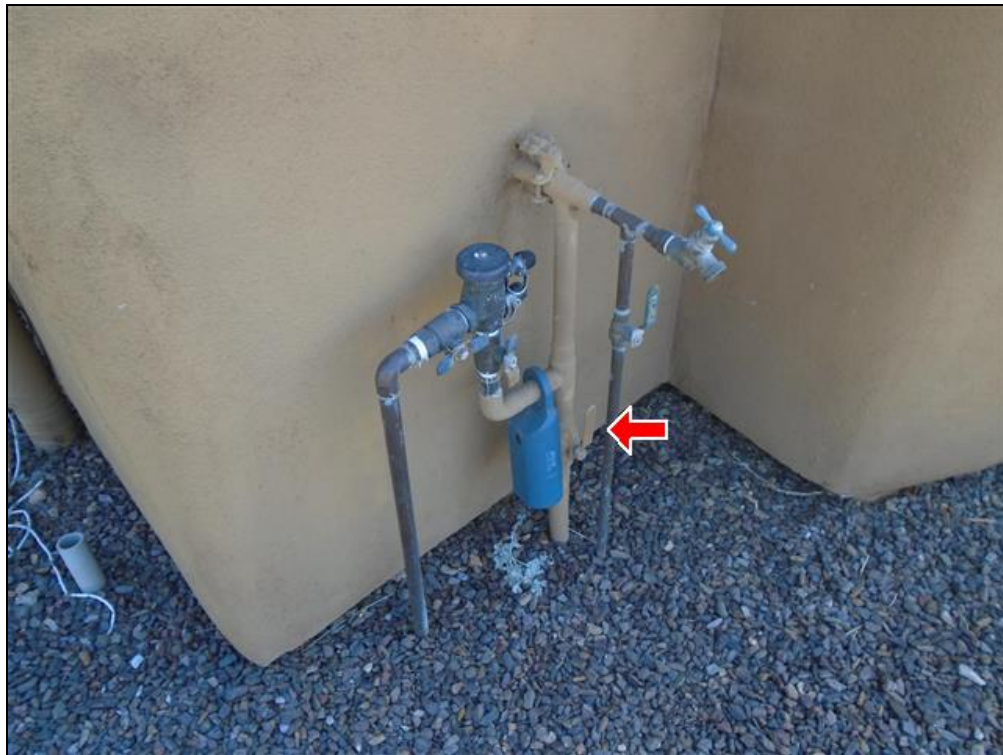
4.14 Item 1(Picture)

The main water shut off valve is located on the front right of the house.

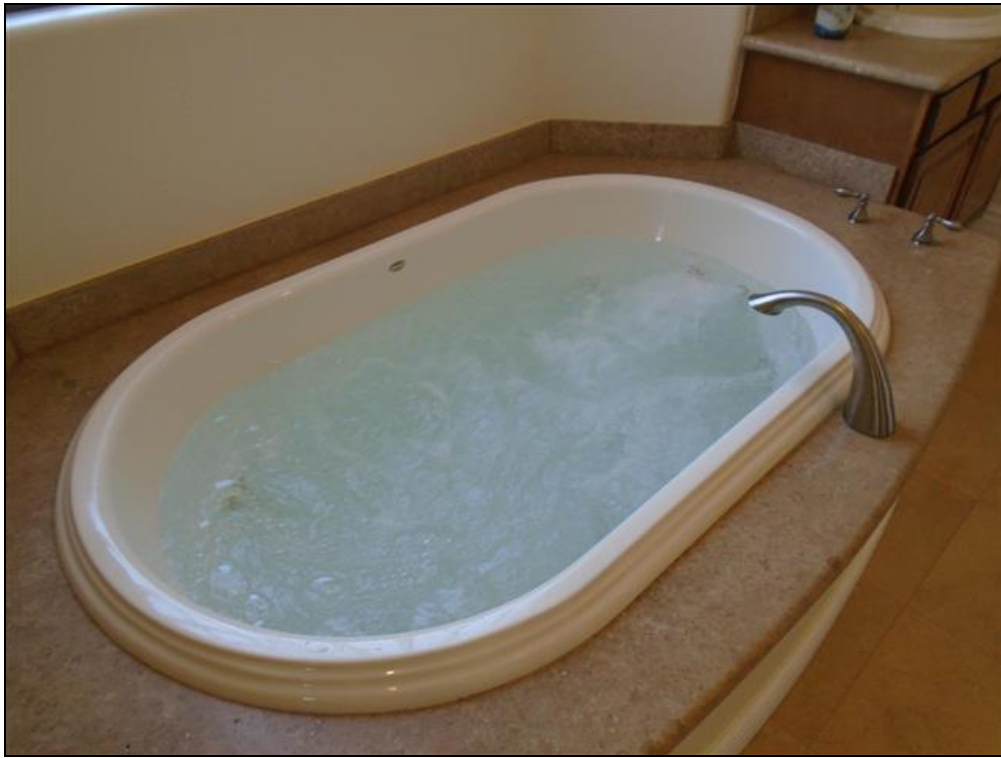
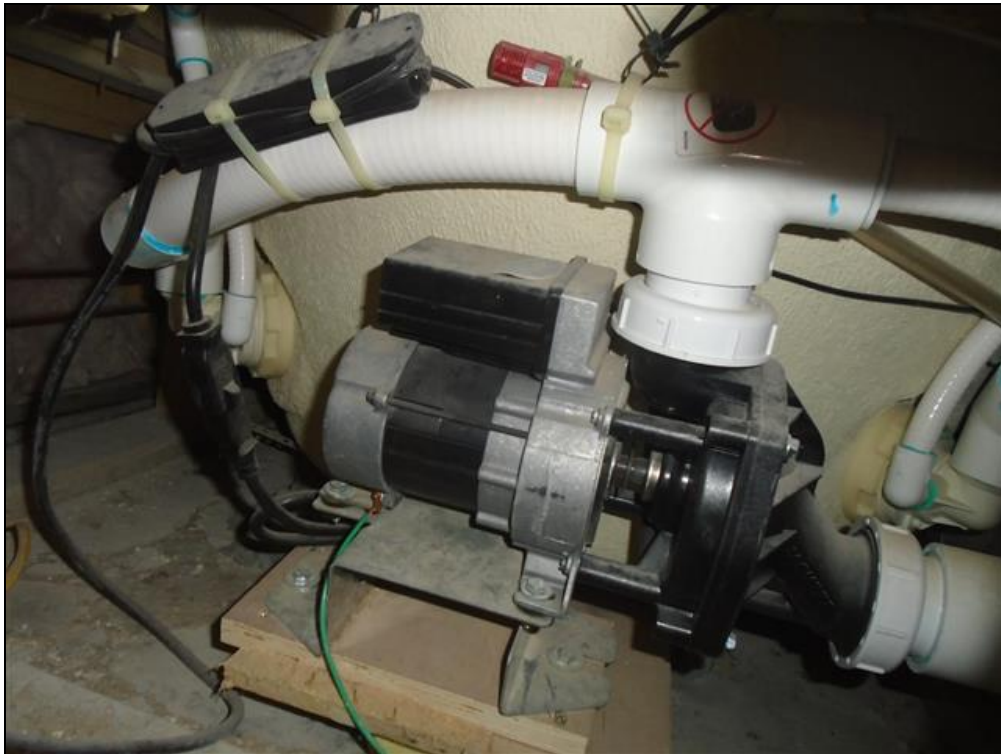
The jetted master tub is in satisfactory condition and operational, the electric supply is GFCI protected and the reset is in the tub access panel (under the left master sink).

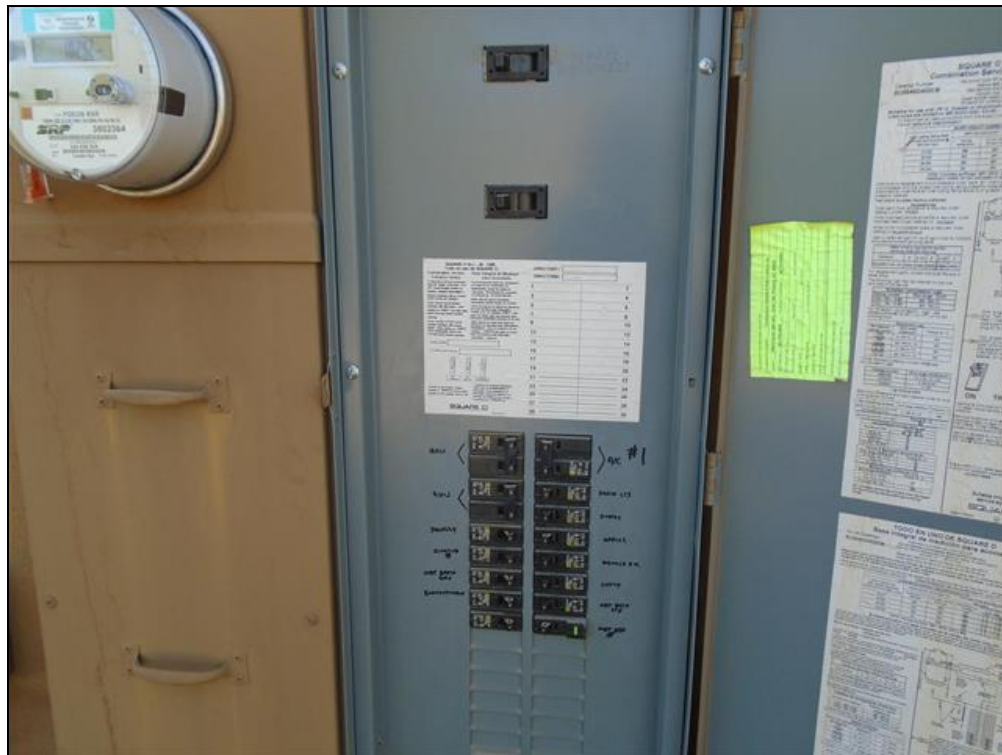
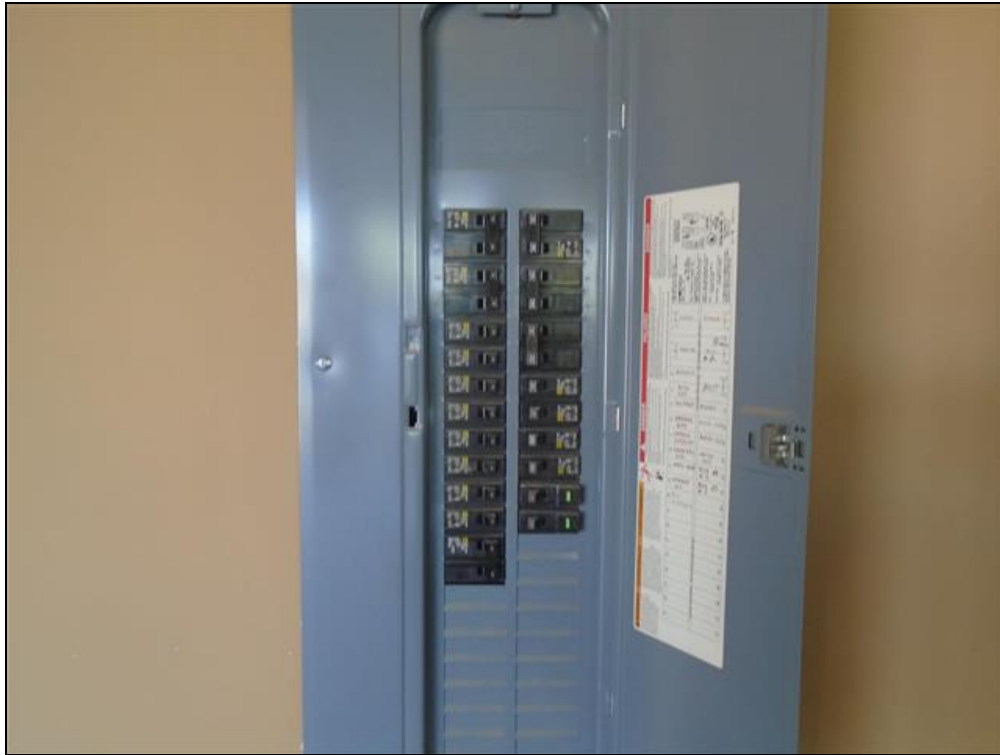
(1) The main disconnect and distribution panel are located on the left side of the house. The sub panel is in the garage.

Overall the main, distribution, and sub panels are in satisfactory condition.

(2) Replace missing screw to secure the dead front panel of the main distribution panel.

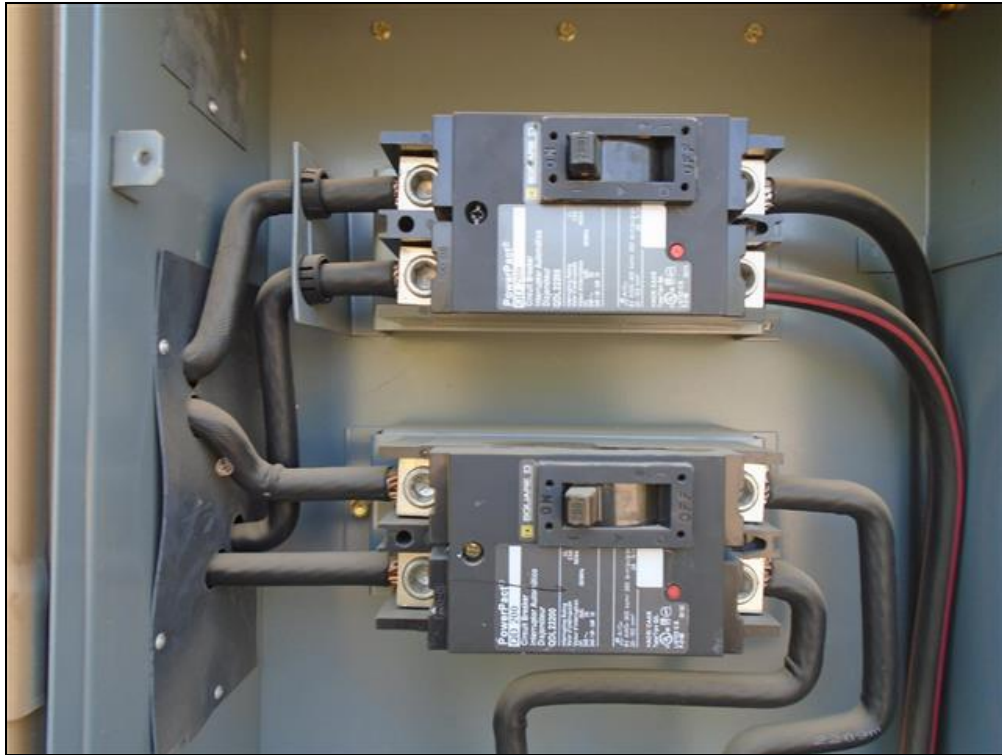
5.1 Item 1(Picture)

The visible portion of the electric service conductor and main overcurrent protection device are in satisfactory condition.

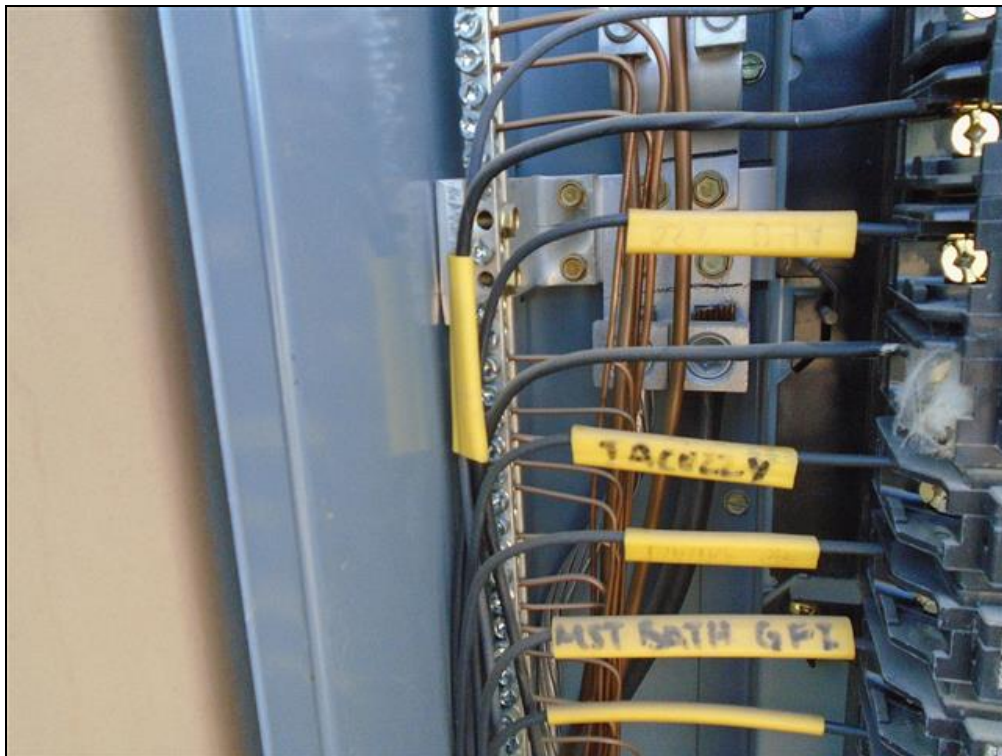
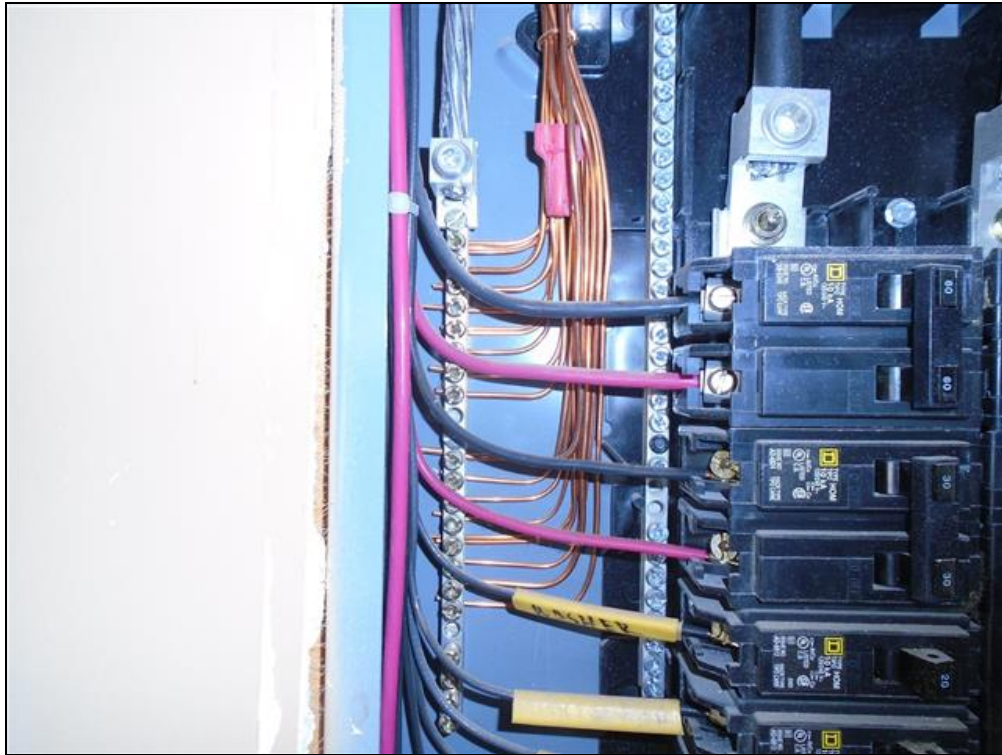
5.3 Item 2(Picture) Copper 15/20 amp branch circuits.

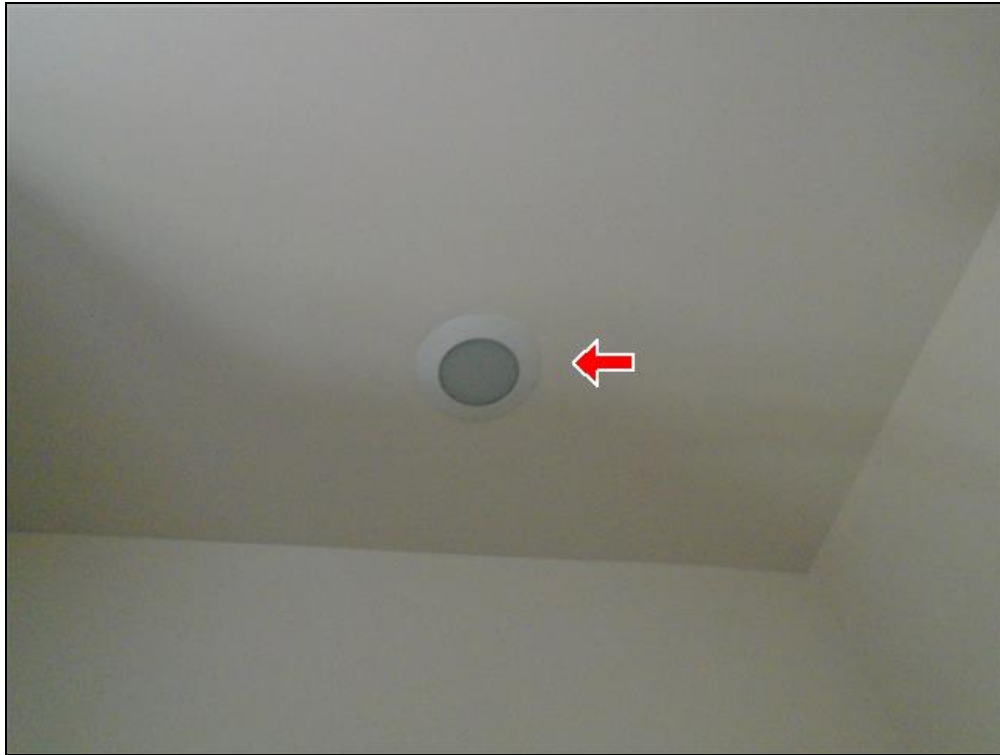
5.6 Item 1(Picture)

- (1) A representative number of lights/switches were tested and are in satisfactory condition and operational.
- (2) The guest shower light is inoperable, remedy as needed.

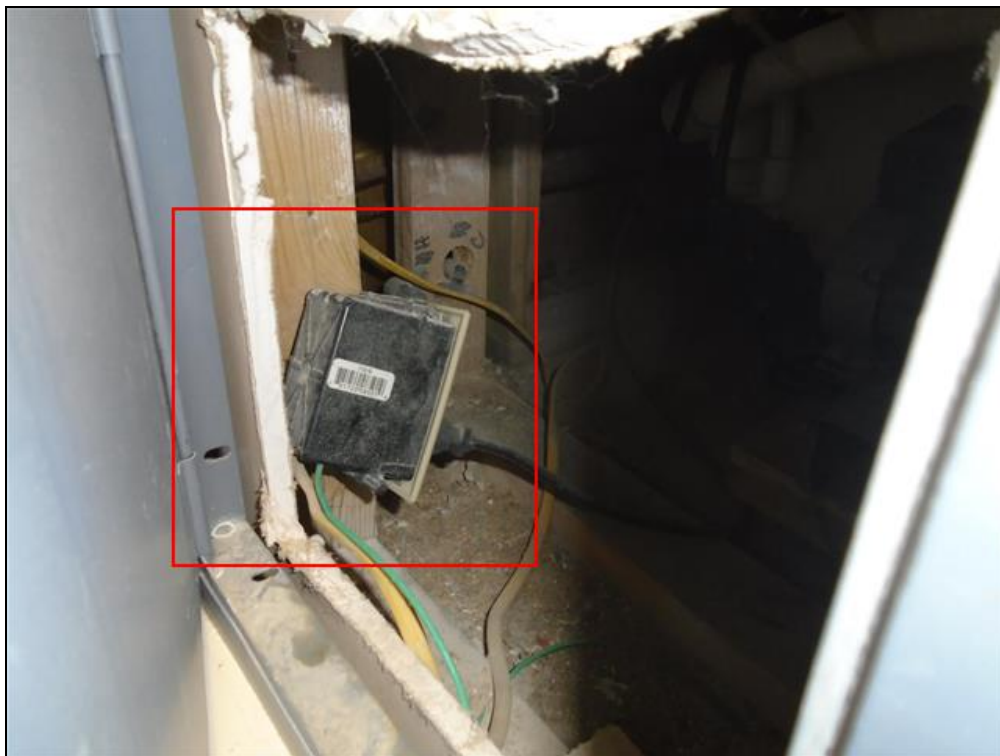
5.7 Item 1(Picture)

- (1) A representative number of receptacles were tested for polarity and ground and found to be operational and in satisfactory condition.
- (2) The outlet in the jetted tub access panel is not secured to the wall, remedy as needed.

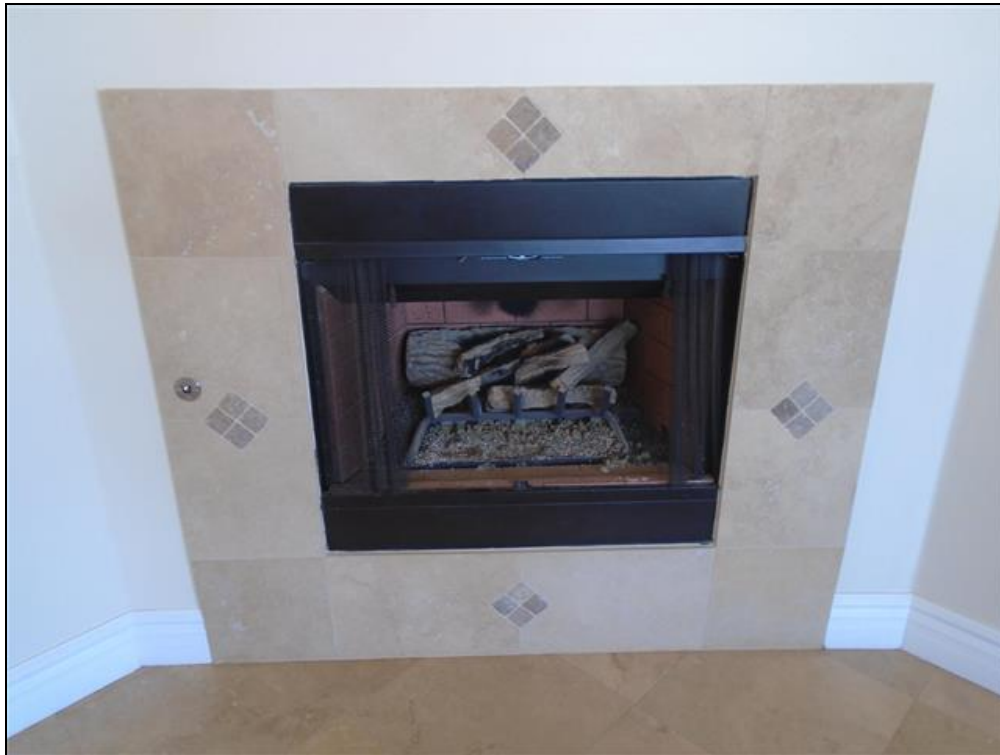
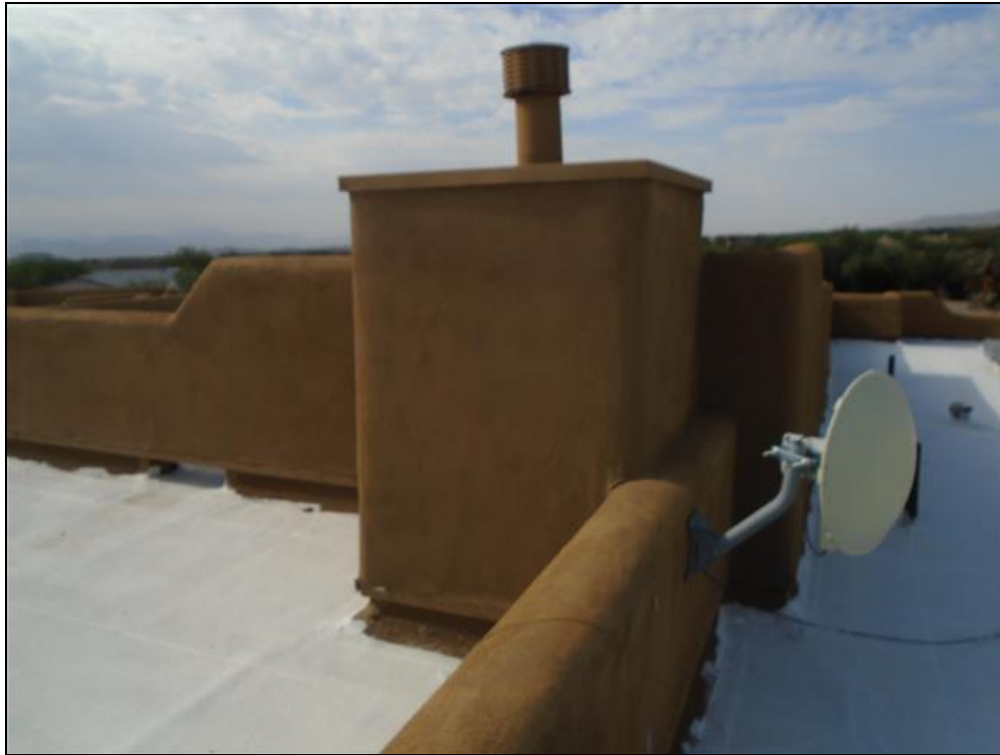
The visible portions of the fireplace are in satisfactory condition. I recommend professional cleaning/inspection before use.

The gas log lighter was not tested (requires open flame). Ask the current owner to demonstrate operation to your satisfaction.

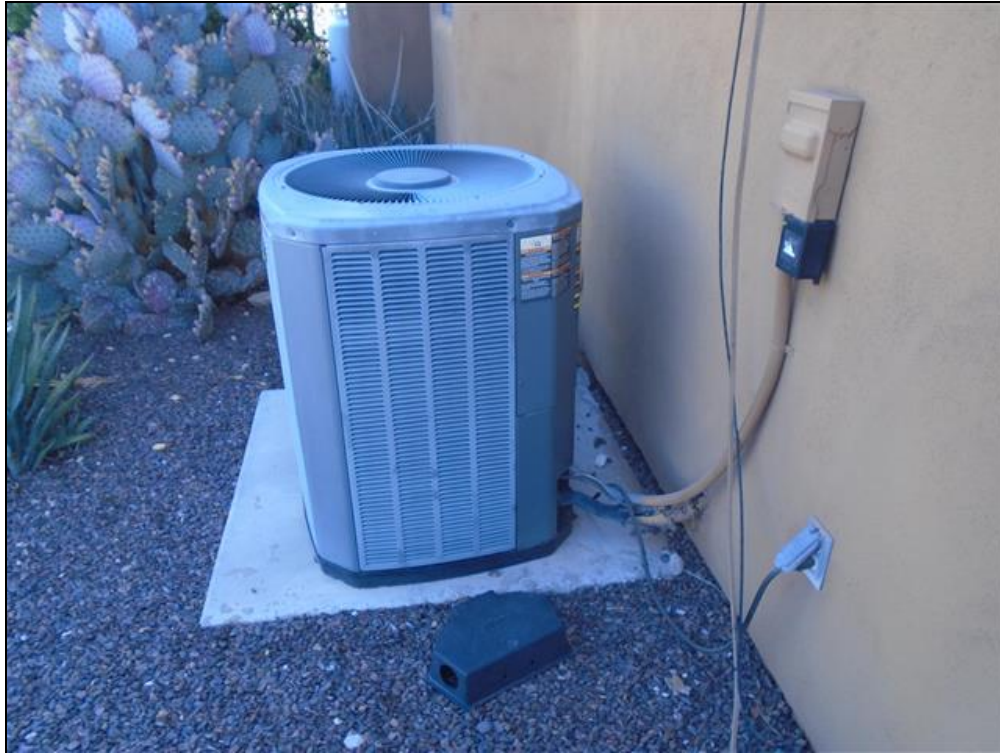
(1) Overall, the visible portions of the cooling equipment are in satisfactory condition and operational.

7.0 Item 1(Picture) 2006 model, 2.5 ton

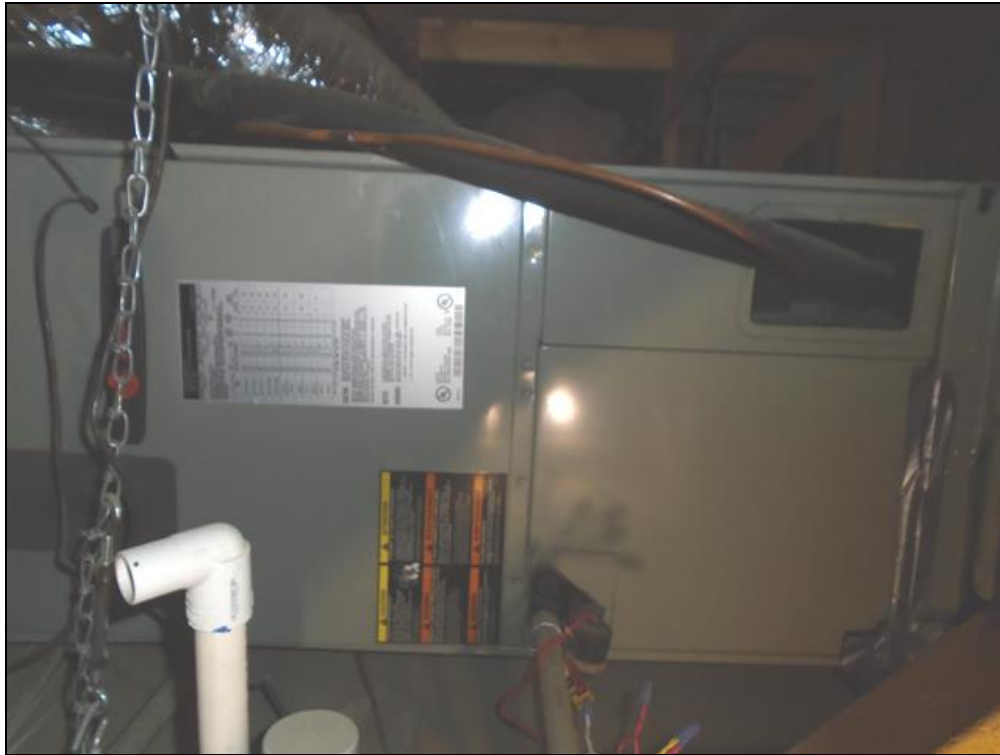
7.0 Item 4(Picture)

(2) There is evidence of previous condensate leakage into the hallway return air chase, monitor for future leakage and repair as needed.

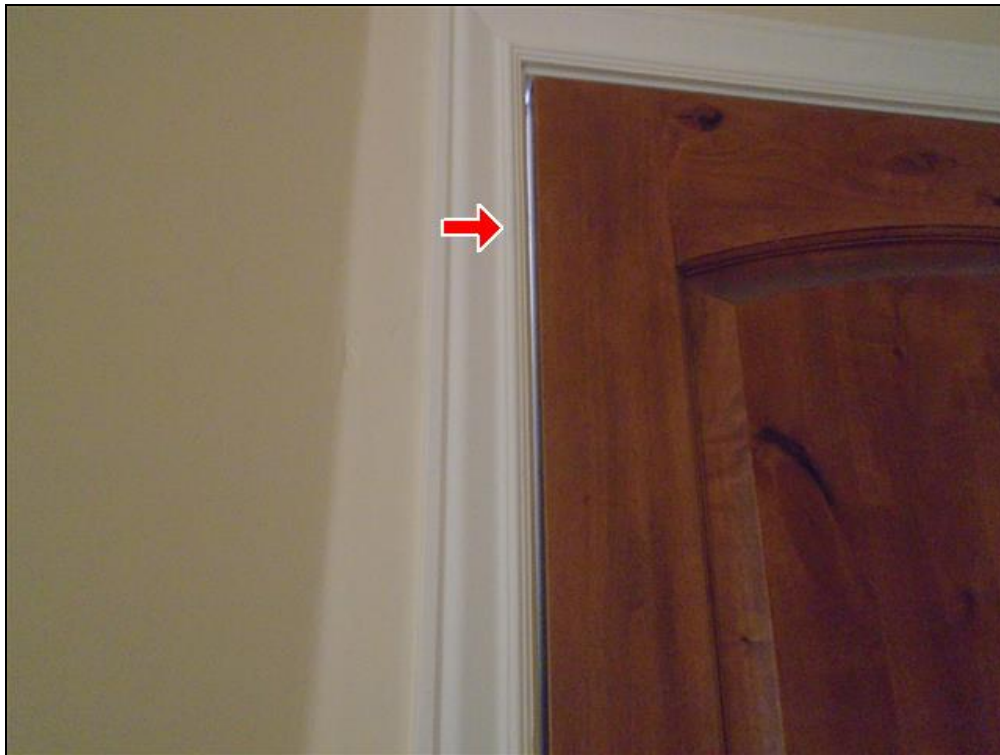
8.6 Item 1(Picture)

(2) There is daylight visible around the fire-door (house to garage). Adjust as needed to seal the opening.

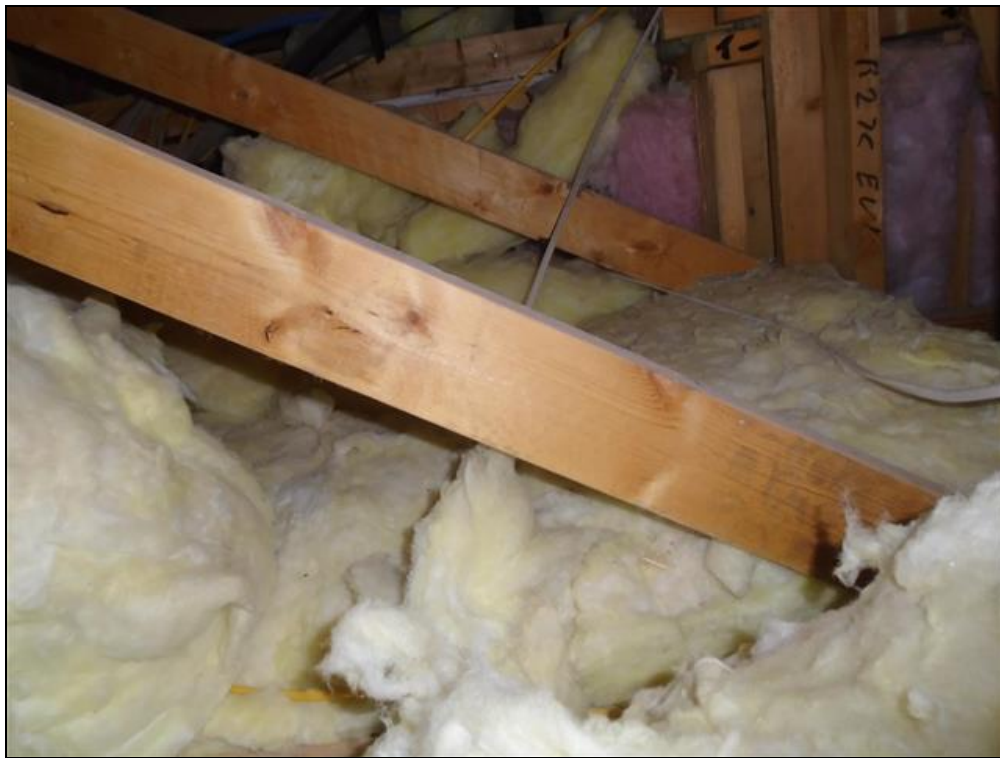
The visible insulation is in satisfactory condition. Attic visibility is limited, portions of the attic are not visible from the attic access.

9.0 Item 1(Picture) Fiberglass batt insulation.

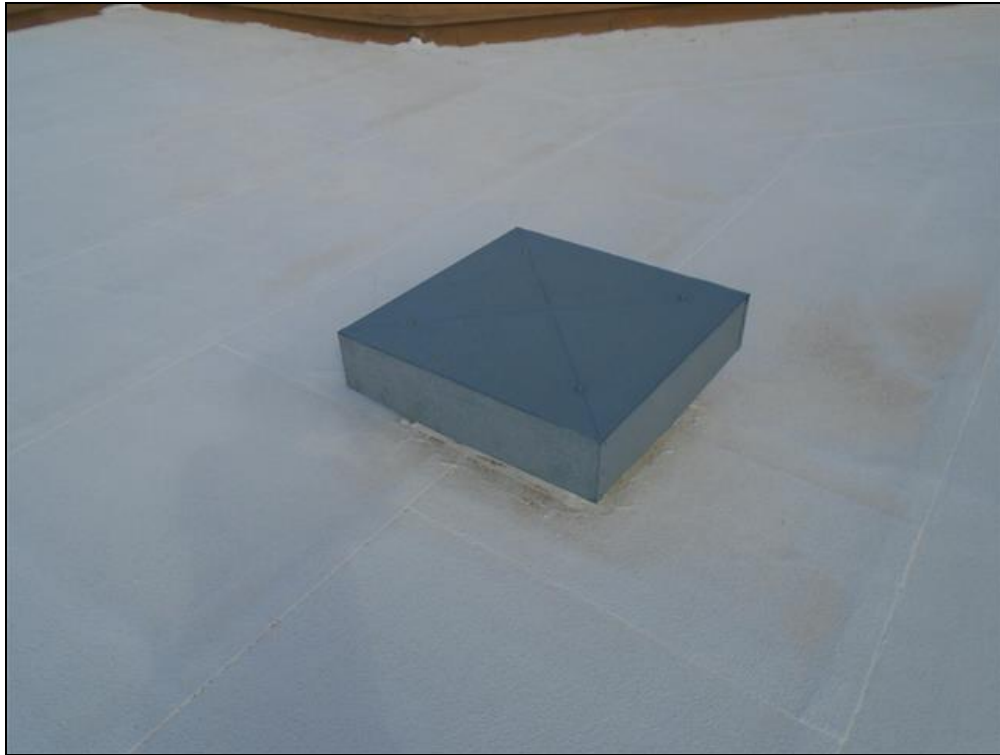
The visible portions of the attic ventilation are in satisfactory condition.

9.2 Item 1(Picture) Pan Vent

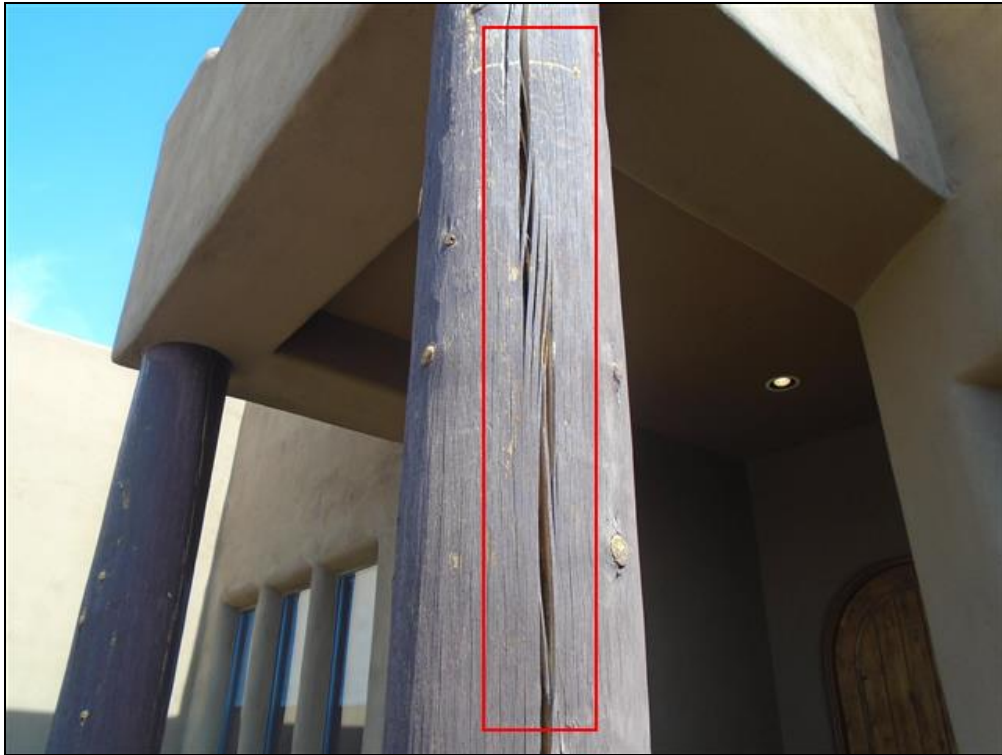
1.3 Item 3(Picture)

(2) The front porch exposed wood beams need to be re-sealed to prevent further cracking. We recommend re-sealing these beams once a year to prevent water intrusion into the cracks of the wood.

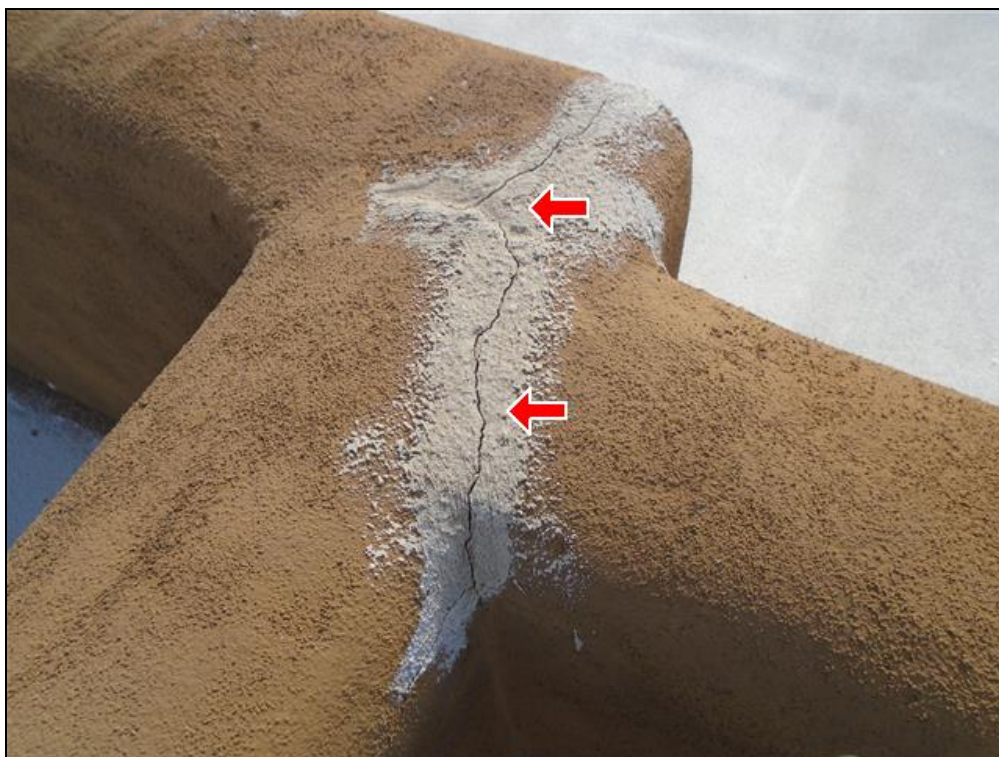
2.0 Item 1(Picture)

(2) Repair the small cracks and holes in the parapet walls and seal as needed to prevent water intrusion.

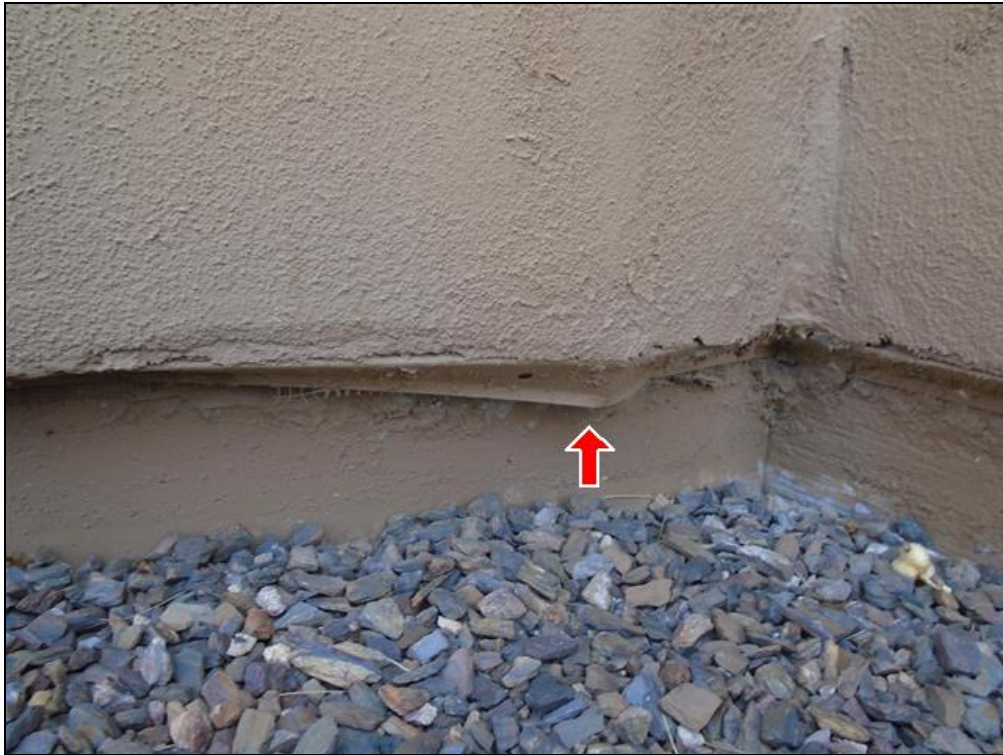
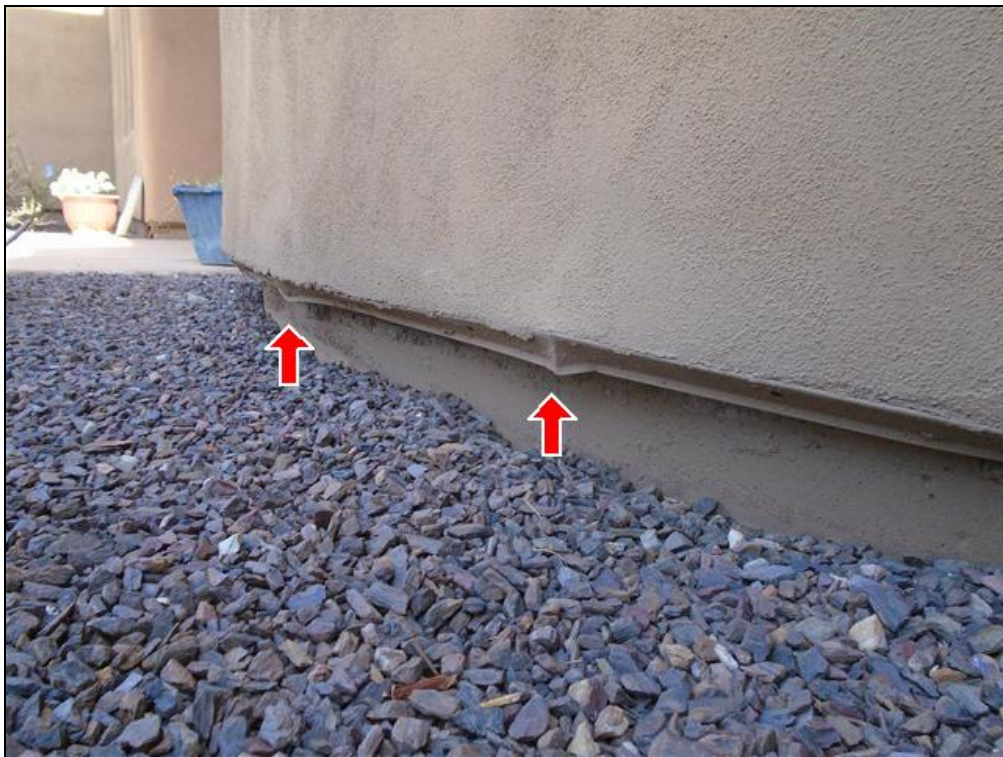
(2) The weep screed is loose on portions of the front of the house, secure as needed.
