Inspection Report

Property Address:
123 2nd Star on the Right Ln.
Scottsdale AZ 85262

Liberty Inspection Service

Date: 7/26/2018	Time: 08:00 AM	Report ID: Sample Report 1
Property: 123 2nd Star on the Right Ln. Scottsdale AZ 85262	Customer: Home Buyer	Real Estate Professional: Sample Agent

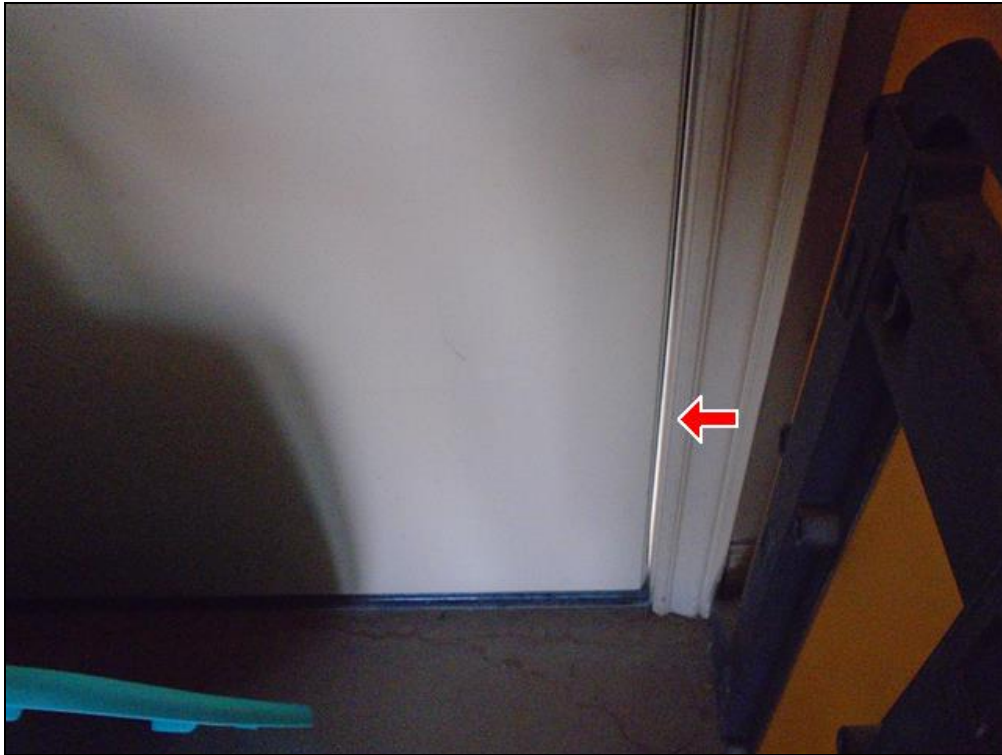
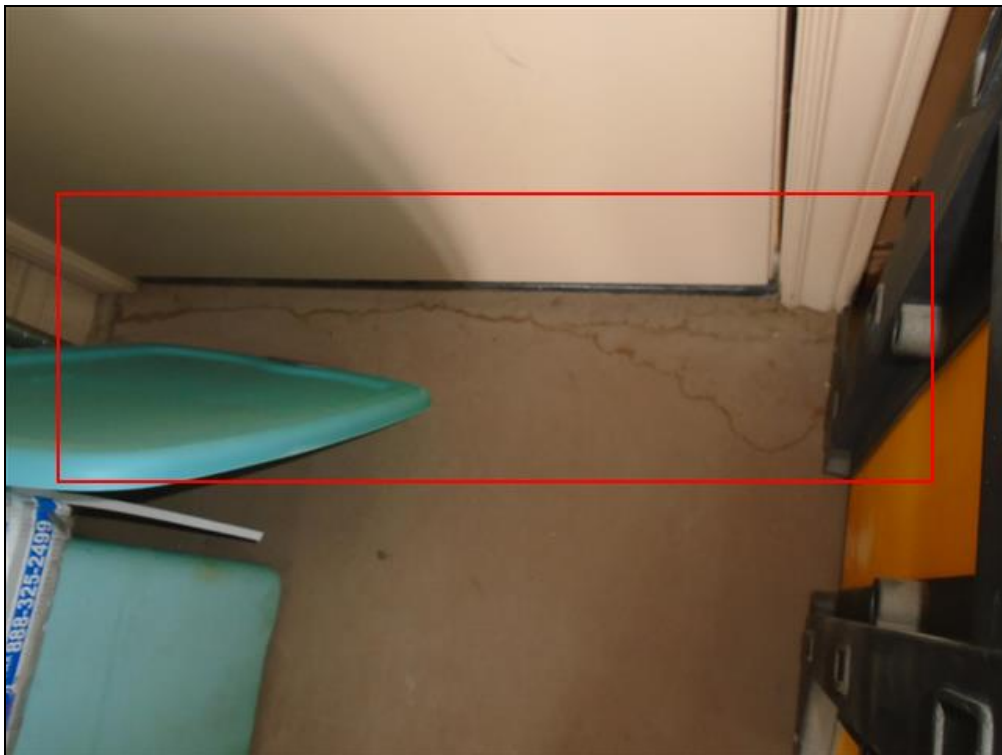
2.2 Item 1(Picture)

(2) There is daylight visible around the garage service door and there is evidence of previous water intrusion, remedy as needed.

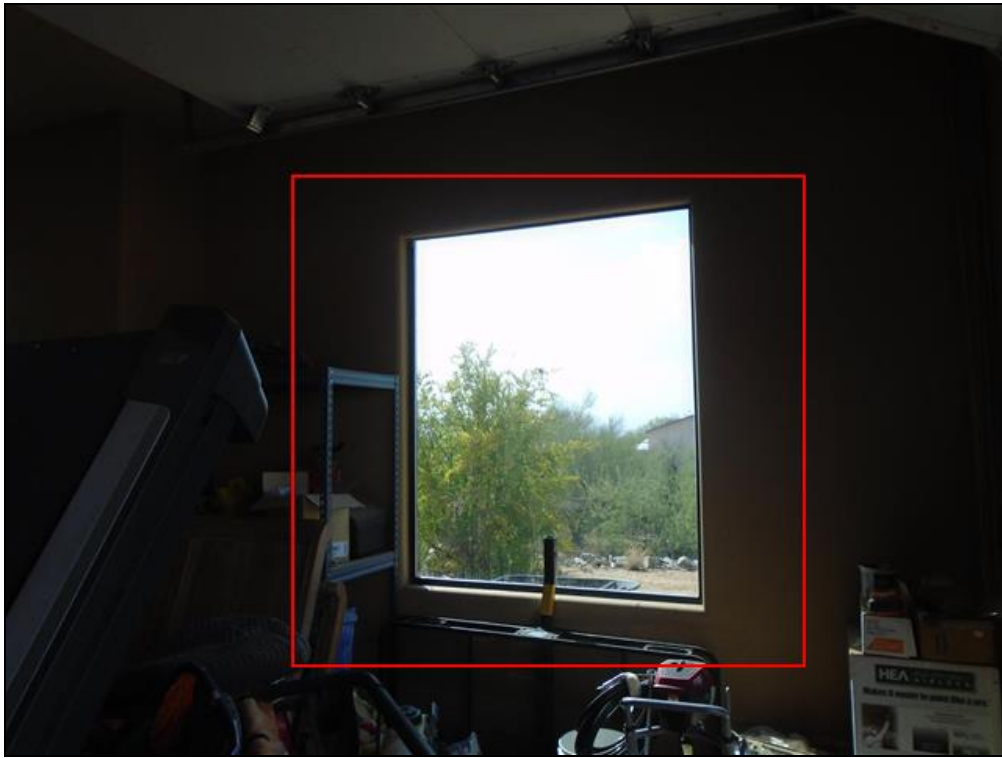
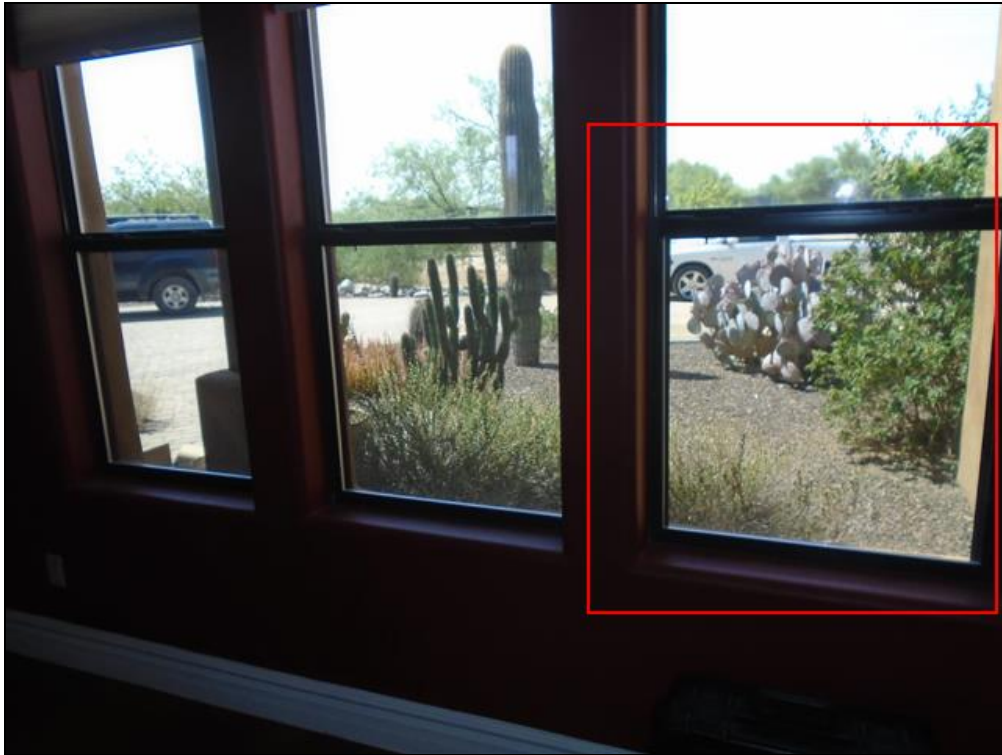
window, and the right office window. I recommend a licensed window installer check all the windows and repair or replace as needed.

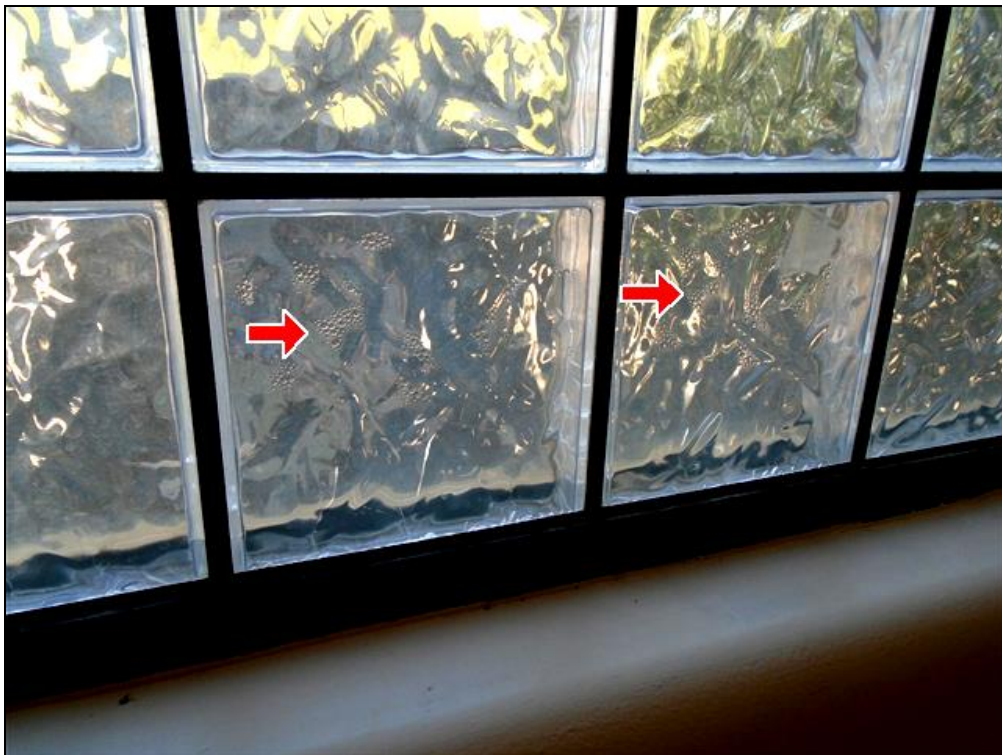
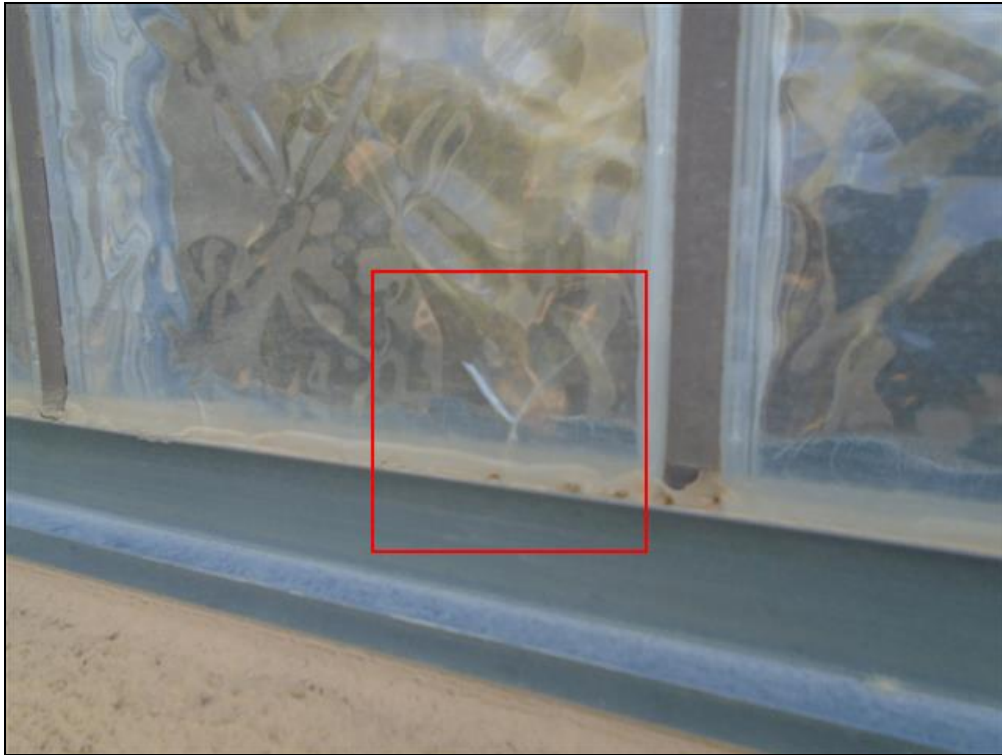
(2) The master bathroom bottom row of glass blocks are cracked and there is water inside of some of the blocks. Remedy as needed.

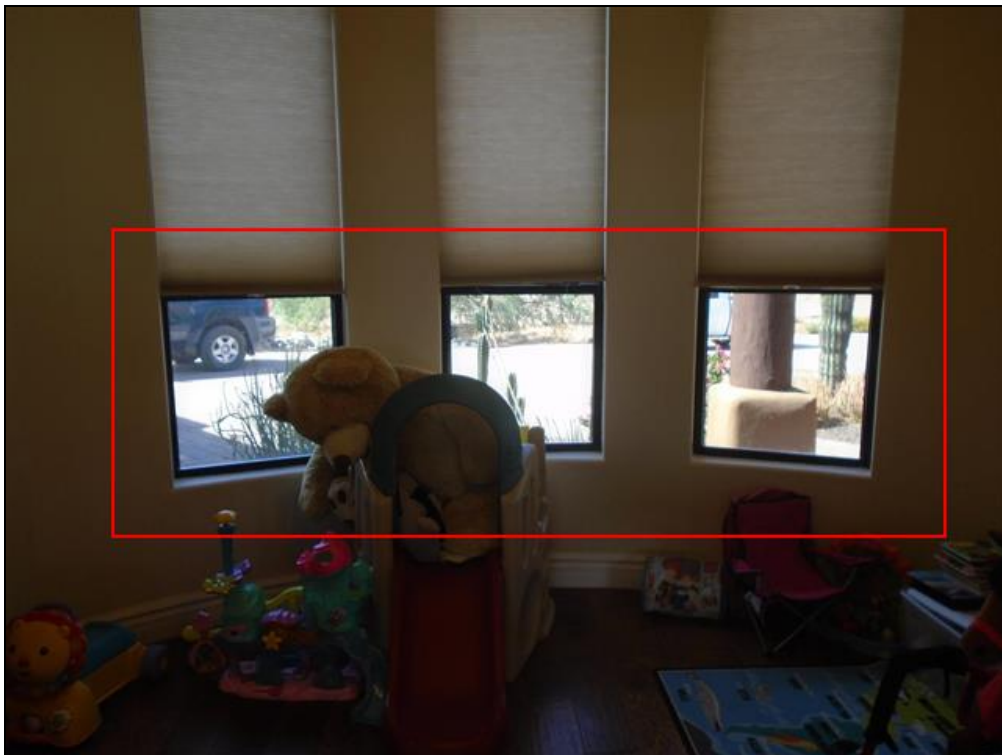
2.3 Item 9(Picture)

(3) There are numerous windows throughout the house that are difficult to operate, do not stay open, have damaged stops or springs need adjustment. I recommend evaluation of all windows by a licensed window installer with remedy as needed.

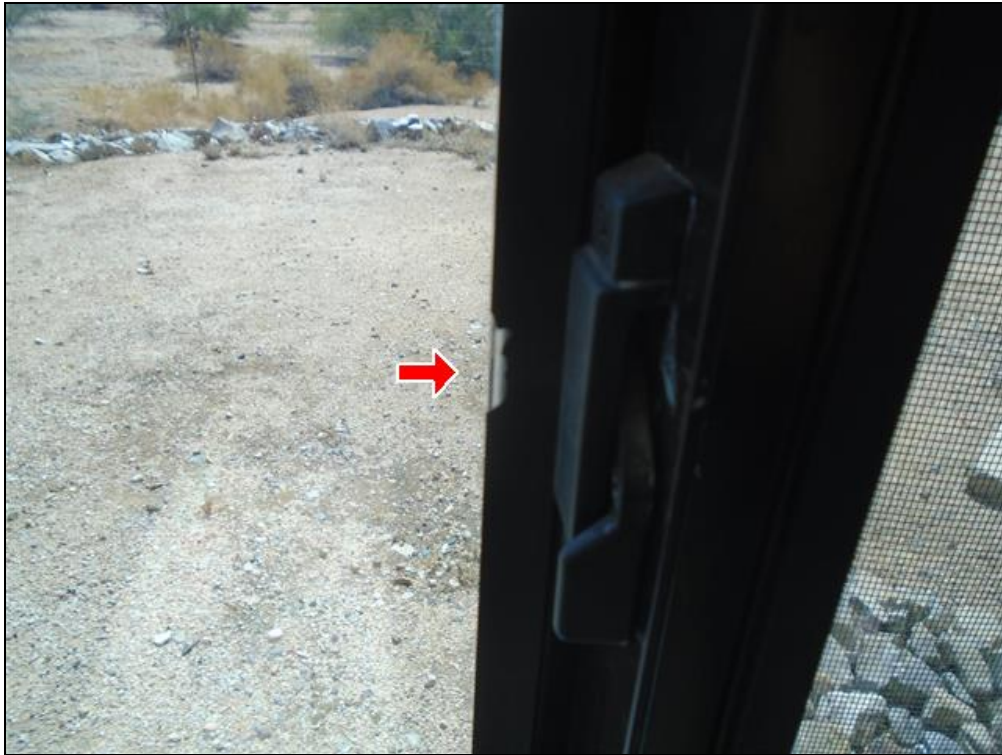
2.3 Item 10(Picture)

(4) The rear right bedroom window top lock is difficult to operate, adjust as needed.

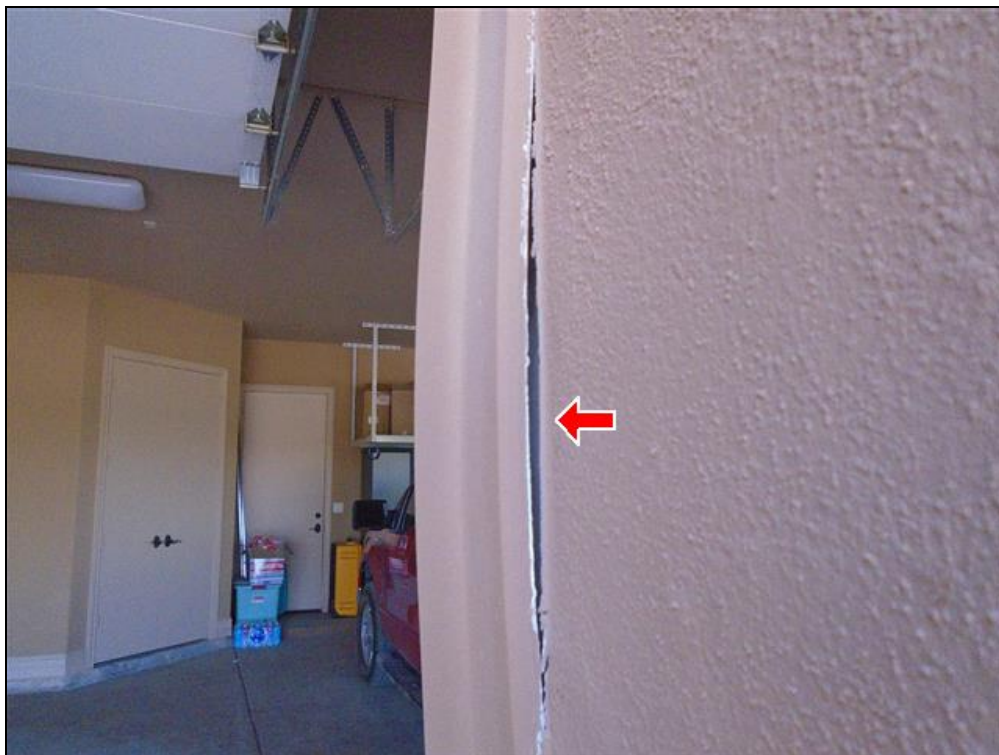
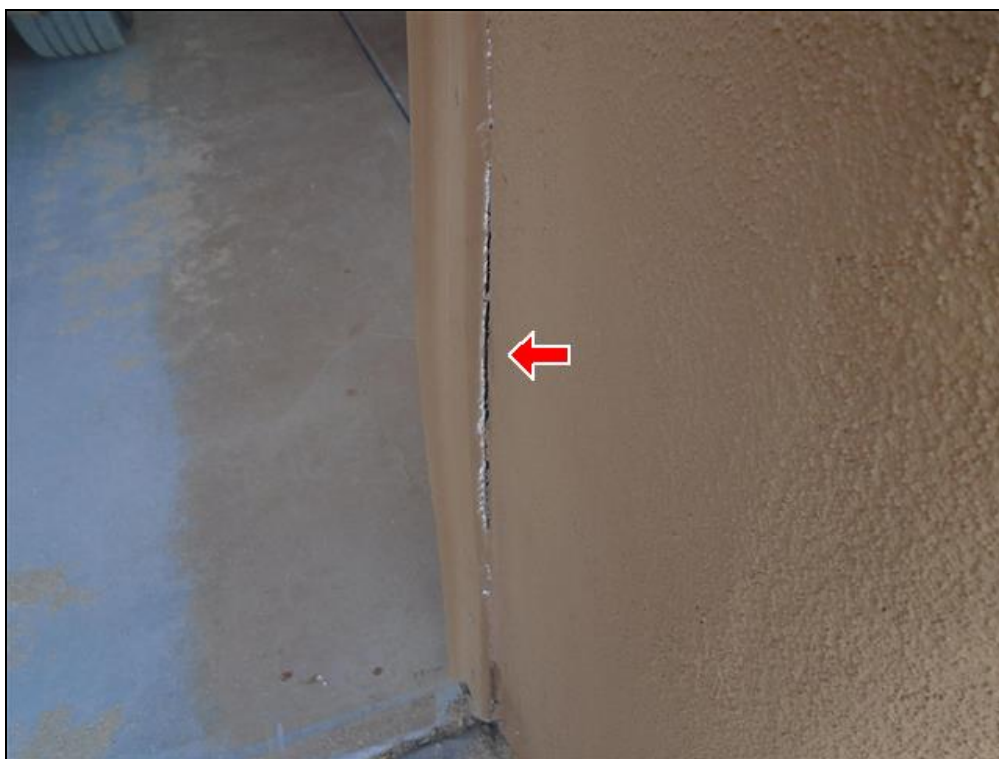
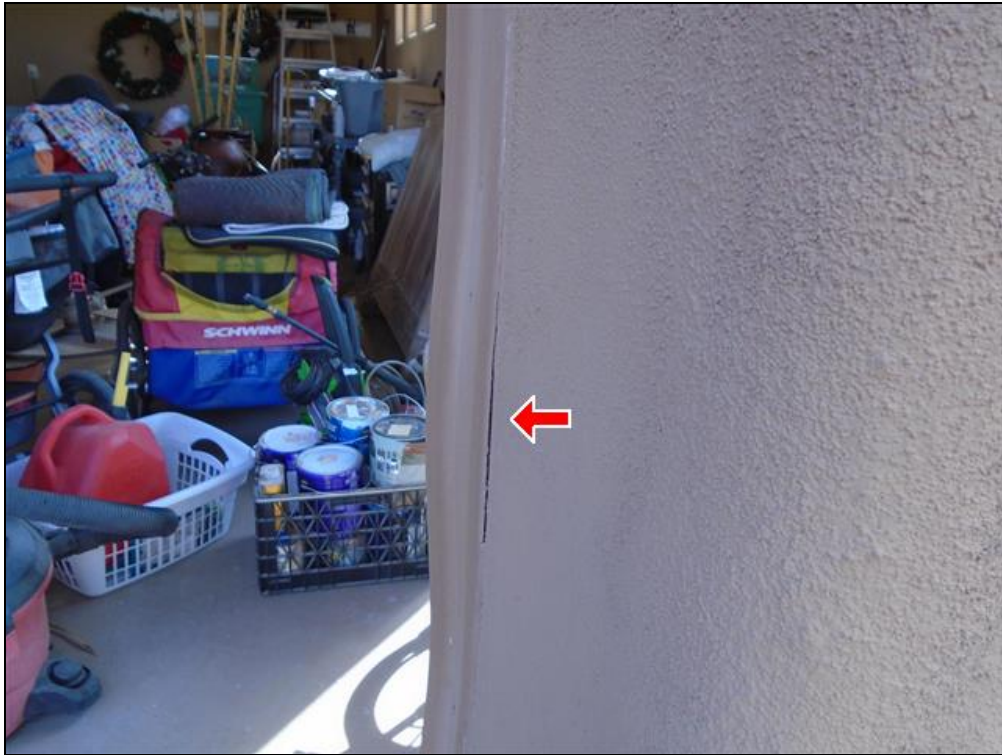
2.4 Item 1(Picture)

(2) The garage door trims are coming loose from the siding, secure as needed.

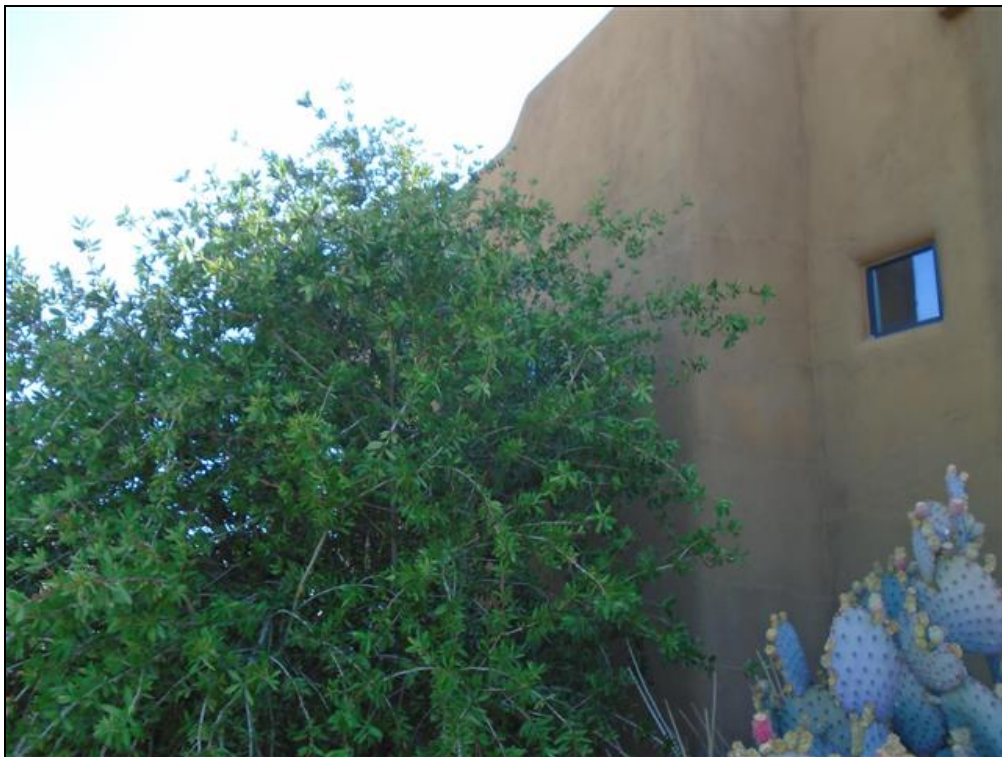
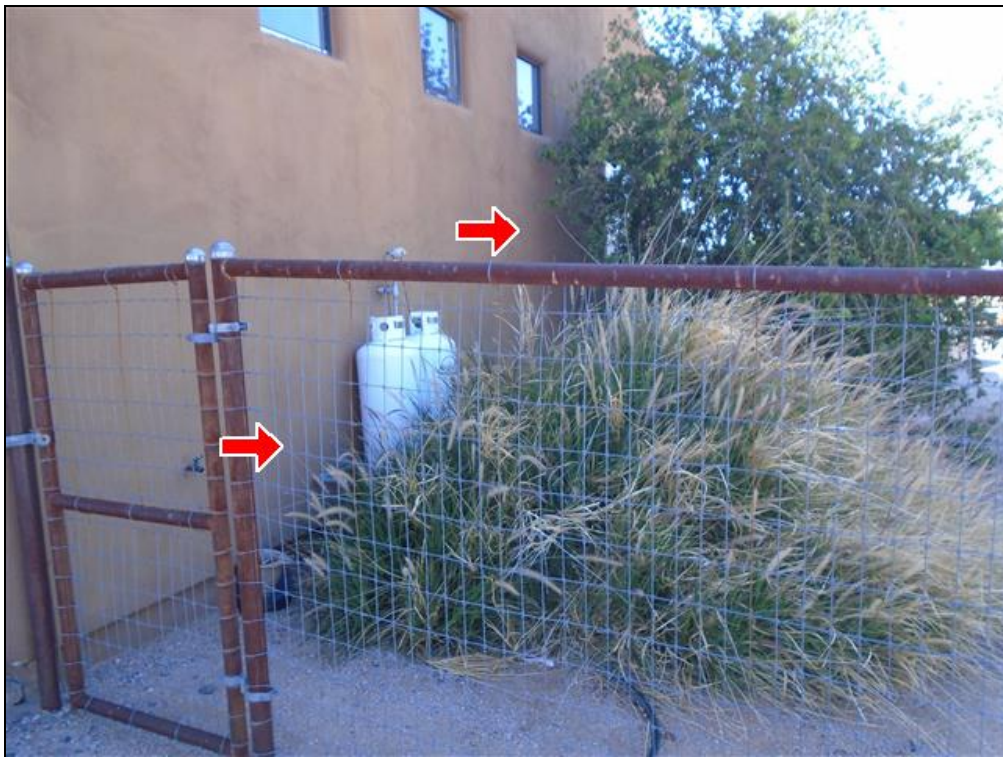
Tree limbs/vegetation in contact with the exterior can damage the finish and provide access for rodents. Trim as needed to prevent damage.

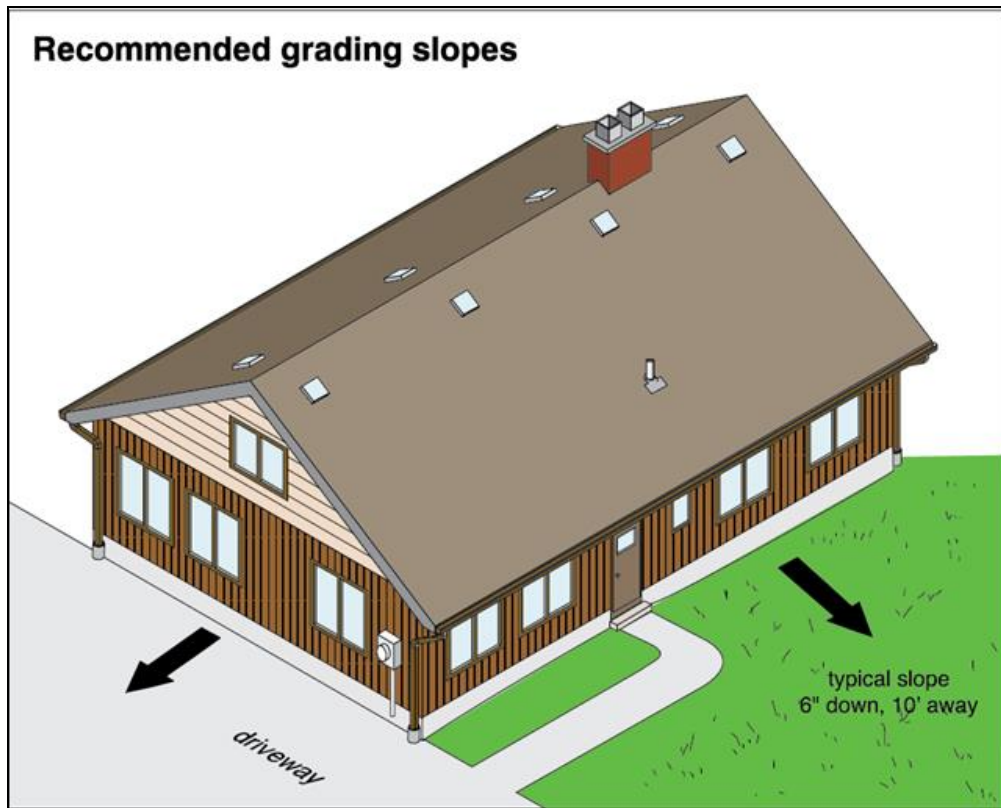
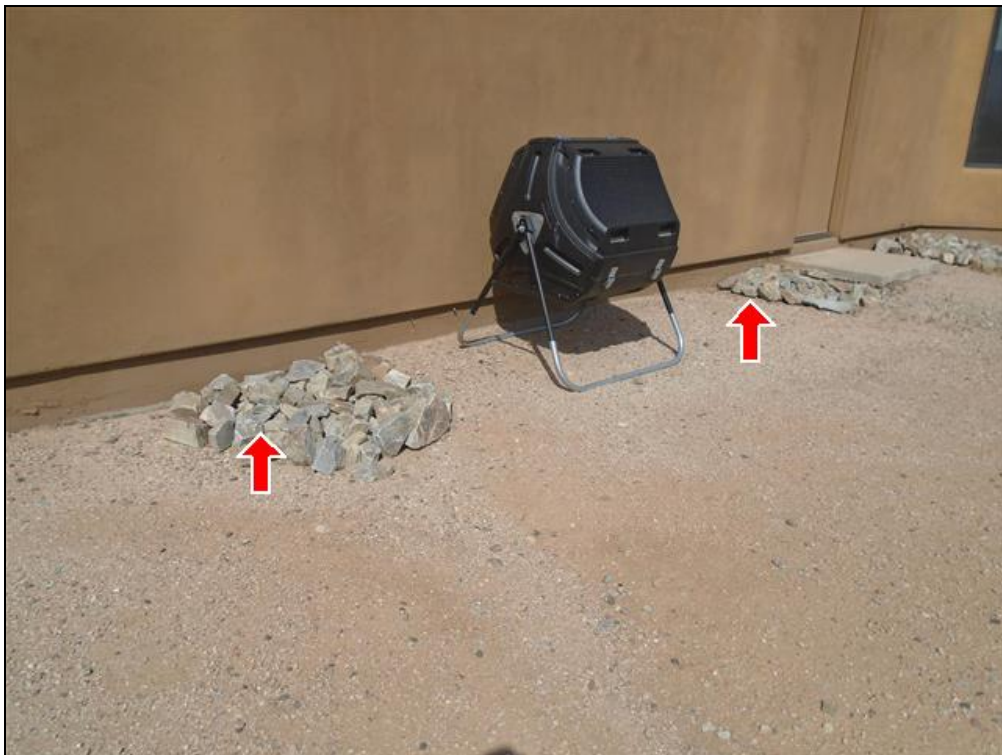
The grade is sloped toward the house on the left side, and rear. This will direct surface water into the soil adjacent to the foundation and cause water damage to the foundation concrete. Adjust the grade to direct surface water away from the foundation to prevent water damage.

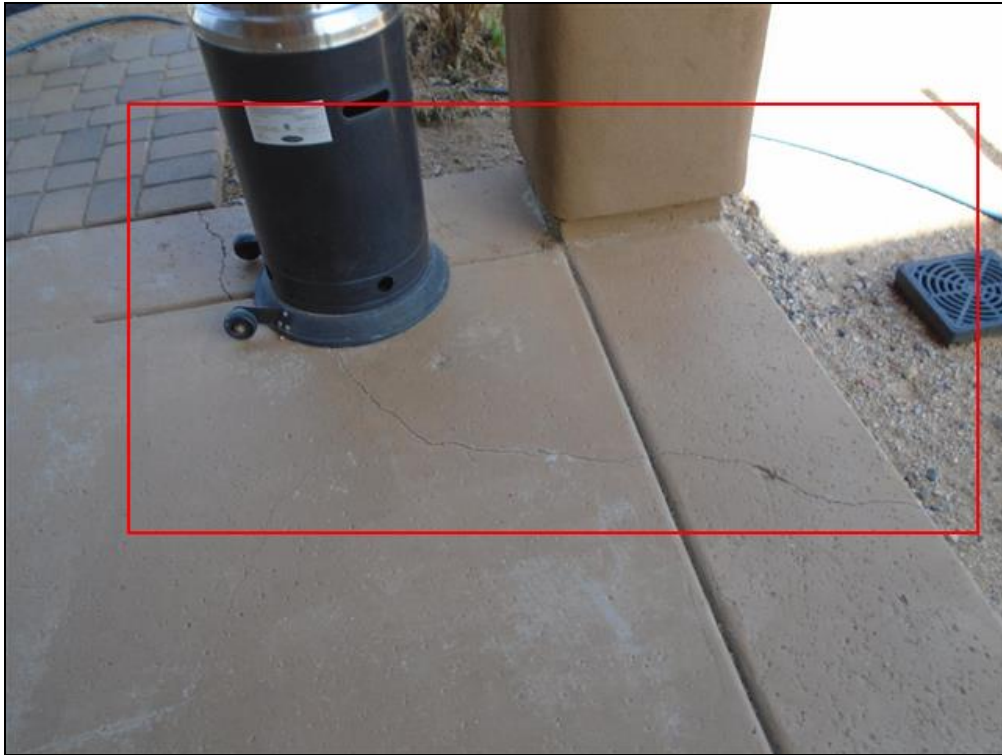
2.10 Item 1(Picture)

(2) There is evidence of previous movement (settling) in a portion of the rear porch. Monitor for further movement with remedy as needed.

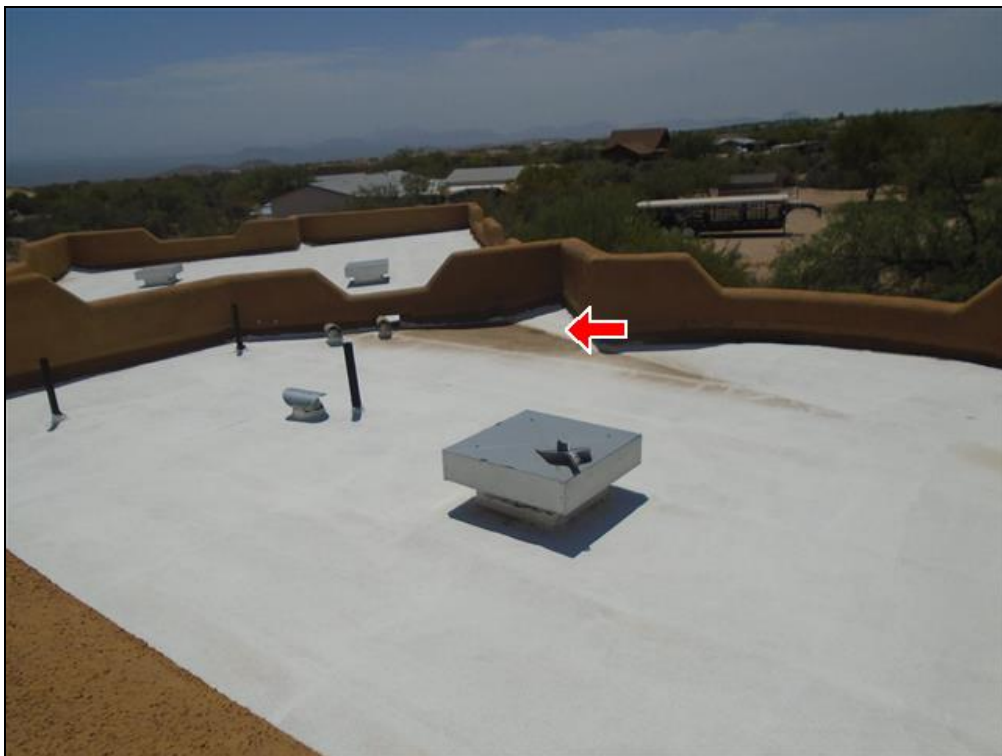
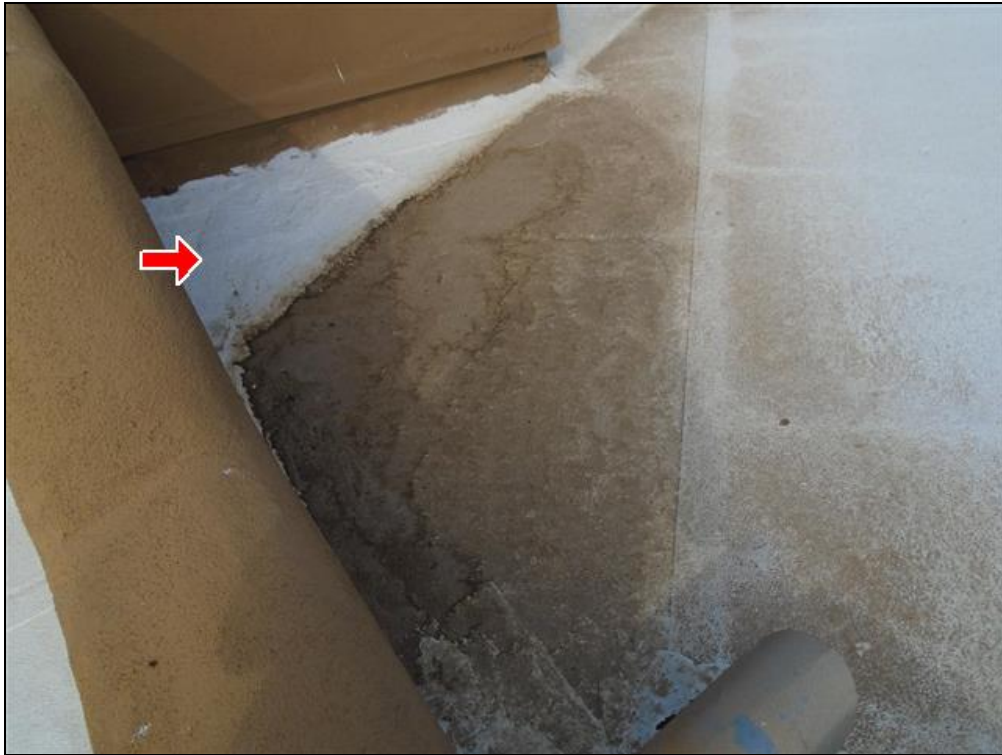
(2) There is evidence of ponding water on the front portion of the roof, adjust as needed to prevent damage to the finish and leakage.

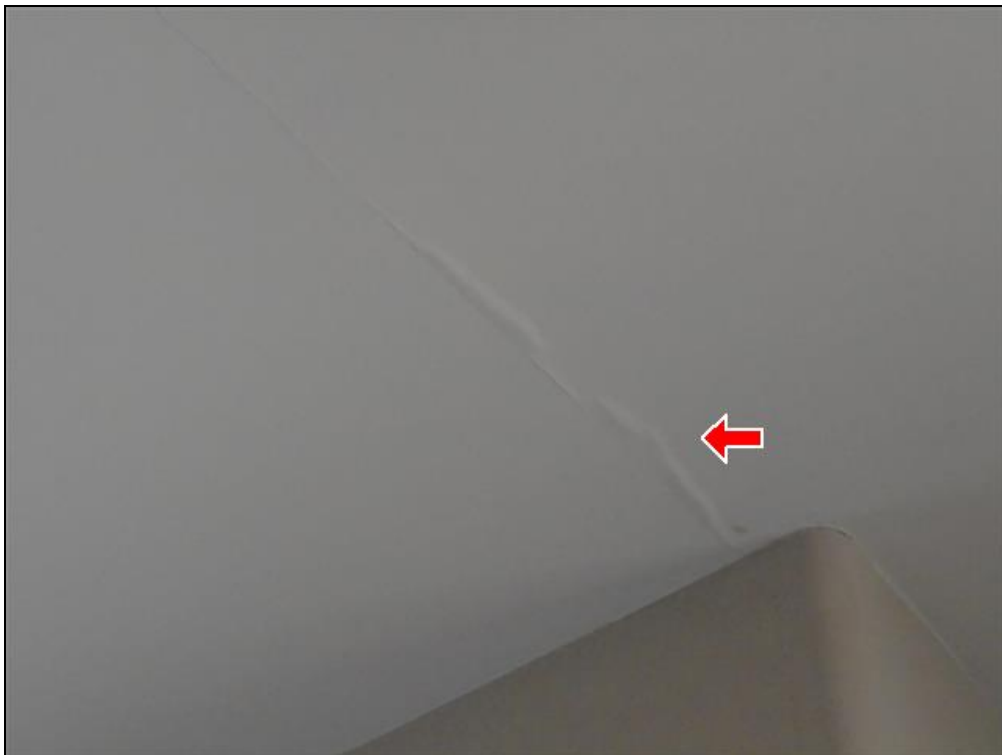
3.3 Item 1(Picture)

There are signs of previous leakage (water stains) on the rear porch decking and garage. Monitor for further leakage and repair if necessary.

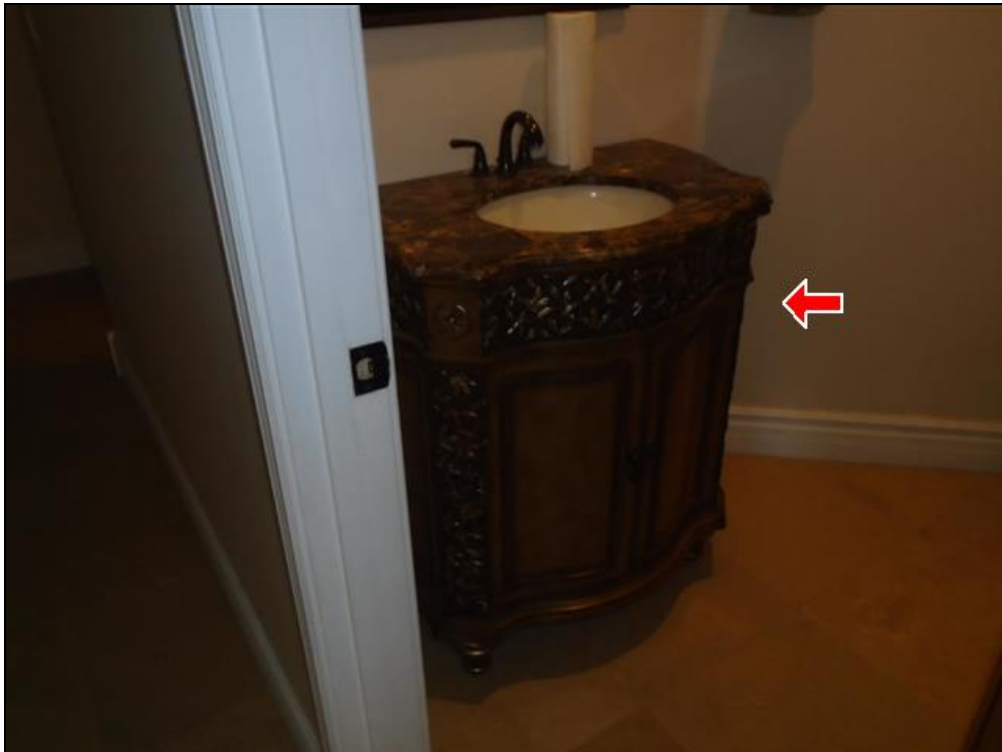
4.2 Item 1(Picture)

(2) Secure the powder bathroom vanity to the wall to prevent movement and damage to plumbing.

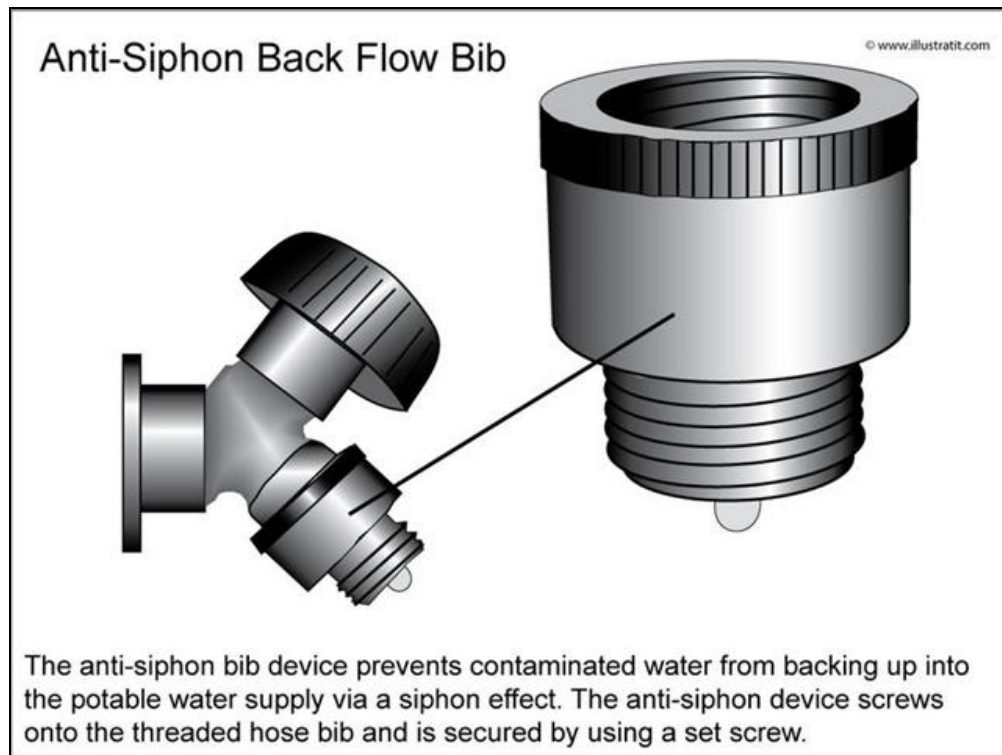
4.5 Item 1(Picture)

Exterior hose bibs require anti-siphon devices to prevent possible contamination of the potable water supply. Consider the addition of anti-siphon devices to the exterior hose bibs.

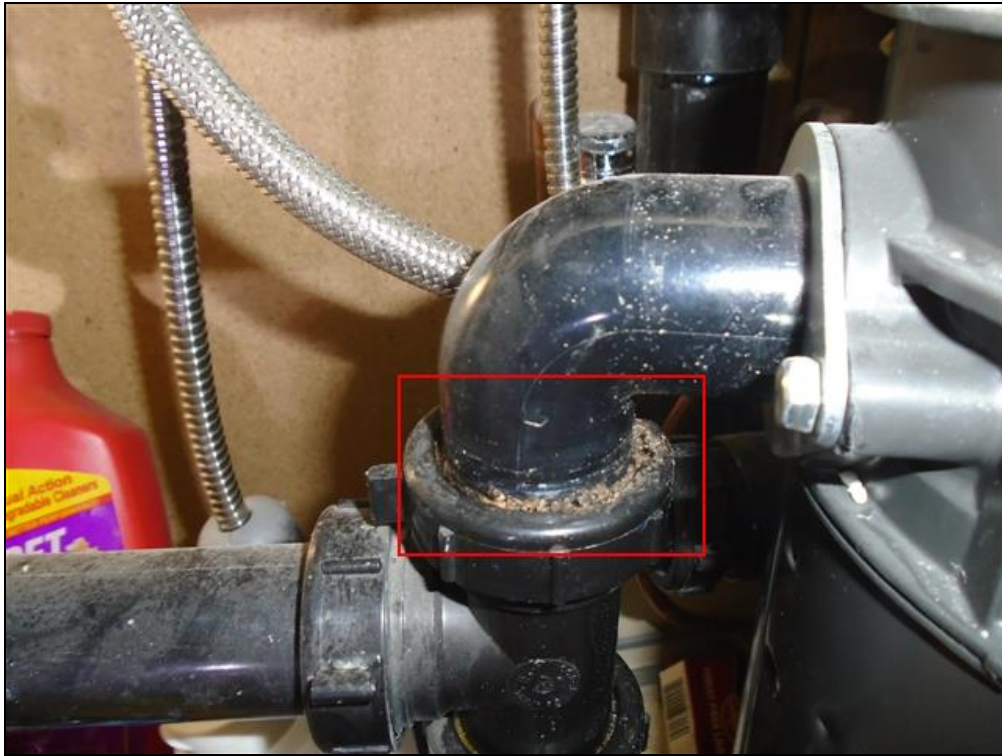
4.7 Item 1(Picture)

There is evidence of leakage at the kitchen sink drain. Repair as needed.

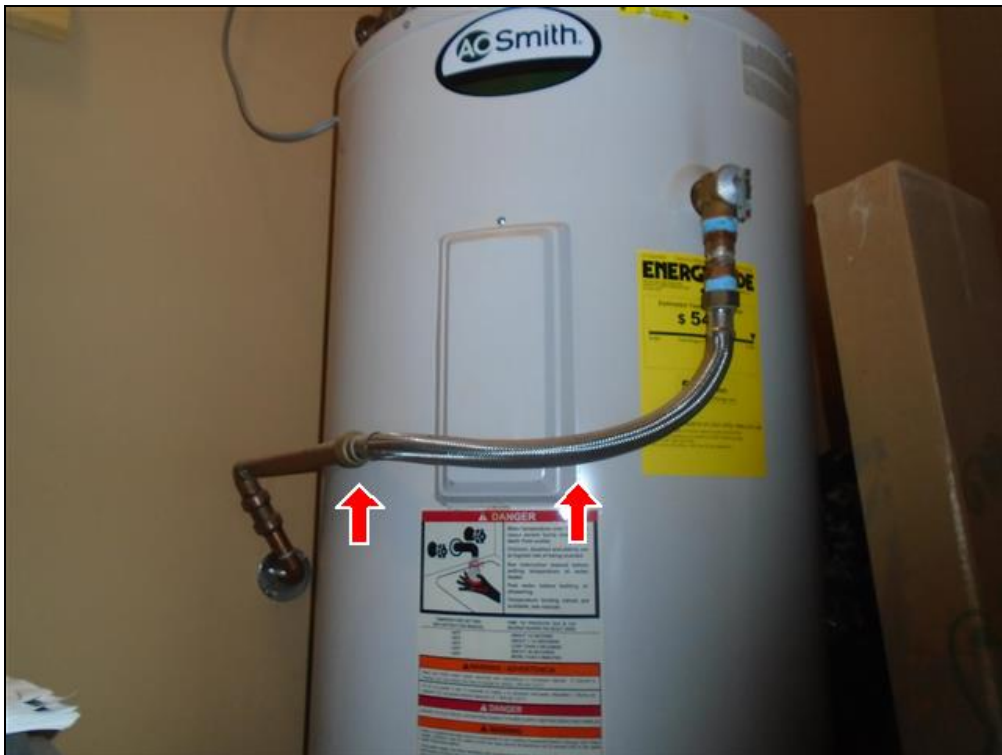
4.10 Item 1(Picture)

The TPR drain is not approved material. I recommend replacement with 3/4 inch full bore copper by a licensed professional plumber.

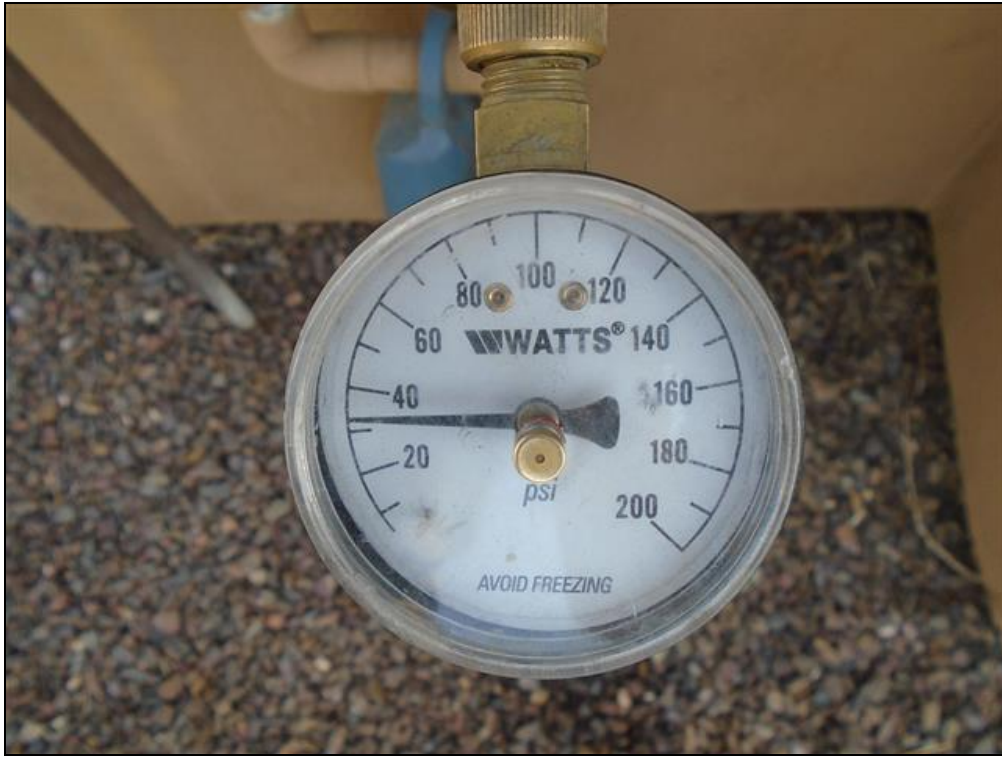
4.13 Item 1(Picture)

Water pressure below 40psi is considered low by industry standards. The water pressure on this home is below 40psi. I recommend professional evaluation and remedy as needed to increase water pressure to the recommended range of 40 - 80psi.

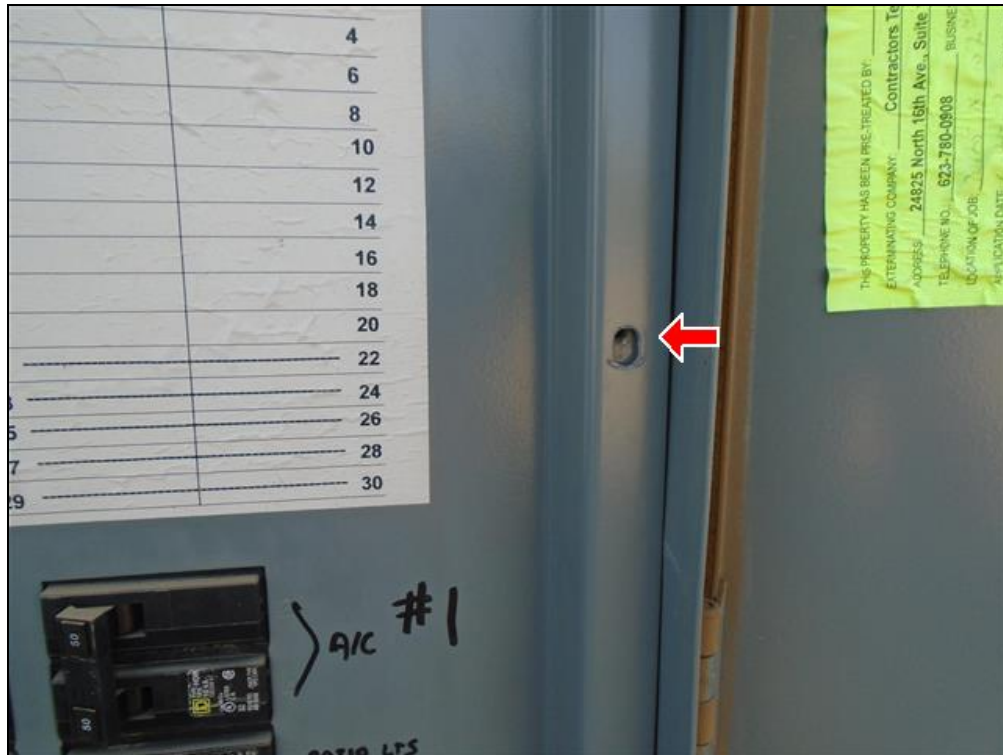
5.0 Item 3(Picture)

(2) Replace missing screw to secure the dead front panel of the main distribution panel.

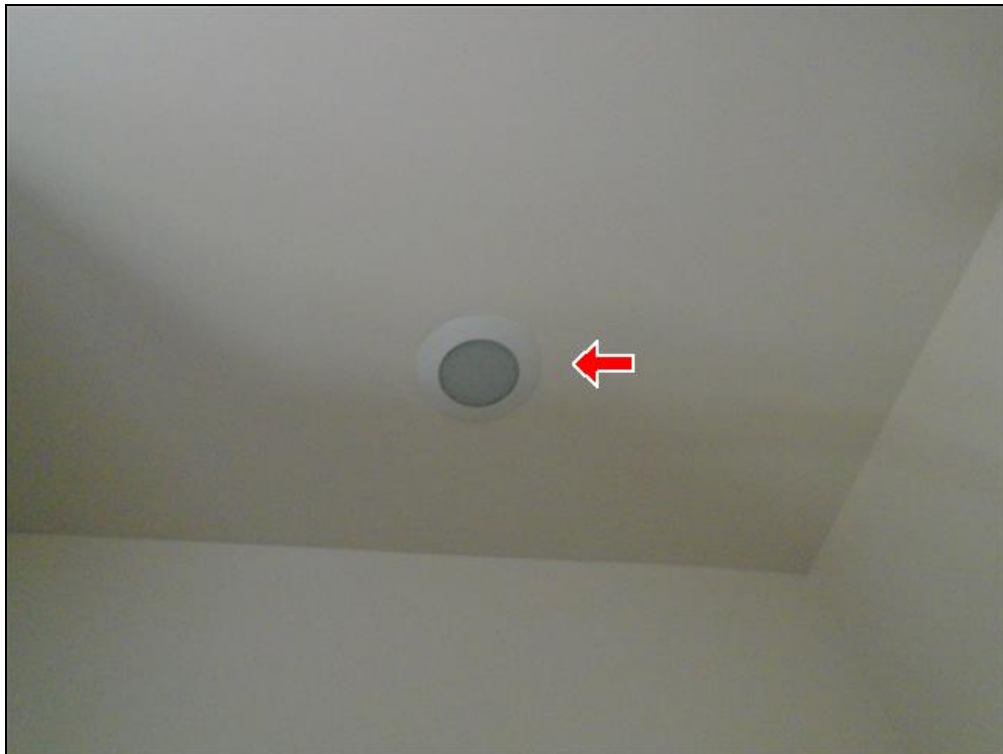
5.6 Item 1(Picture)

(2) The guest shower light is inoperable, remedy as needed.

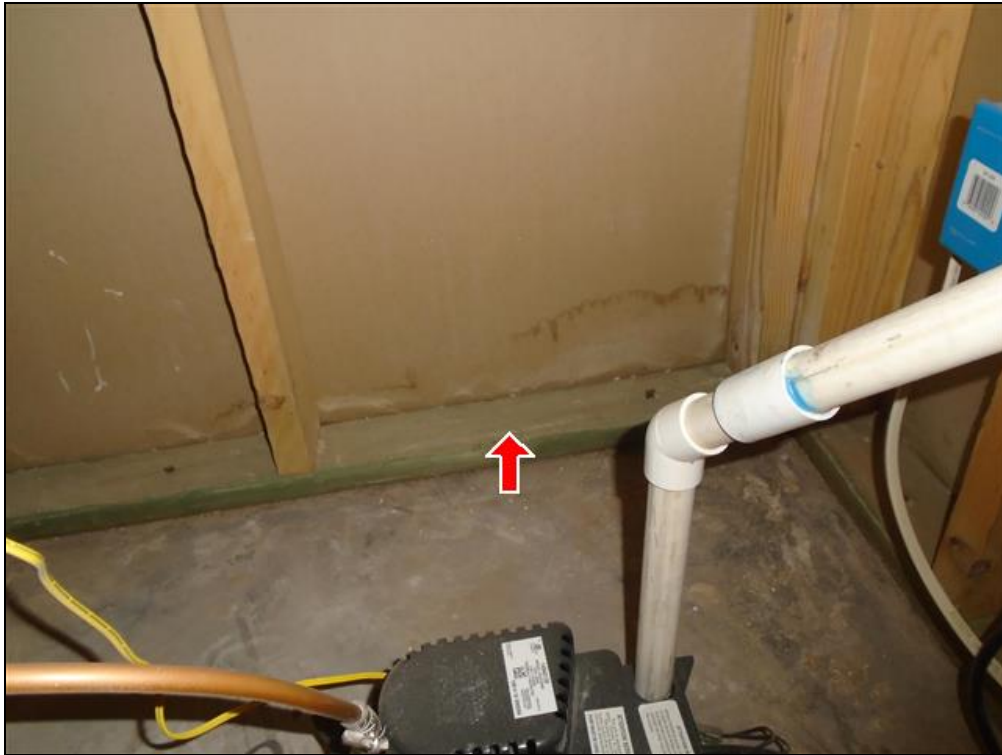
7.0 Item 5(Picture)

(2) There is evidence of previous condensate leakage into the hallway return air chase, monitor for future leakage and repair as needed.

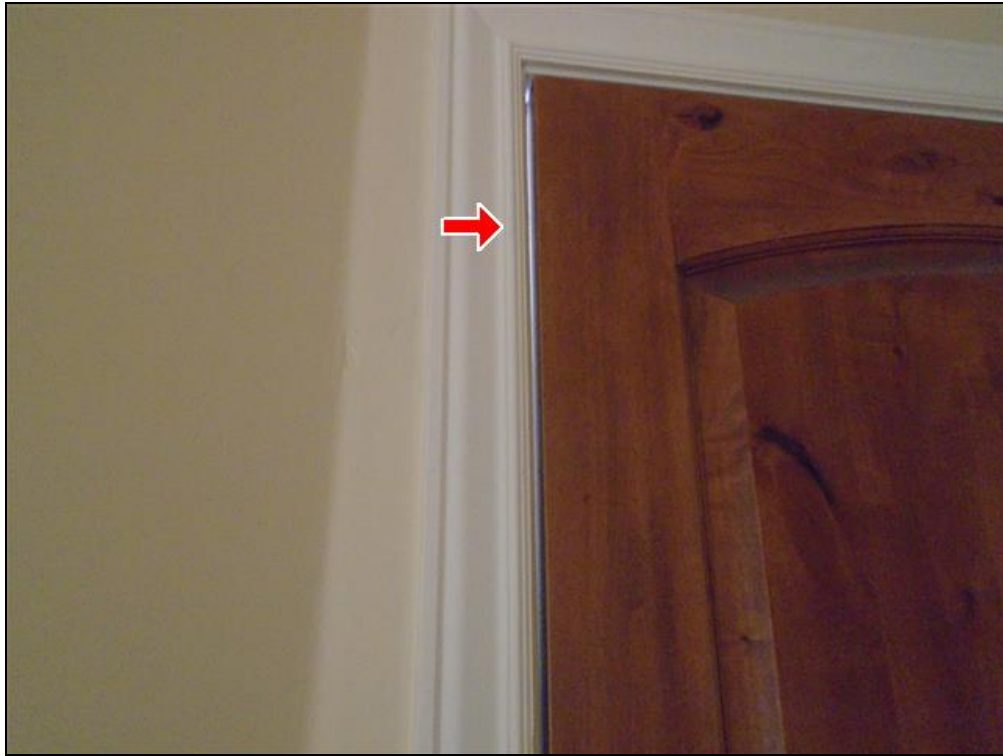
8.6 Item 1(Picture)

(2) There is daylight visible around the fire-door (house to garage). Adjust as needed to seal the opening.
