Inspection Report

1234 Winter Ln
Parks AZ 86018

Liberty Inspection Service

Date: 11/30/2018	Time: 08:00 AM	Report ID: Sample 3
Property: 1234 Winter Ln Parks AZ 86018	Customer: Rudolph Rednose	Real Estate Professional:

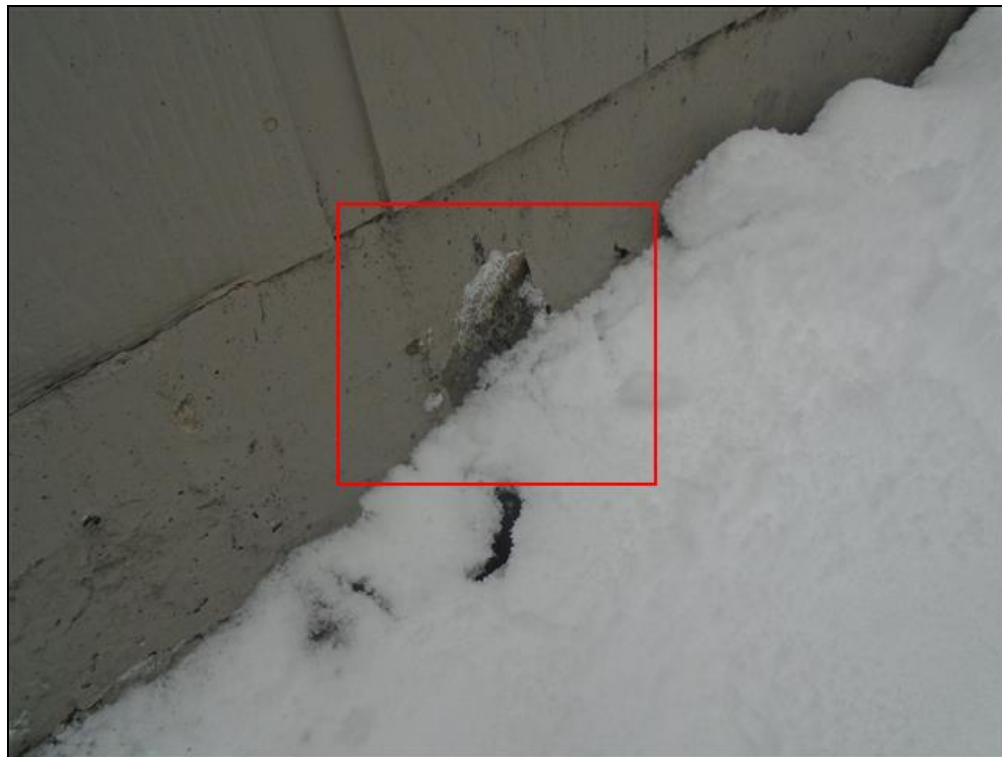
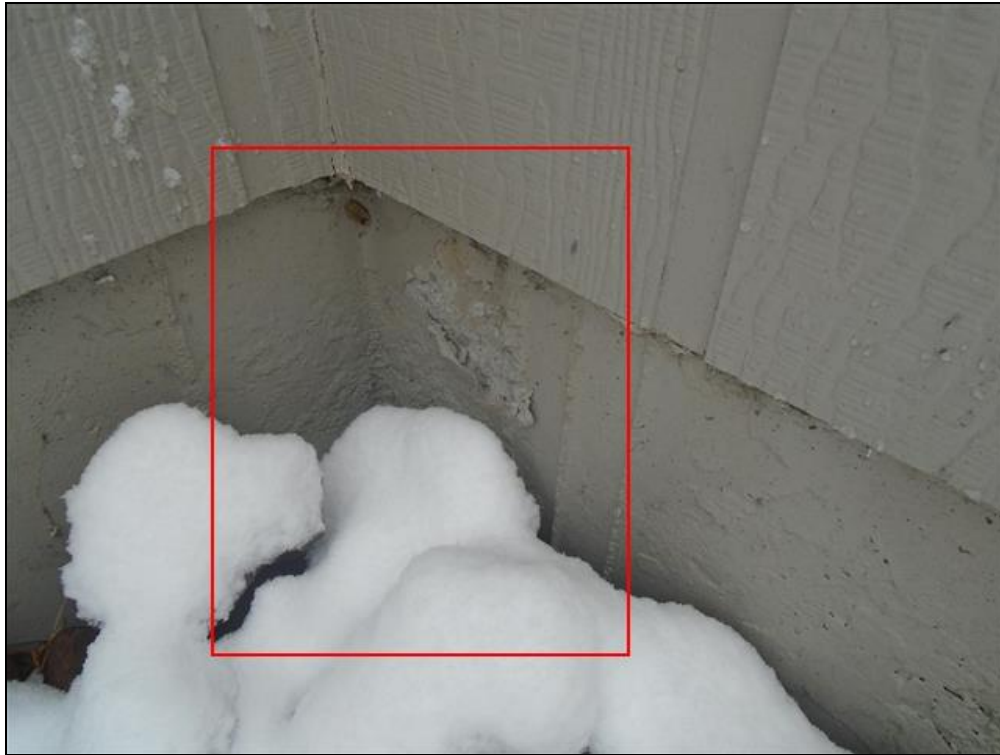
- (1) Overall the visible portions of the foundation are in satisfactory condition.
- (2) There is minor water damage to the foundation on the right side of the house. Repair as needed.

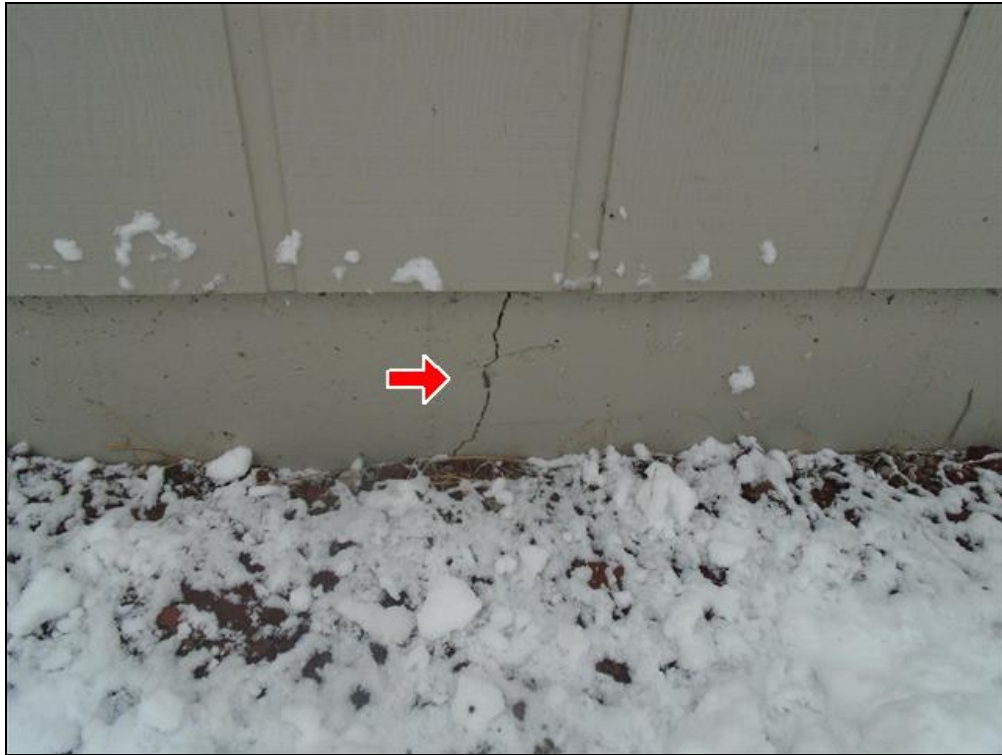
1.2 Item 1(Picture)

(2) There is a crack that extends from the ground up through the walls of the house. I recommend further professional evaluation by a licensed general contractor with repair as needed.

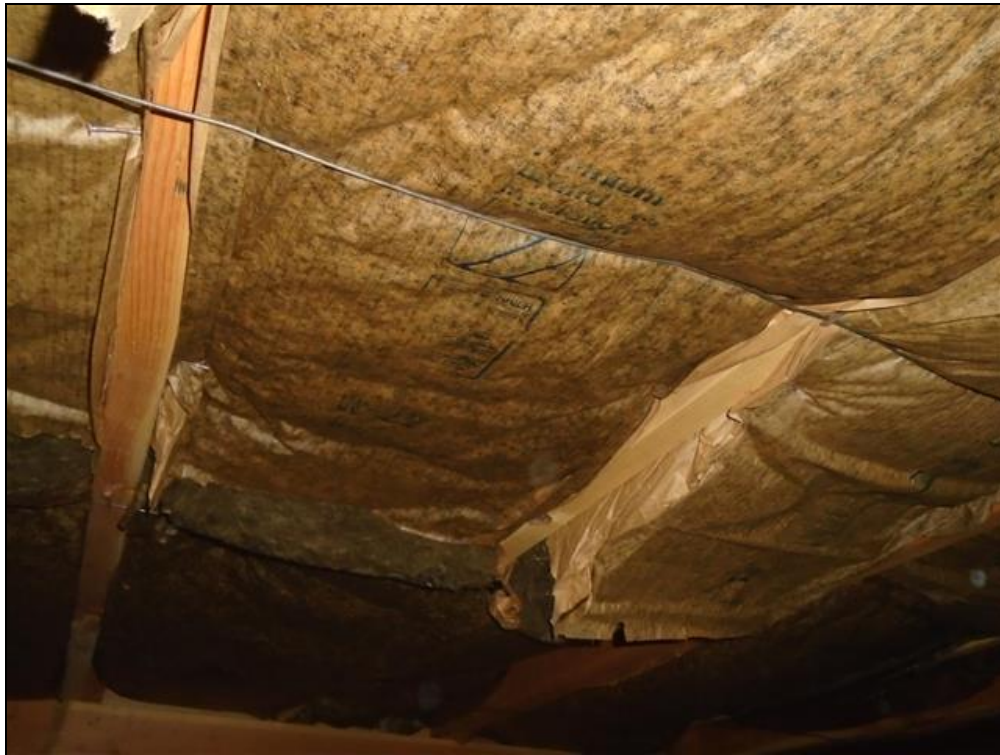
1.6 Item 16(Picture)

(2) Several of the insulating batts are installed with the flammable paper facing exposed. This is a fire hazard. Re-install the batts correctly or remove the paper facing material.

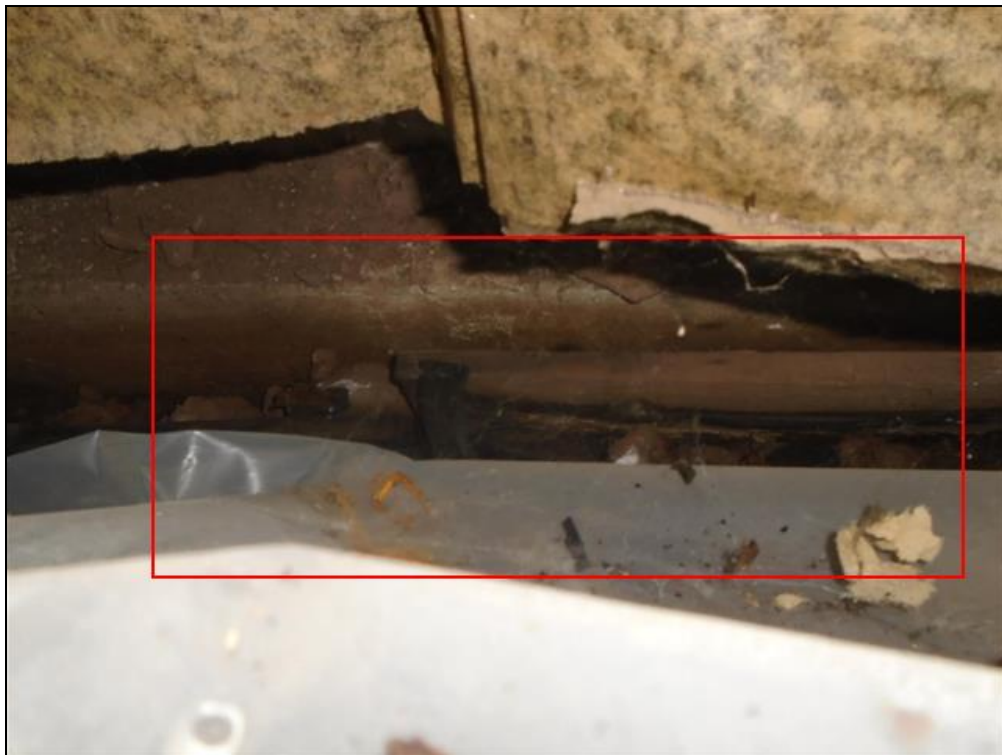
1.6 Item 21(Picture)

(4) The form boards are moisture saturated. I recommend removal of all form boards from the crawl space.

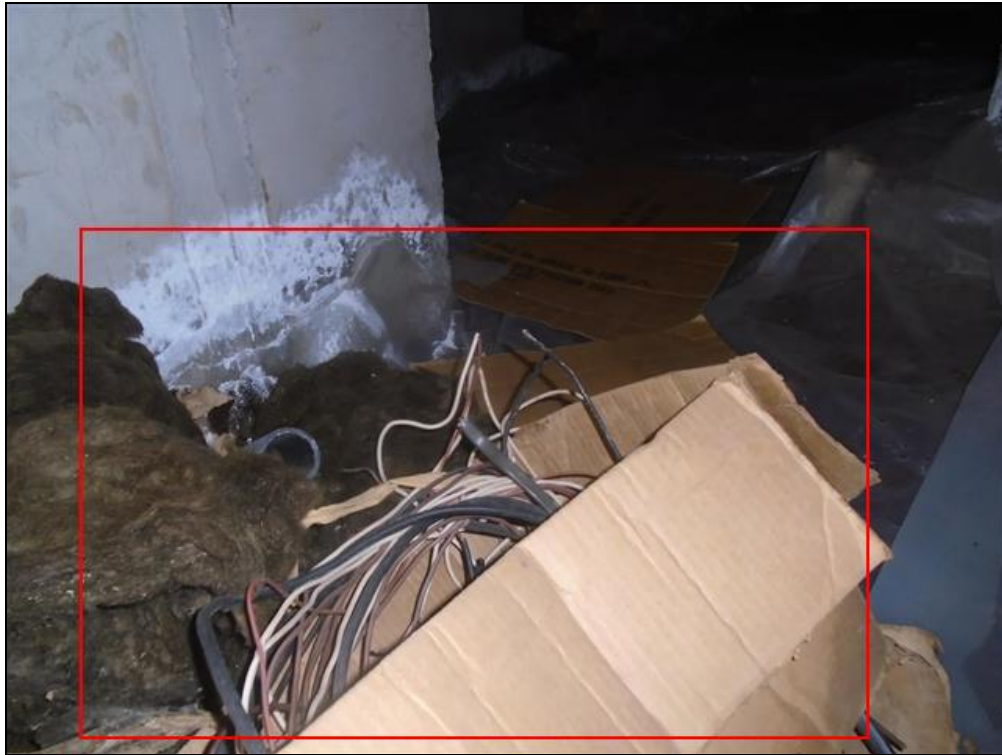
1.6 Item 22(Picture)

(5) I recommend removal of all unused materials.

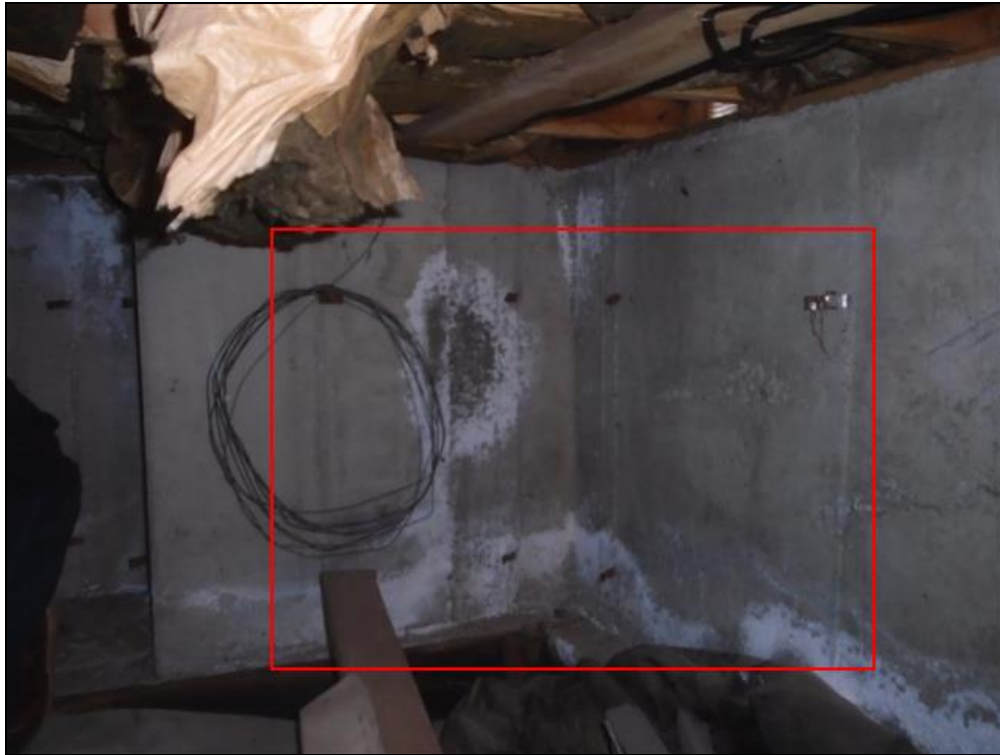
1.6 Item 24(Picture)

(6) There is evidence of water intrusion in several places in the crawlspace. Remedy as needed.

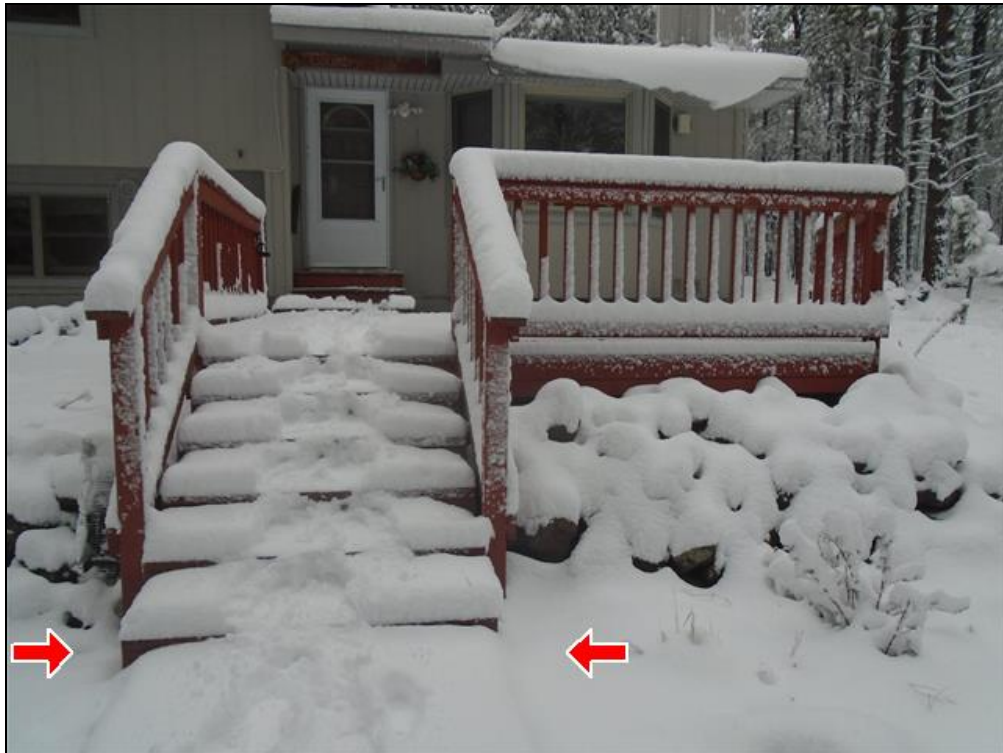
2.5 Item 2(Picture)

(2) The front and rear wood porches are in contact with the ground. I recommend addition of a concrete footer to prevent water damage.

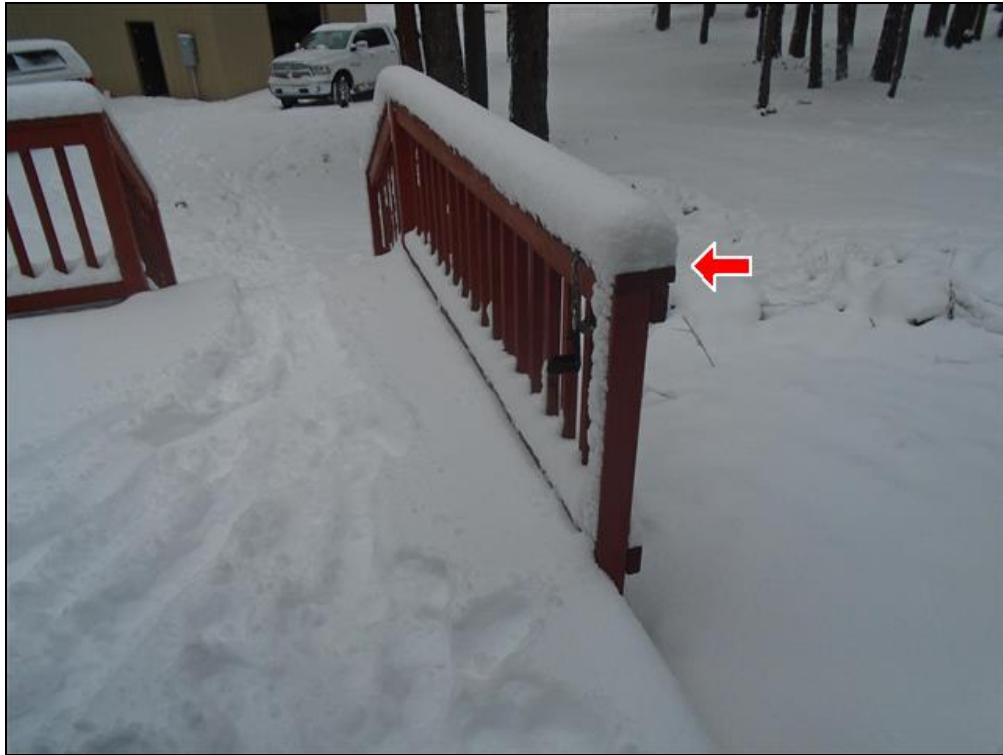
2.6 Item 1(Picture)

- (1) Overall the visible portion of the porches, areaways and railings are in satisfactory condition.
- (2) The front porch railing is loose, secure as needed.

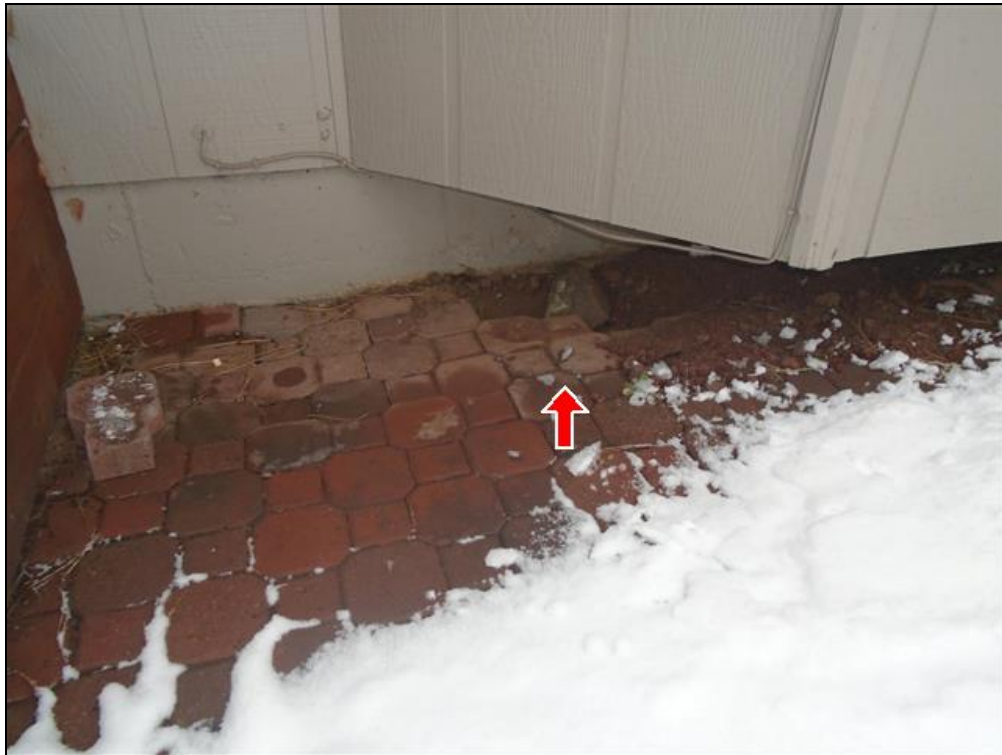
The grade is sloped toward the house in several locations. This will direct surface water into the soil adjacent to the foundation and cause water damage to the foundation concrete. Adjust the grade to direct surface water away from the foundation to prevent water damage.

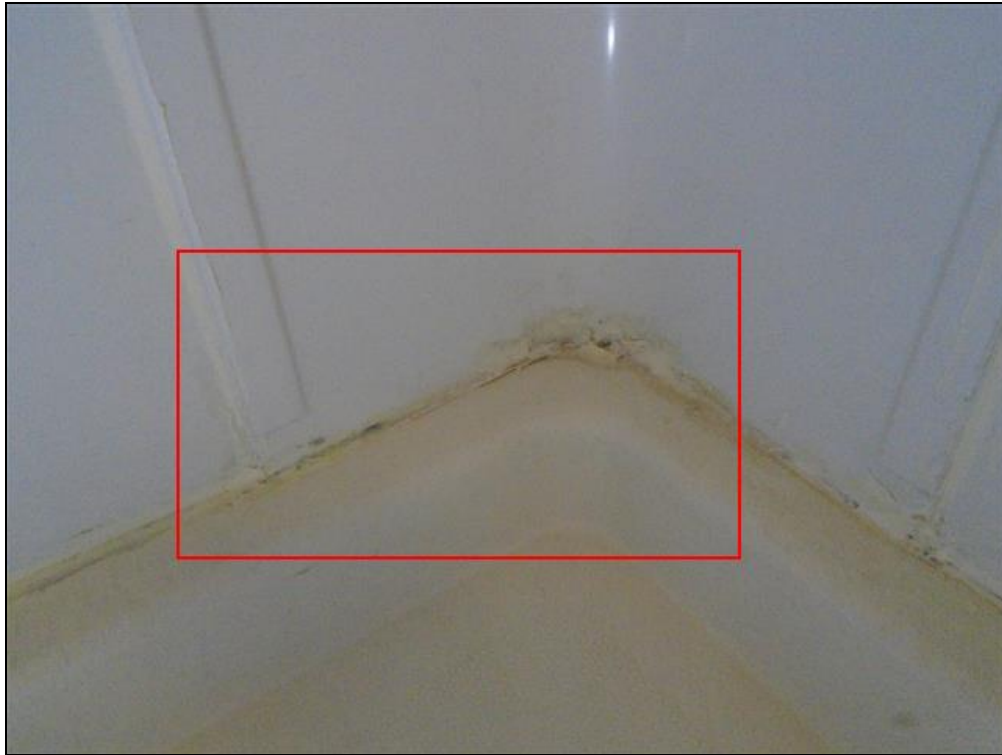
4.2 Item 3(Picture)

- (3) The shower door needs adjustment or repair to operate as intended.
- (4) Seal all cracks in the shower surround to prevent water intrusion.

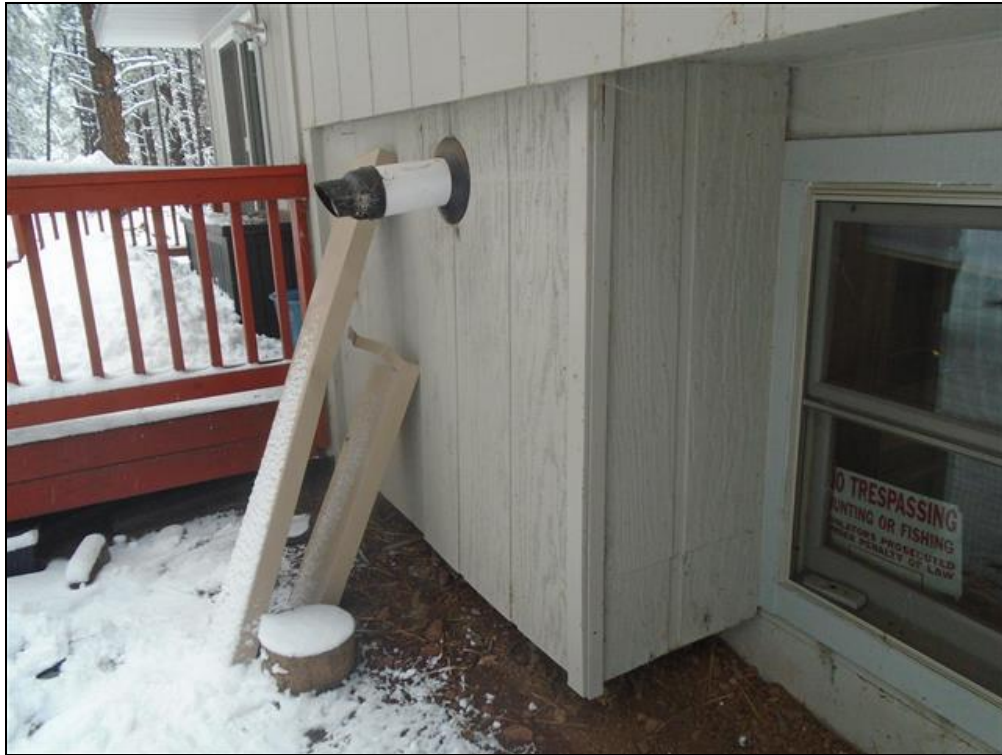
4.9 Item 1(Picture) no exterior access

The water heater is inaccessible. I recommend the addition of a door to the water heater with inspection before closing to verify age and condition.

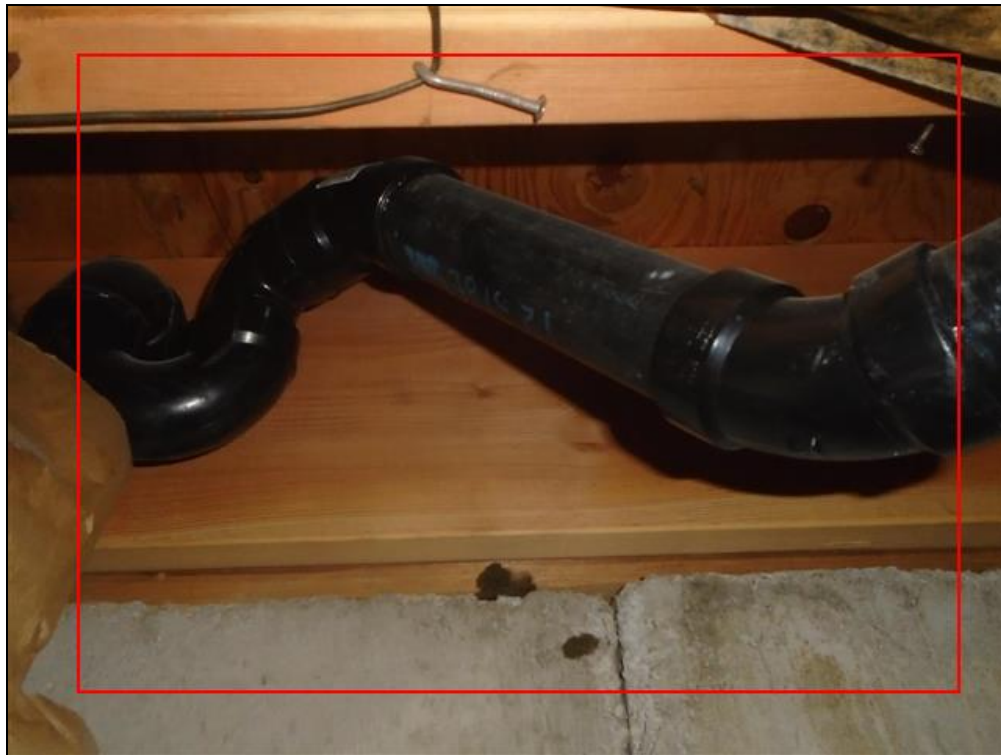
4.15 Item 1(Picture)

(1) There is a P trap but no vent on the bathroom plumbing in the crawl space. I recommend further professional evaluation with repair as needed.

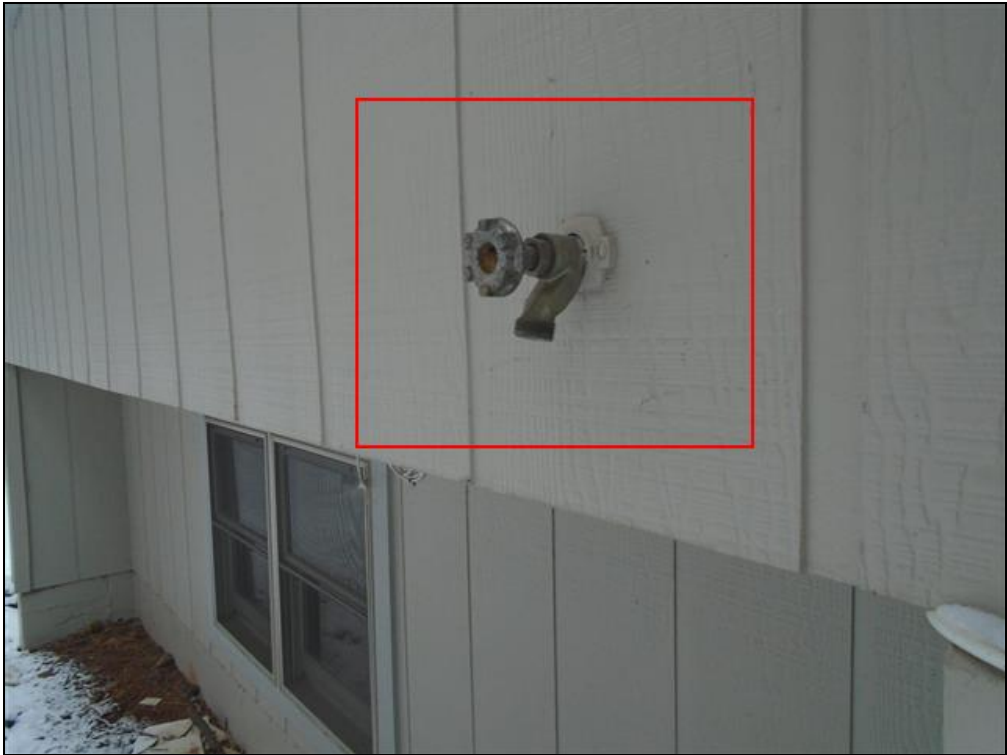
4.15 Item 4(Picture)

(3) I was unable to operate the front hose bib. It may be winterized. Have current owner demonstrate operation with repair as needed.

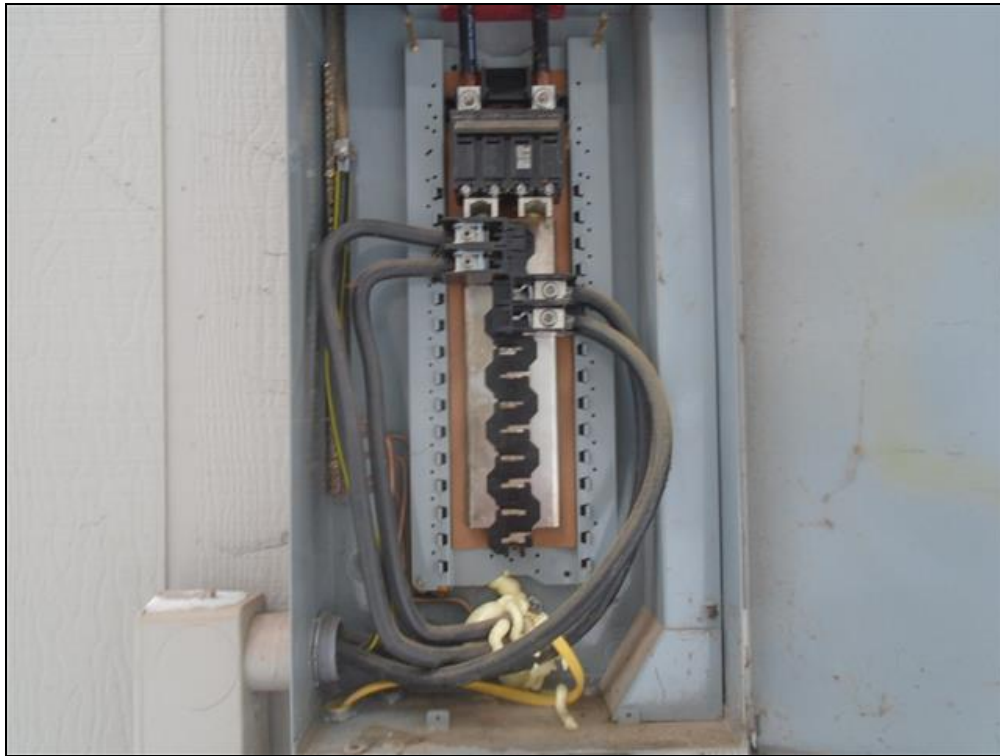
5.0 Item 1(Picture)

(1) The main disconnect is on the left side of the house and distribution panels are located in the laundry room and garage.

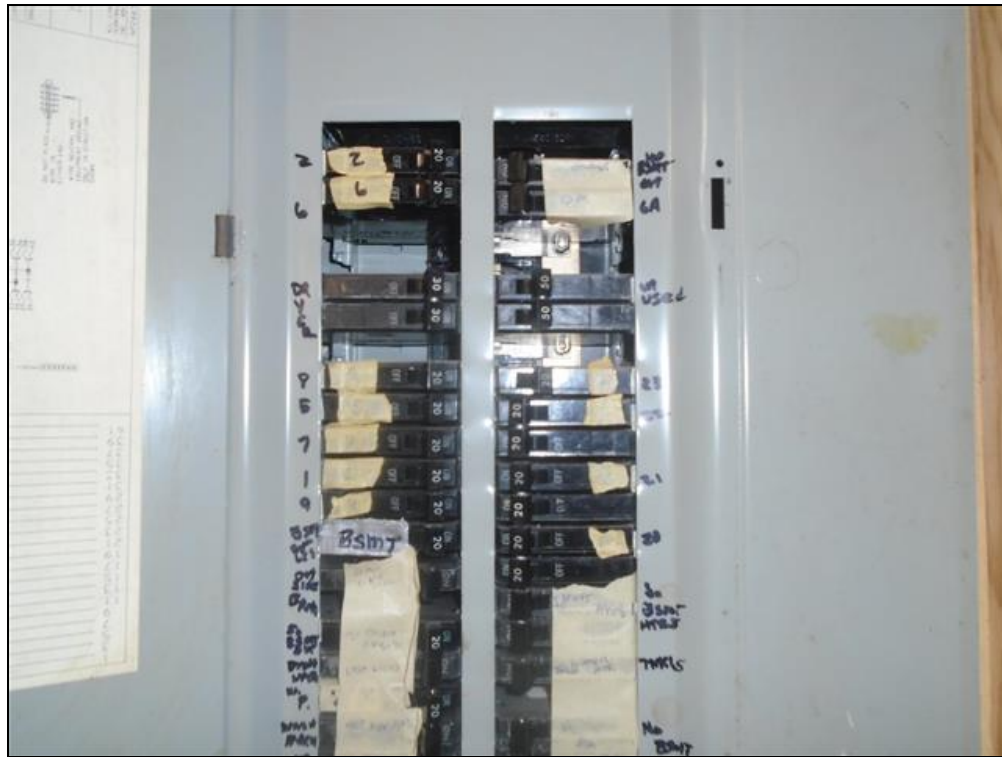
5.0 Item 3(Picture)

(2) The main dead front panel has been removed, I recommend replacement.
(3) Permanently identify all circuit breakers.

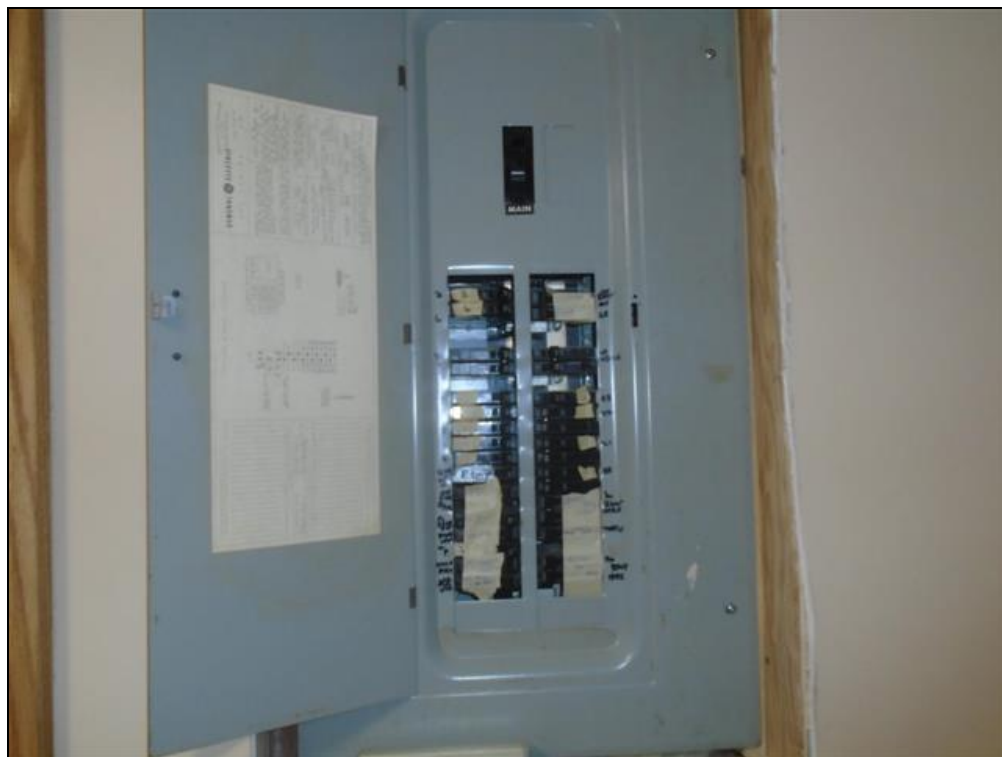
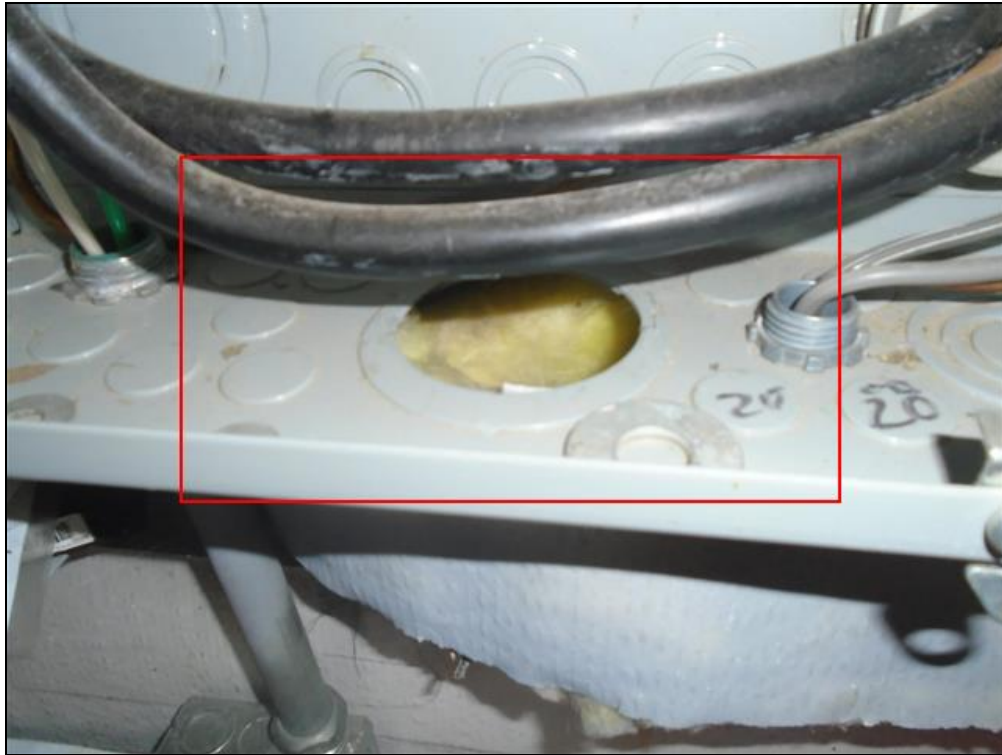
(4) Seal all holes in the panels to prevent electrical hazard..

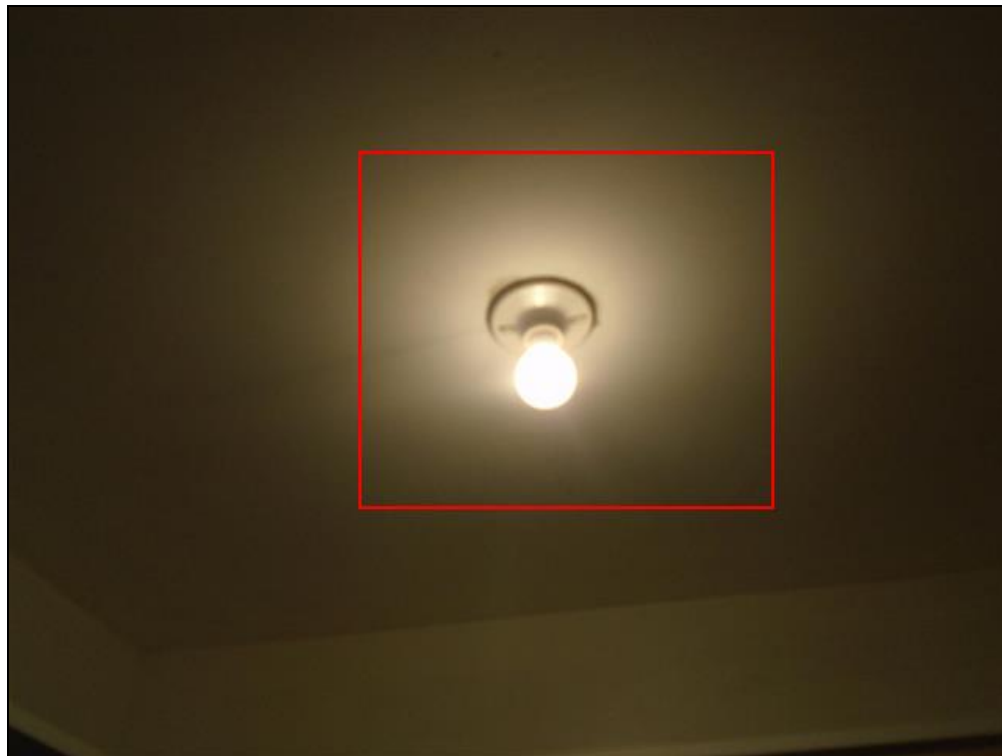
5.6 Item 3(Picture)

(3) Open incandescent bulb fixtures are no longer allowed in closets, fire hazard. A recessed incandescent or surface fluorescent can be installed within 6" of the top shelf or an enclosed incandescent may be installed within 12" of the top shelf or a surface mount fluorescent may be installed on the inside wall over the door. I recommend professional evaluation and remedy as needed.

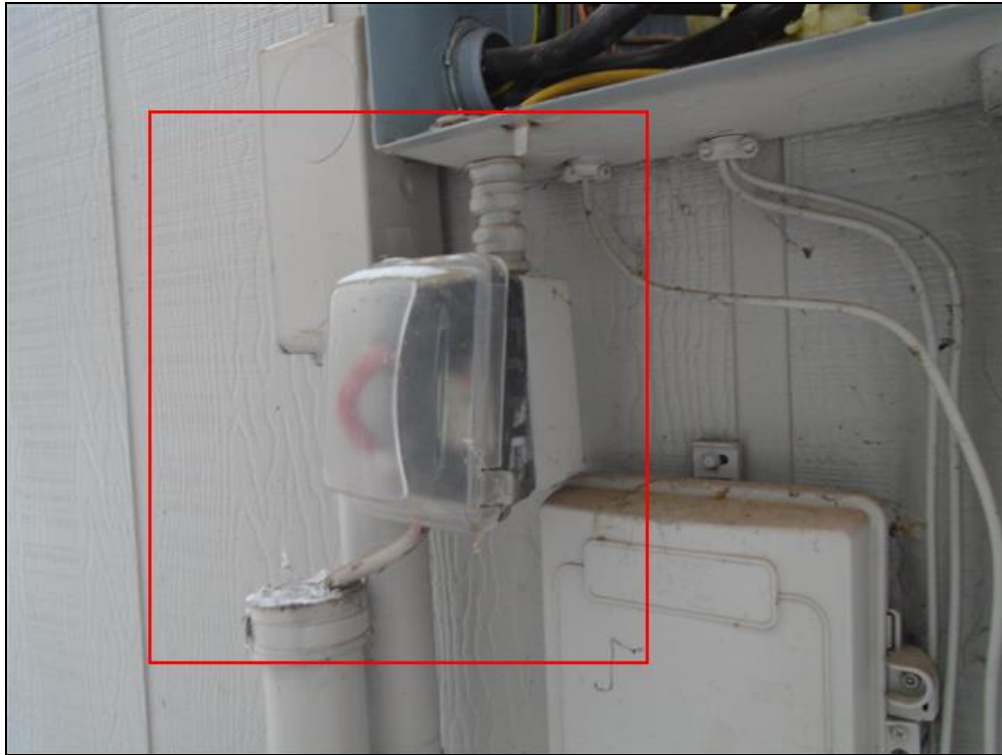
- (1) A representative number of receptacles were tested for polarity and ground and found to be operational and in satisfactory condition.
- (2) The GFCI outlet under the electric service panel is loose, secure as needed.

Extension cords cannot be used as a permanent source of power. Remedy as needed.

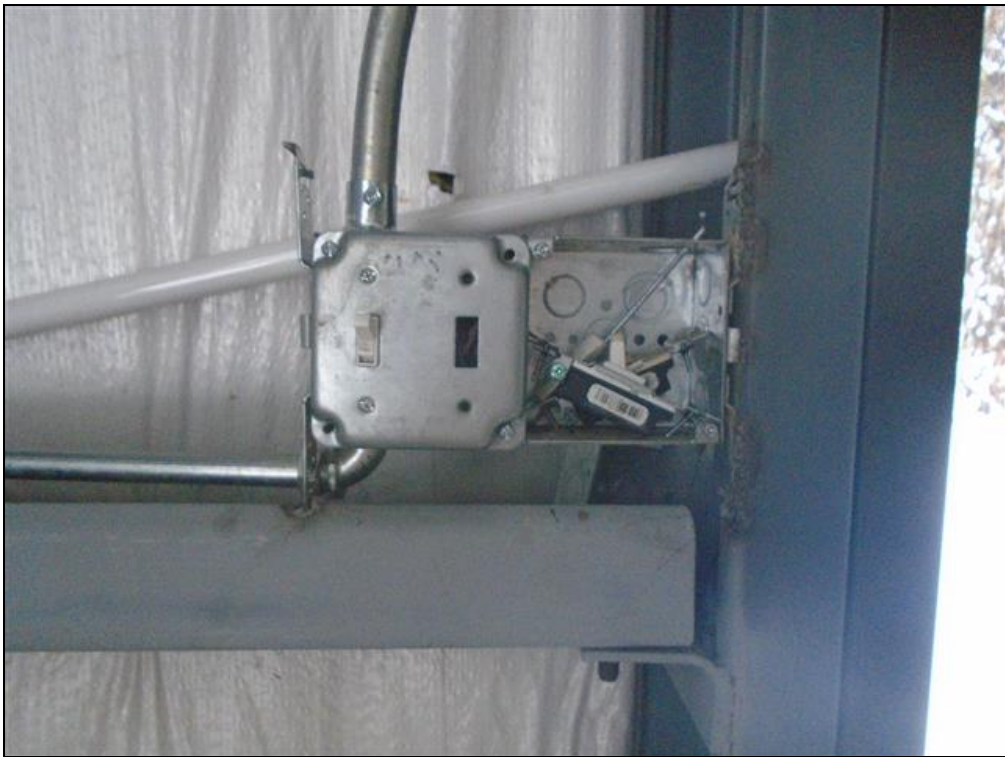
5.10 Item 1(Picture)

There are additions/modifications to the original electrical system, I recommend professional evaluation for safety, suitability and compliance with industry standards. Make sure required permits were obtained, work was performed by licensed contractor and all work was inspected and approved.

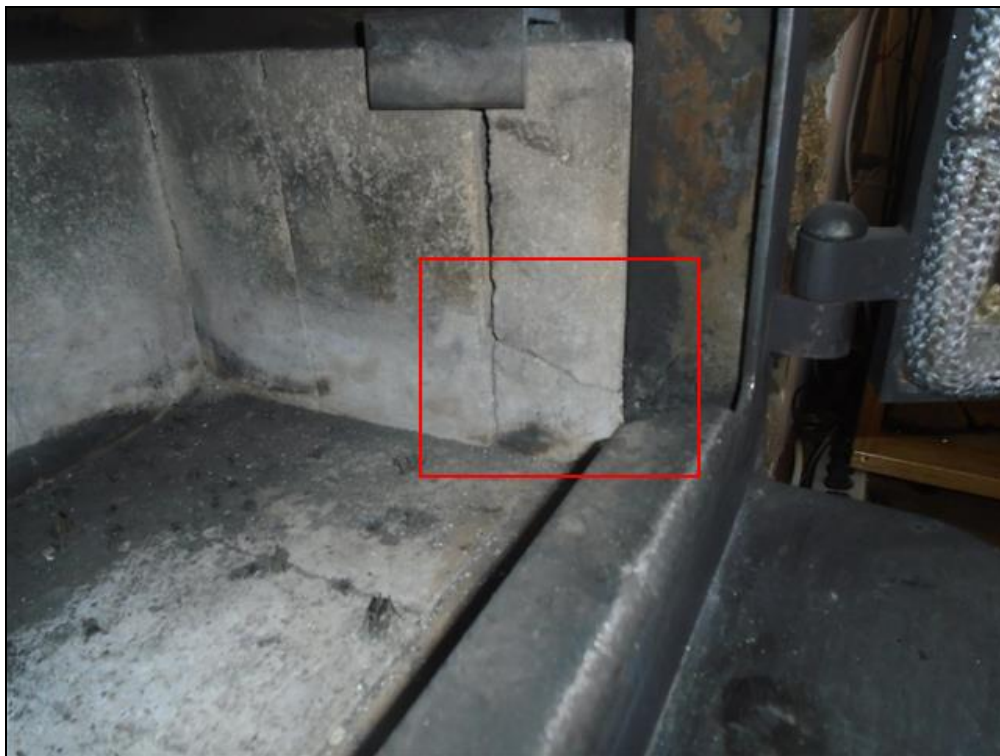
6.3 Item 2(Picture)

(2) One of the fire bricks in the wood stove is cracked. Repair as needed.

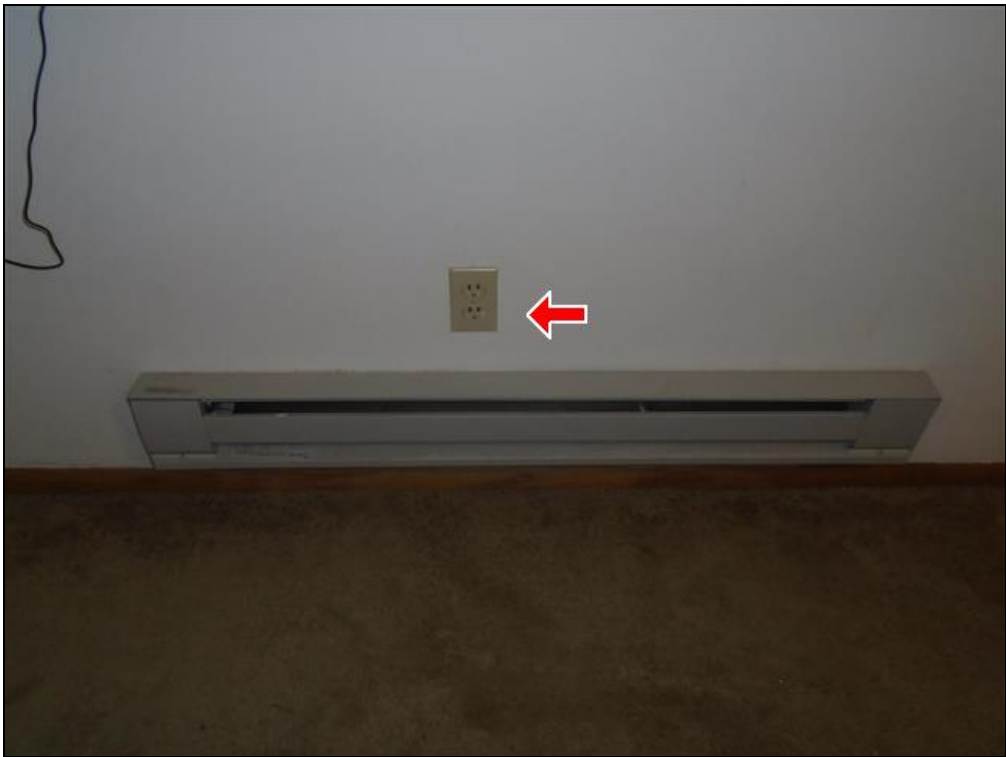
6.7 Item 1(Picture)

Comments: Repair or Replace
Outlets over baseboard heaters can damage the electrical. I recommend removal of the outlet or discontinue use.

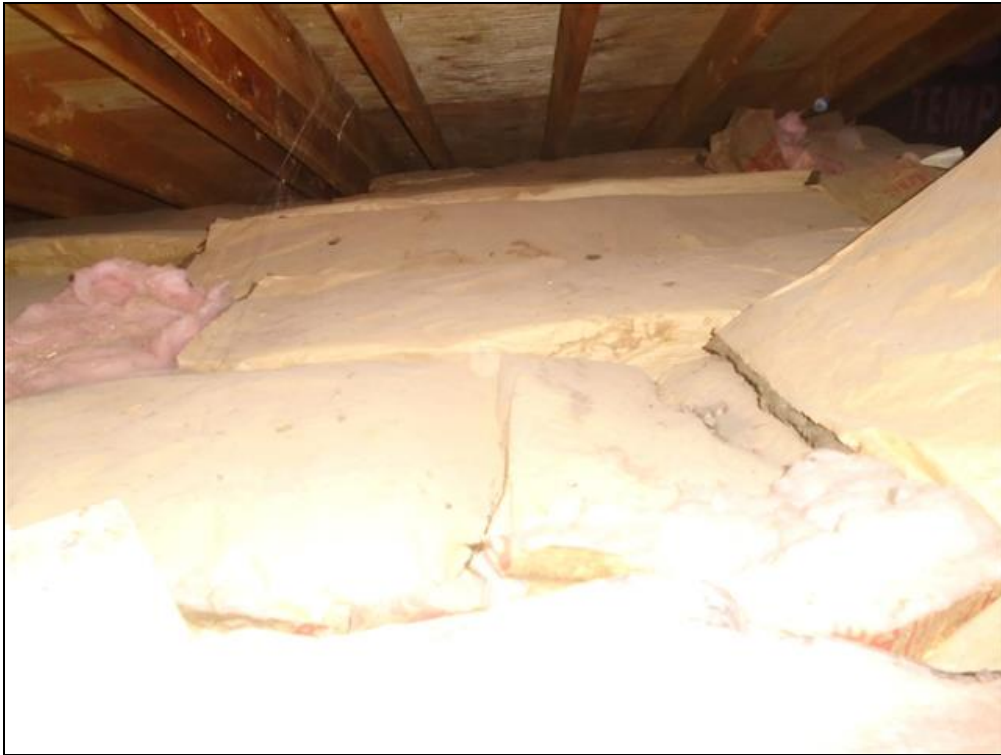
9.0 Item 1(Picture)

(2) Several of the insulating batts are installed with the flammable paper facing exposed. This is a fire hazard. Re-install the batts correctly or remove the paper facing material.

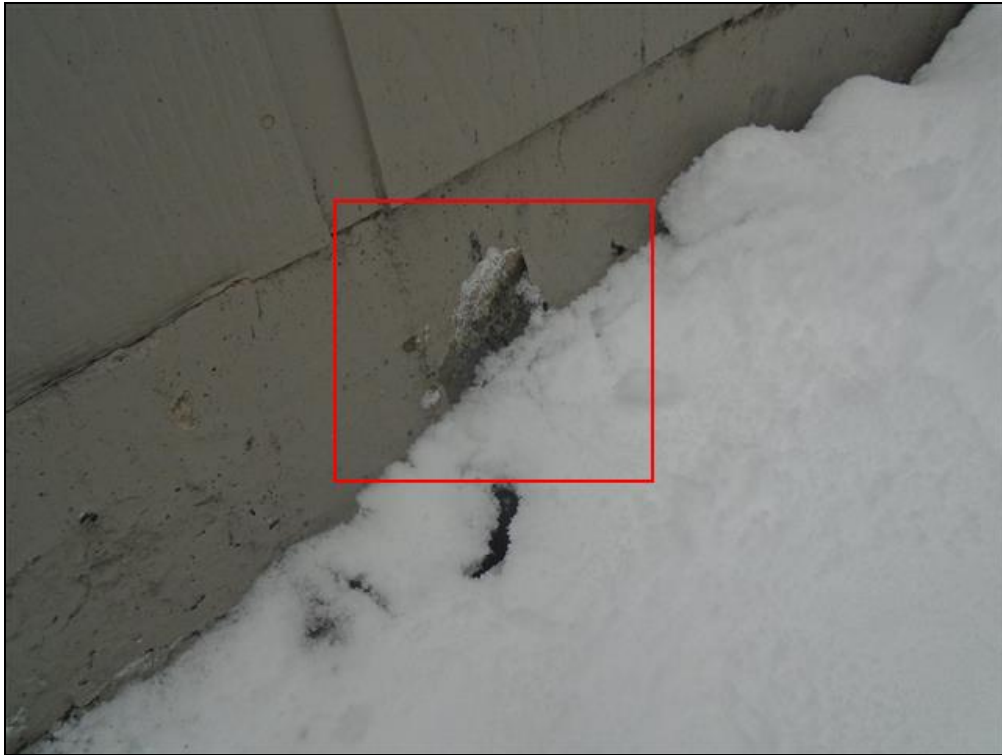
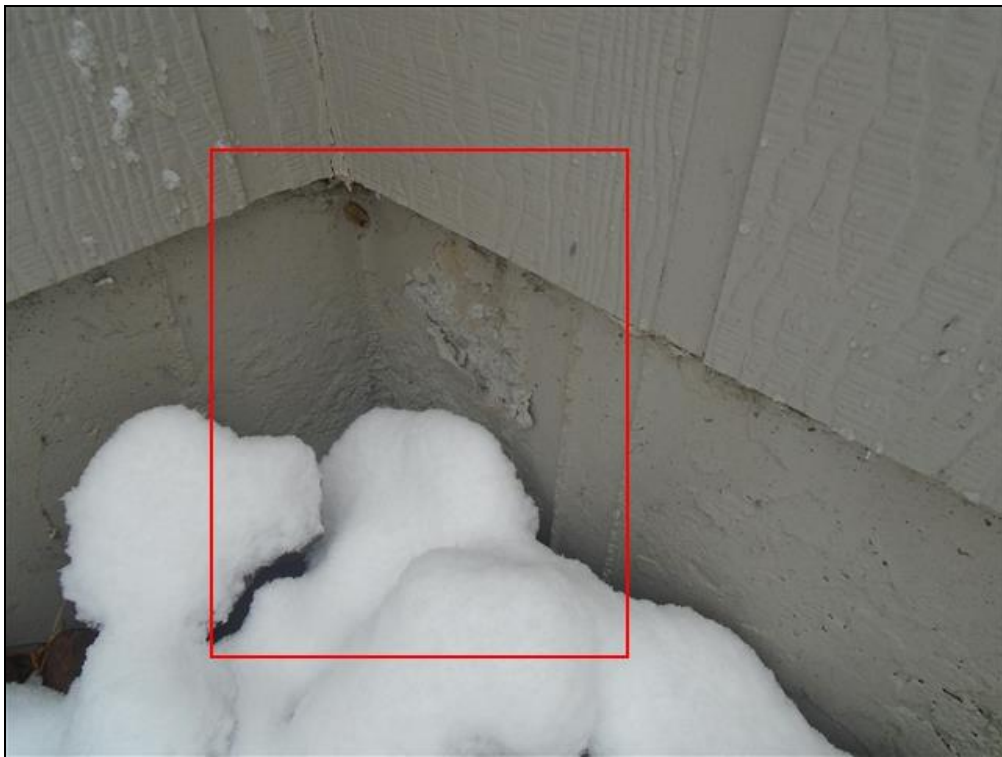
(2) There is minor water damage to the foundation on the right side of the house. Repair as needed.

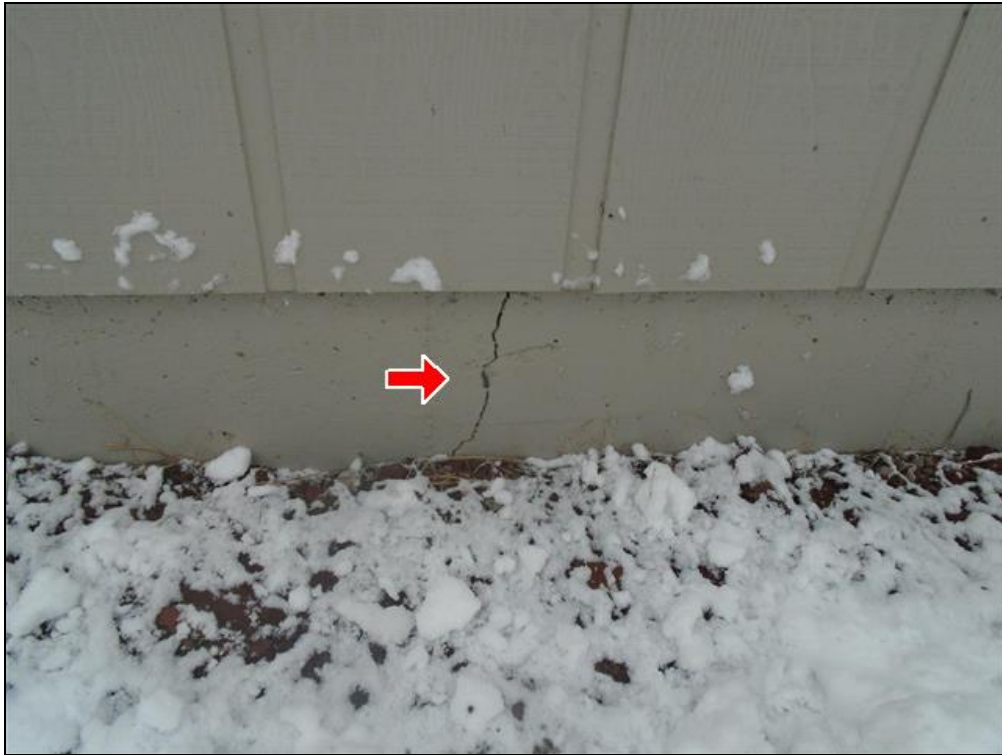
1.2 Item 1(Picture)

(2) There is a crack that extends from the ground up through the walls of the house. I recommend further professional evaluation by a licensed general contractor with repair as needed.

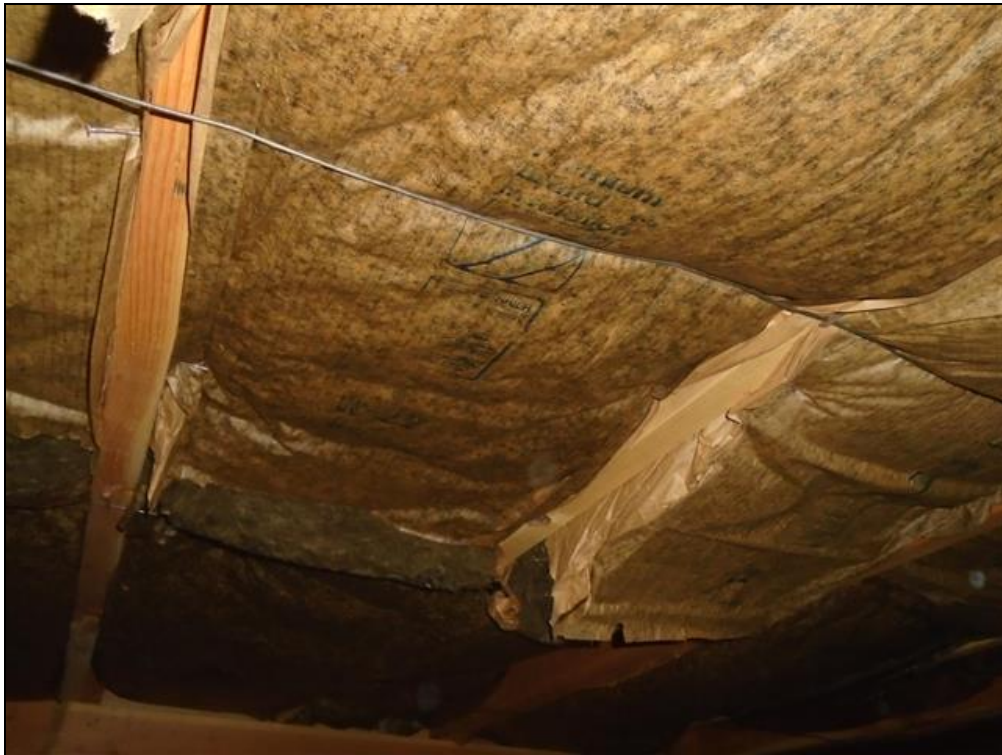
1.6 Item 16(Picture)

(2) Several of the insulating batts are installed with the flammable paper facing exposed. This is a fire hazard. Re-install the batts correctly or remove the paper facing material.

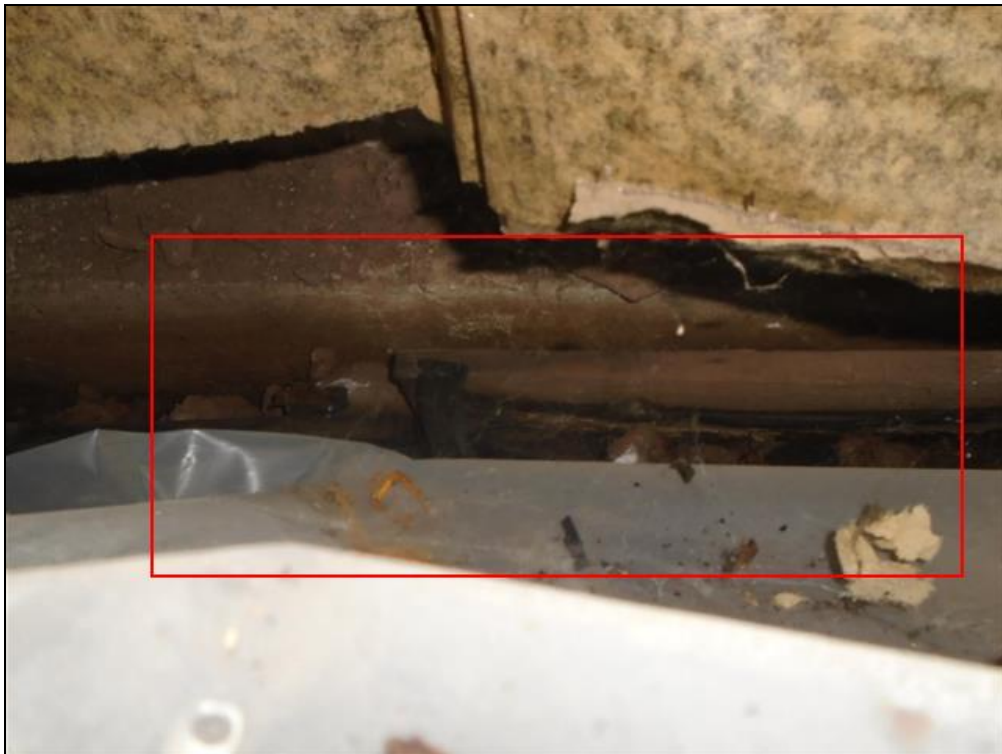
1.6 Item 21(Picture)

(4) The form boards are moisture saturated. I recommend removal of all form boards from the crawl space.
