Inspection Report

1234 Winter Ln
Parks AZ 86018

Liberty Inspection Service

Date: 11/30/2018	Time: 08:00 AM	Report ID: Sample 3
Property: 1234 Winter Ln Parks AZ 86018	Customer: Rudolph Rednose	Real Estate Professional:

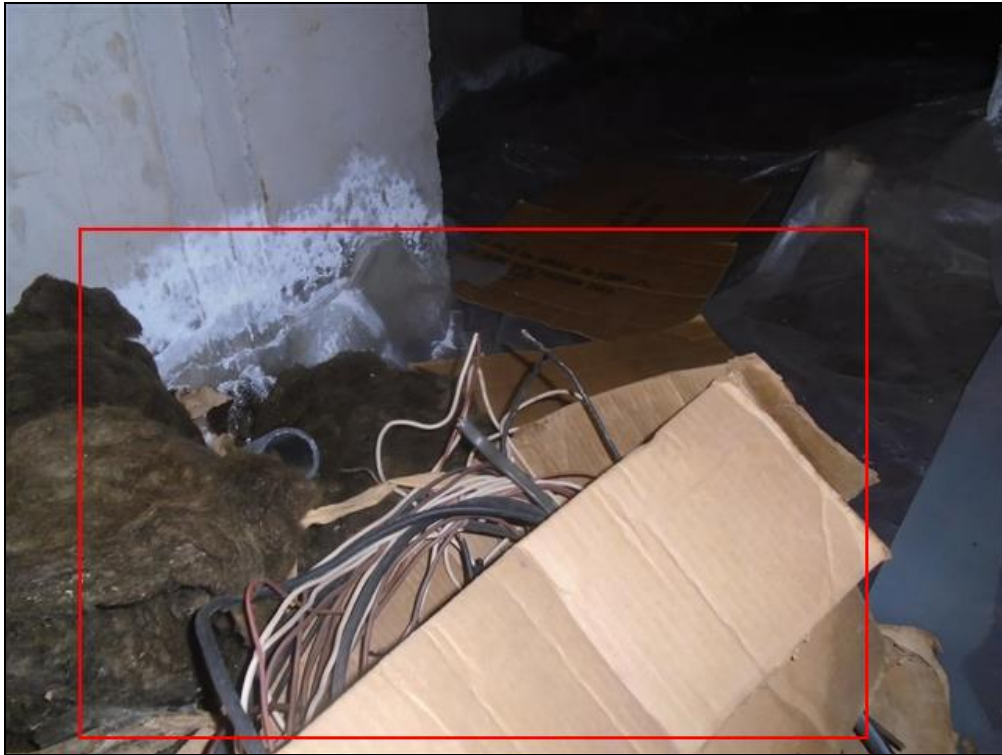
1.6 Item 22(Picture)

(5) I recommend removal of all unused materials.

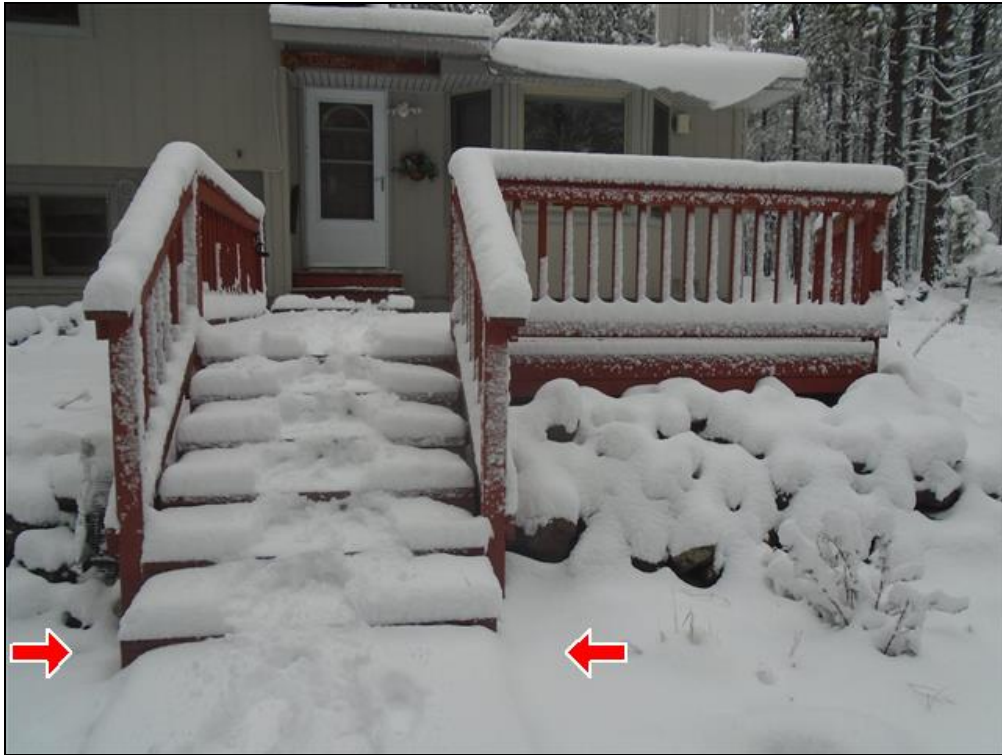
2.5 Item 2(Picture)

(2) The front and rear wood porches are in contact with the ground. I recommend addition of a concrete footer to prevent water damage.

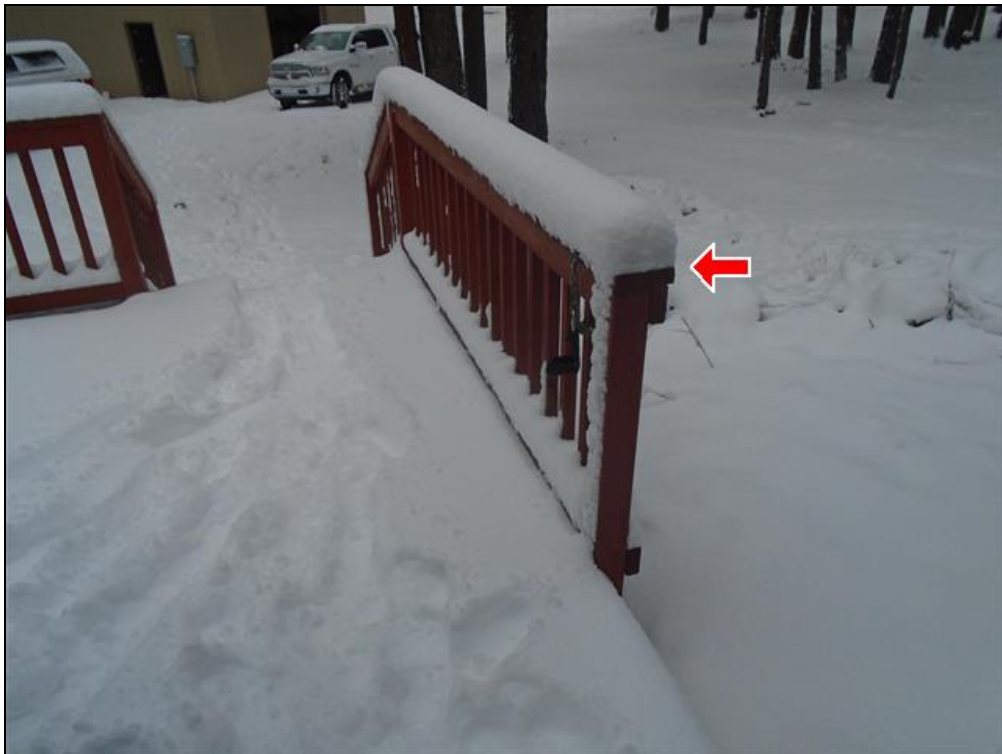
2.6 Item 1(Picture)

(2) The front porch railing is loose, secure as needed.

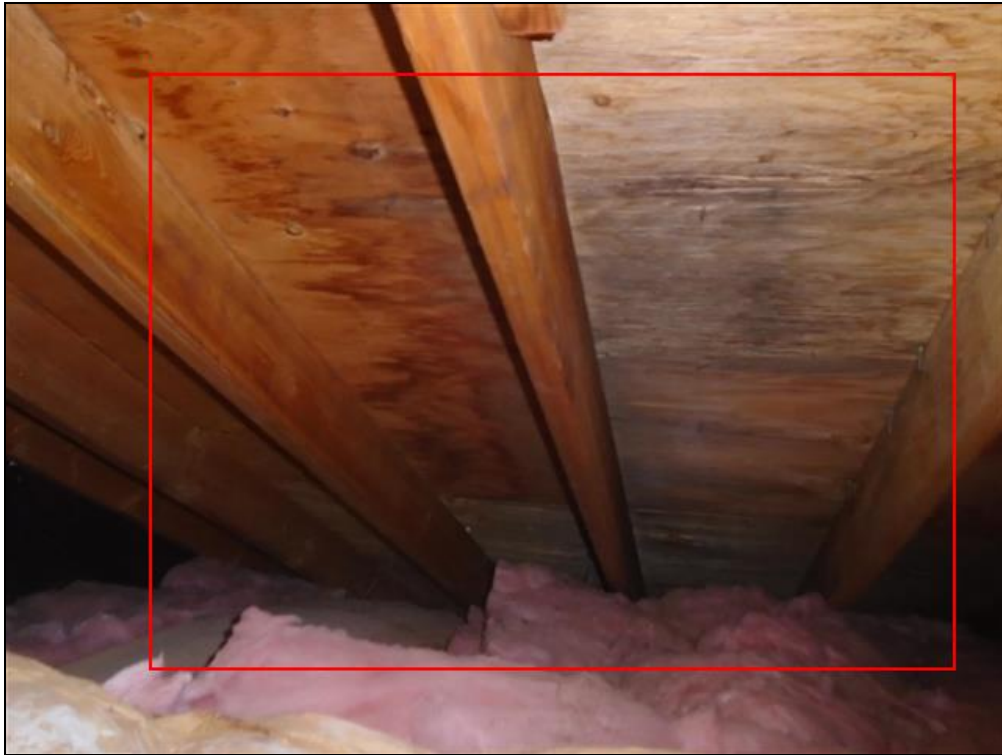
3.3 Item 1(Picture)

There are water stains on the underside of the roof decking. I recommend further evaluation with repair as needed.

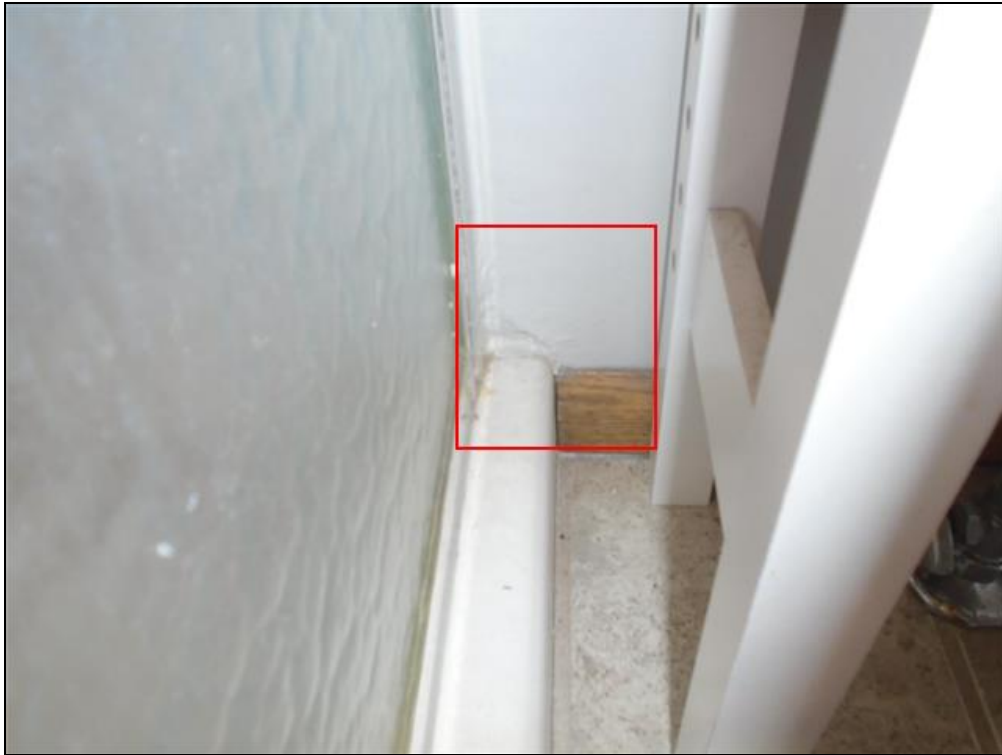
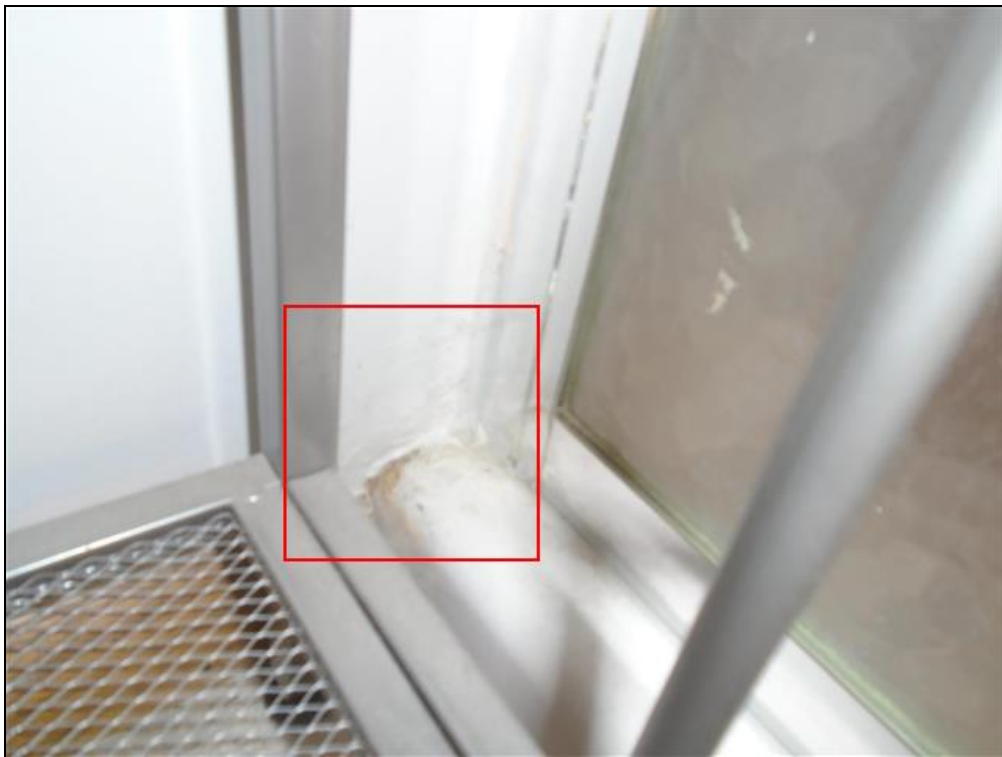
- (1) The toilet flush valve is loose, secure as needed.
- (2) There is evidence of previous water intrusion into the walls near the shower. Monitor for future leakage and repair as needed.

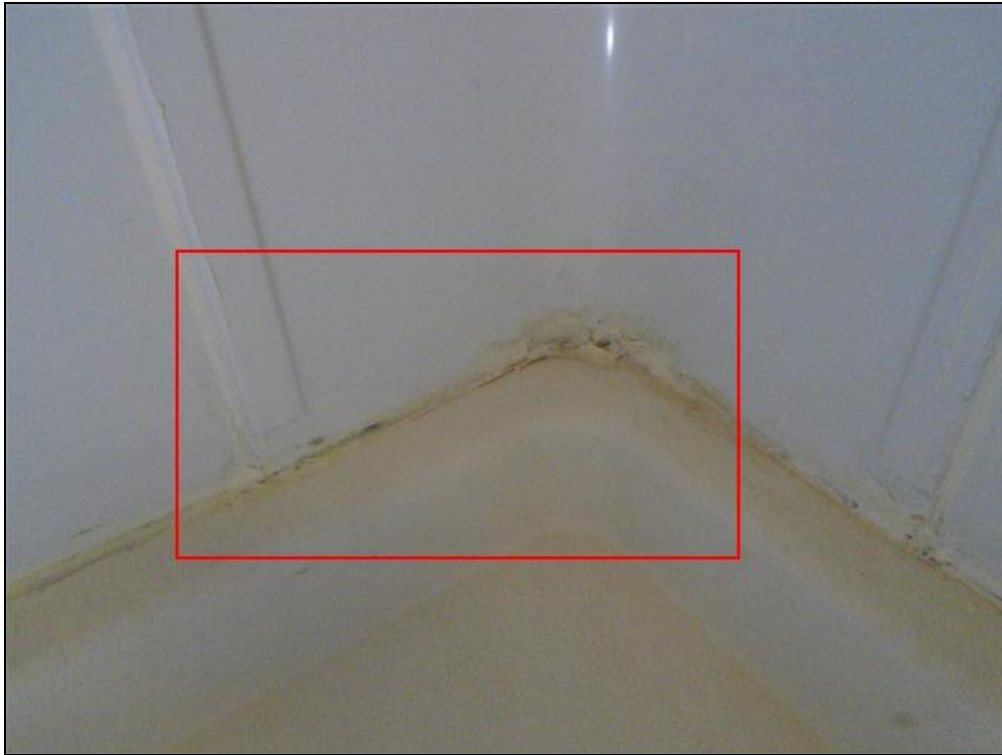
4.2 Item 3(Picture)

- (3) The shower door needs adjustment or repair to operate as intended.
- (4) Seal all cracks in the shower surround to prevent water intrusion.

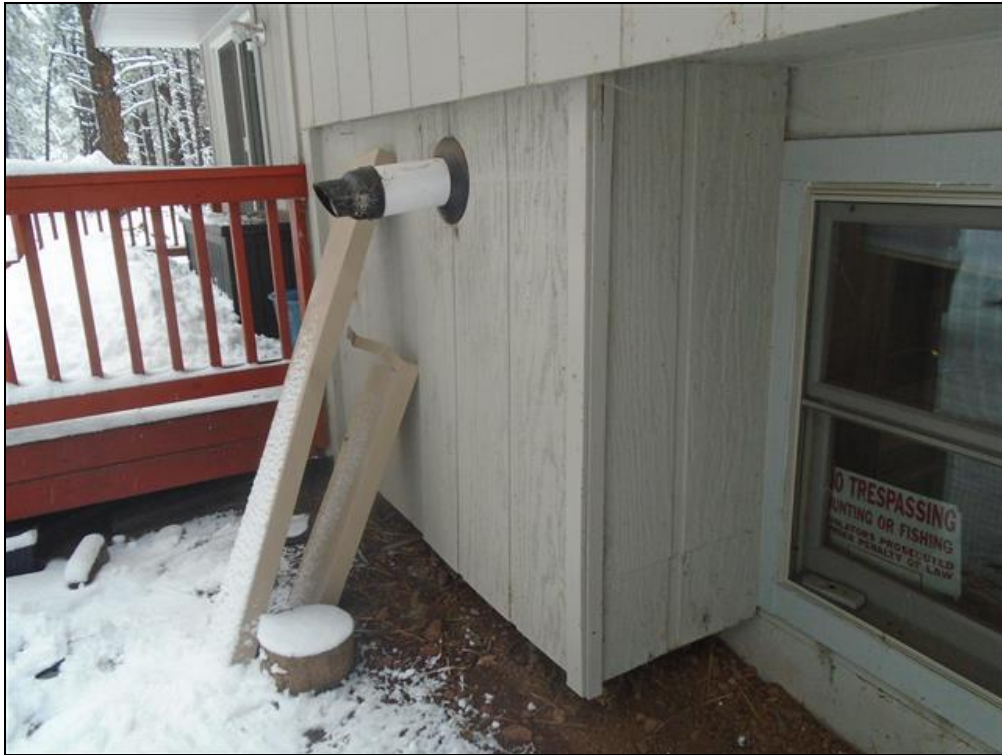
The water heater is inaccessible. I recommend the addition of a door to the water heater with inspection before closing to verify age and condition.

4.9 Item 1(Picture) no exterior access

4.9 Item 2(Picture) no interior access

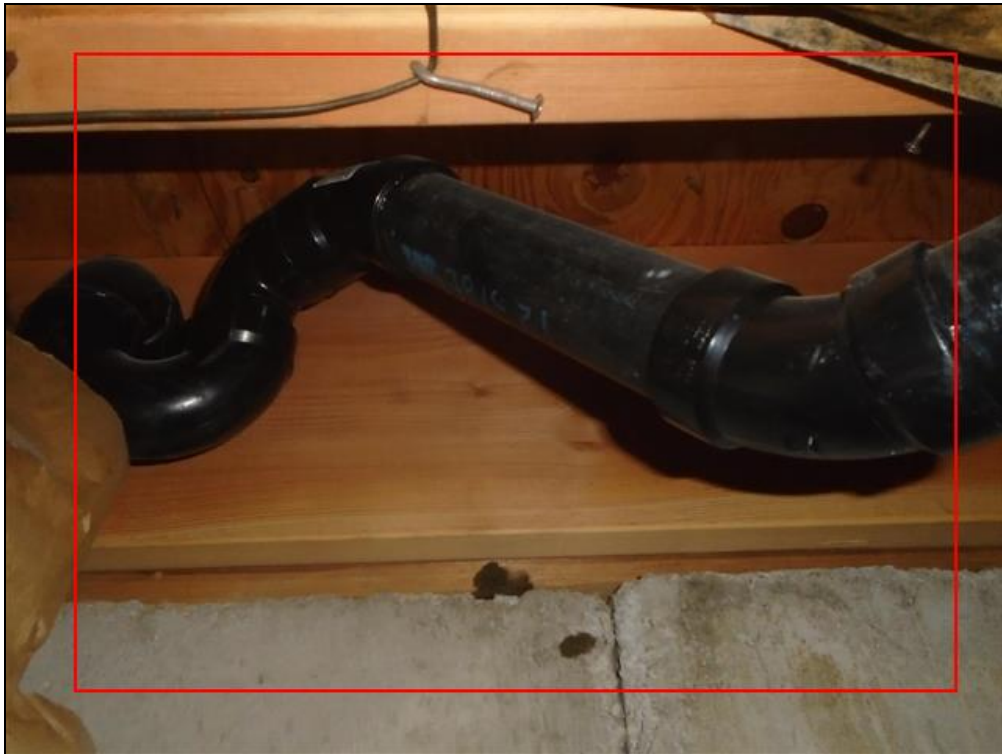
4.15 Item 1(Picture)

(1) There is a P trap but no vent on the bathroom plumbing in the crawl space. I recommend further professional evaluation with repair as needed.

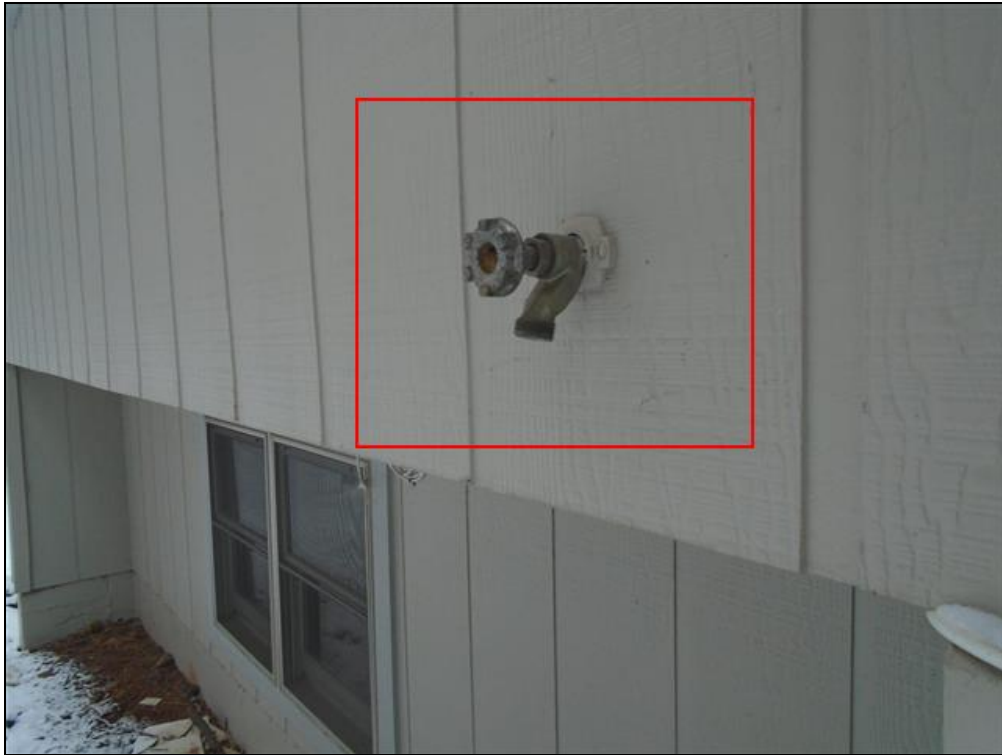
4.15 Item 4(Picture)

(3) I was unable to operate the front hose bib. It may be winterized. Have current owner demonstrate operation with repair as needed.

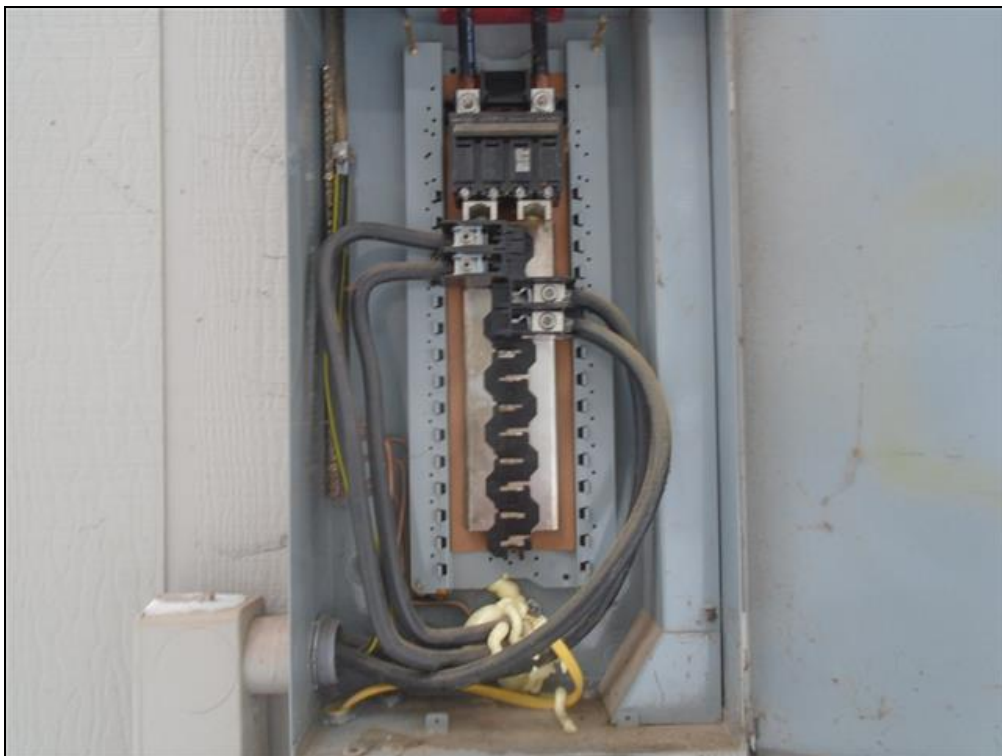
5.0 Item 1(Picture)

(1) The main disconnect is on the left side of the house and distribution panels are located in the laundry room and garage.

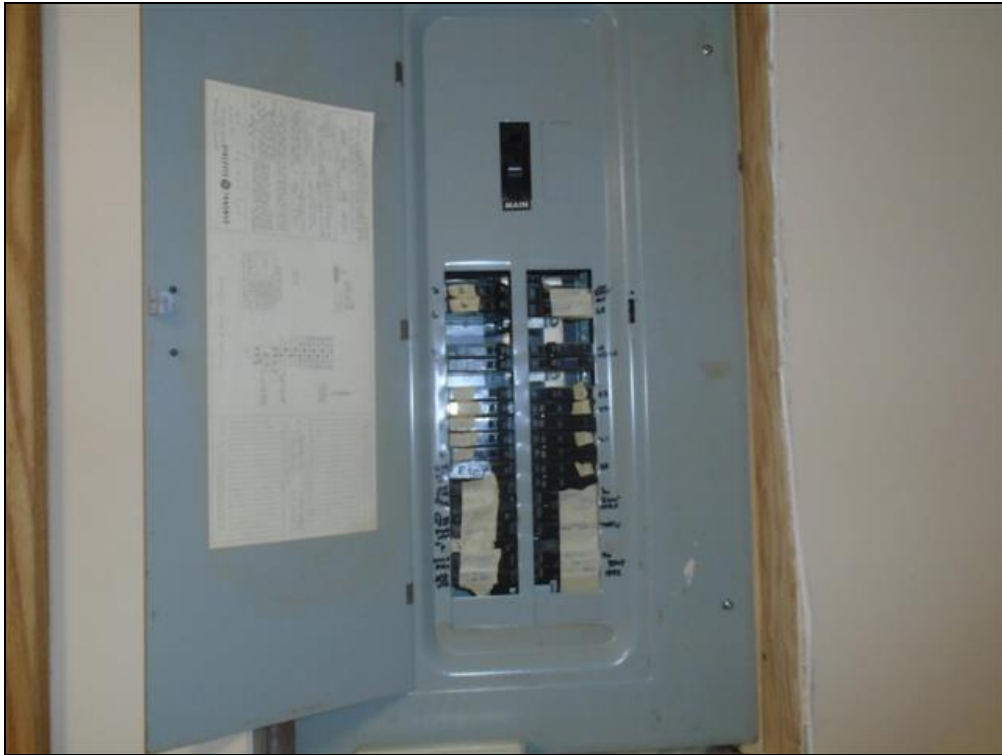
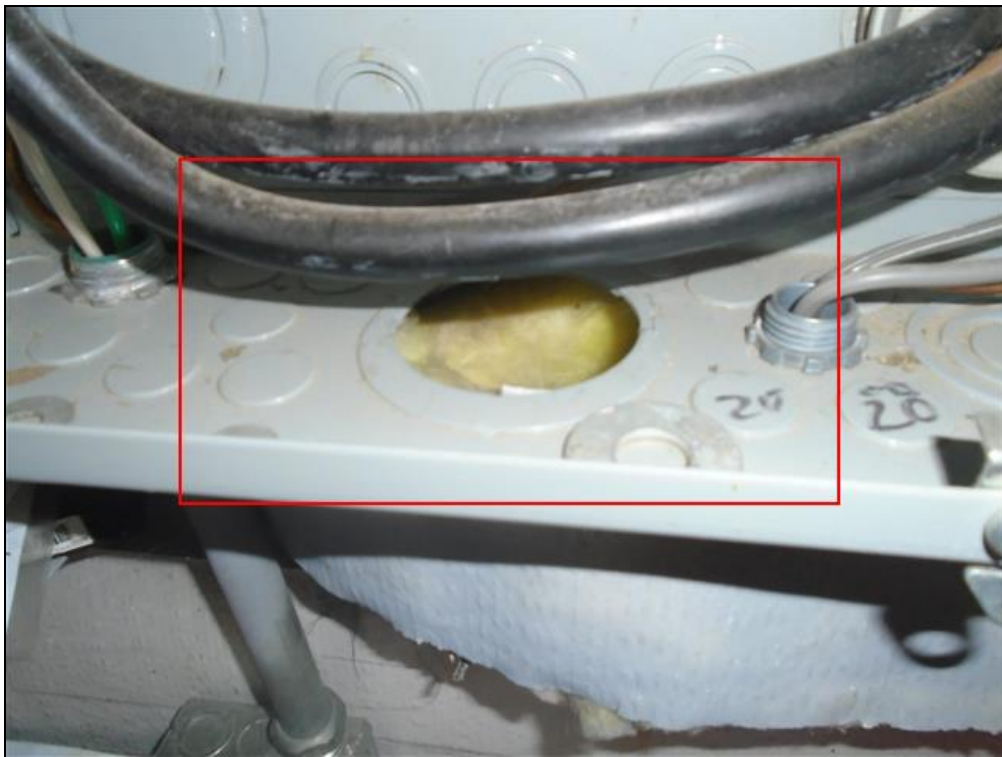
- (4) Seal all holes in the panels to prevent electrical hazard..

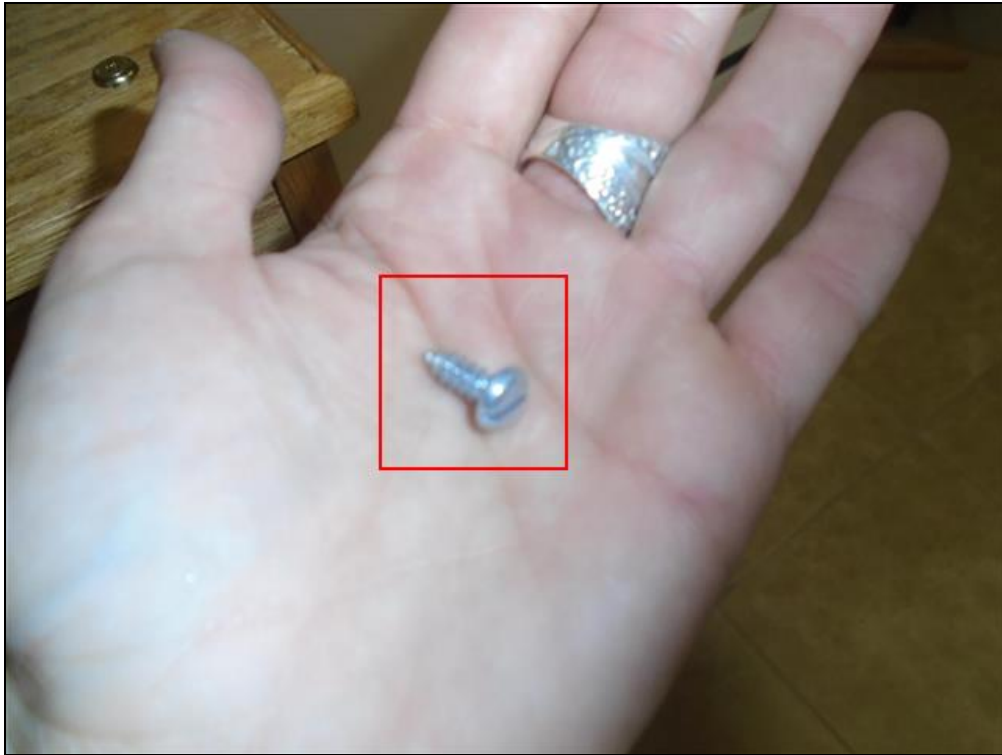
5.0 Item 6(Picture)

(5) The pointed screw used to secure the dead front panel can damage the insulation on the wires inside the box. I recommend replacement with a flat tipped screw designed for use with a dead front panel.

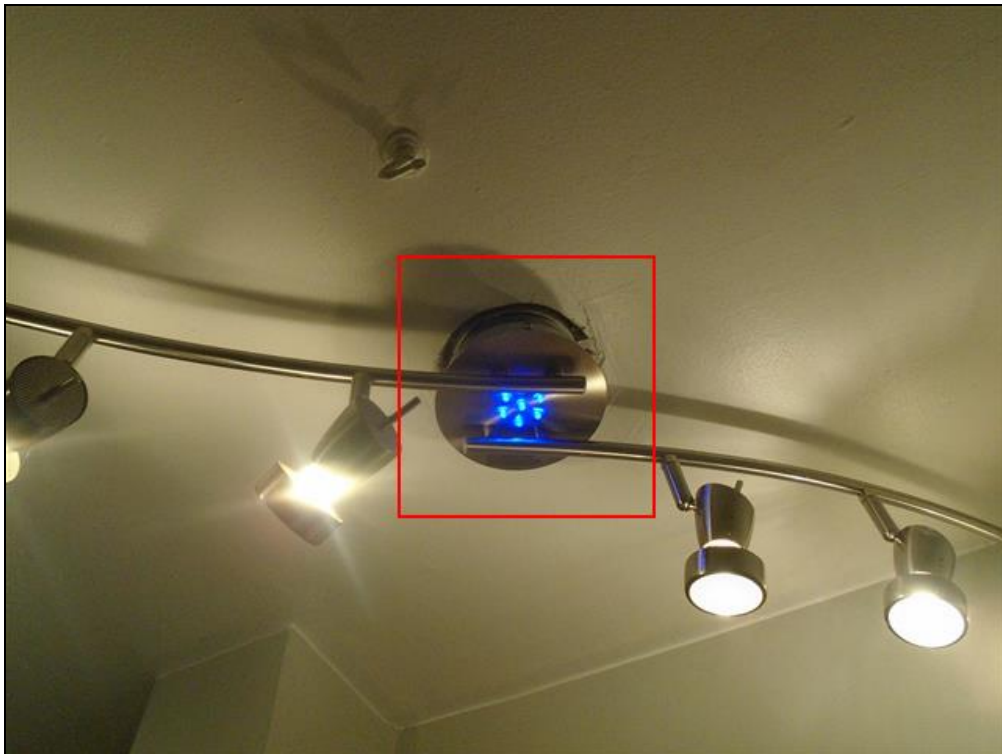
5.6 Item 1(Picture)

(2) The bathroom shower light trim has been removed, I recommend replacement.

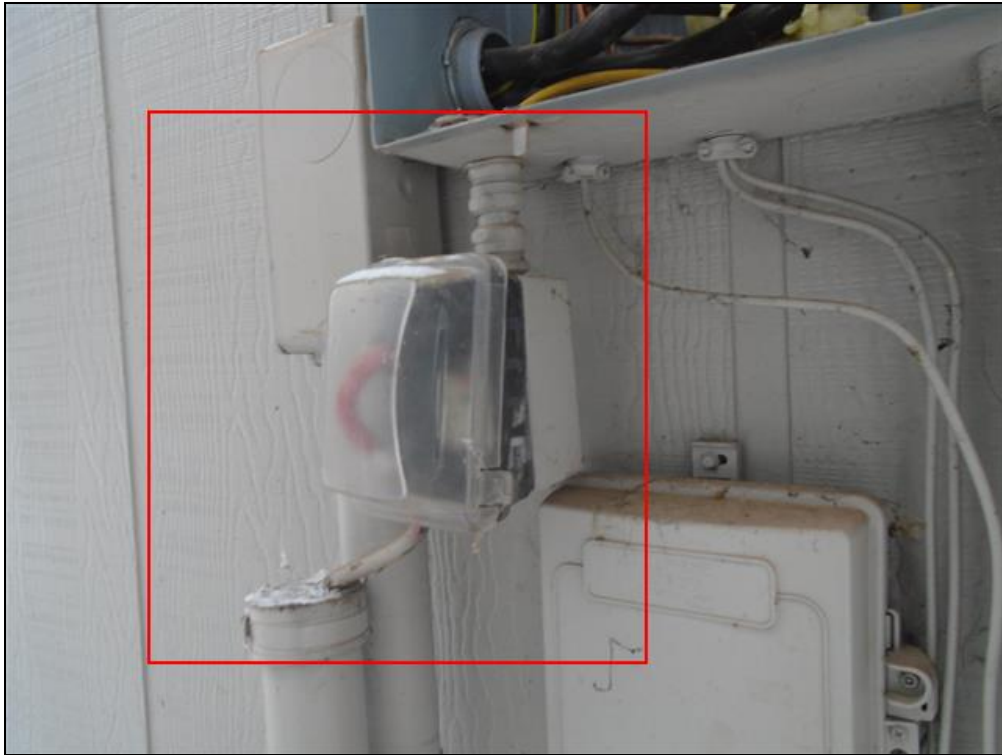
Extension cords cannot be used as a permanent source of power. Remedy as needed.

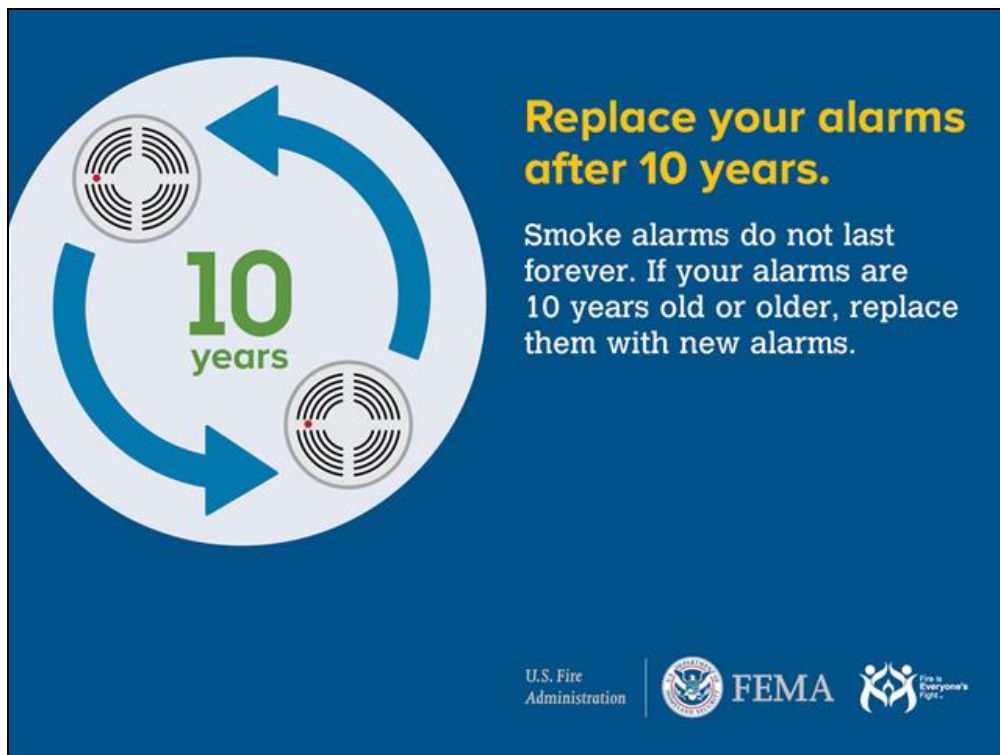
5.9 Item 1(Picture)

(2) All smoke detectors over ten years old lose their sensitivity to smoke. I recommend the installation of new smoke detectors in each bedroom and hallway.

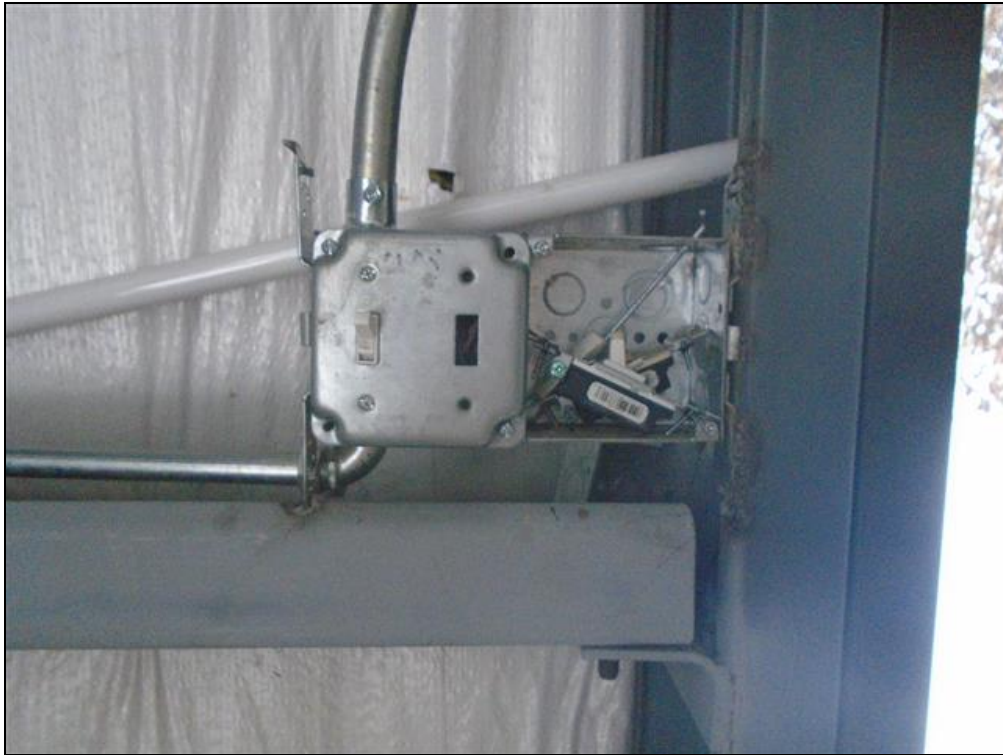
5.10 Item 1(Picture)

There are additions/modifications to the original electrical system, I recommend professional evaluation for safety, suitability and compliance with industry standards. Make sure required permits were obtained, work was performed by licensed contractor and all work was inspected and approved.

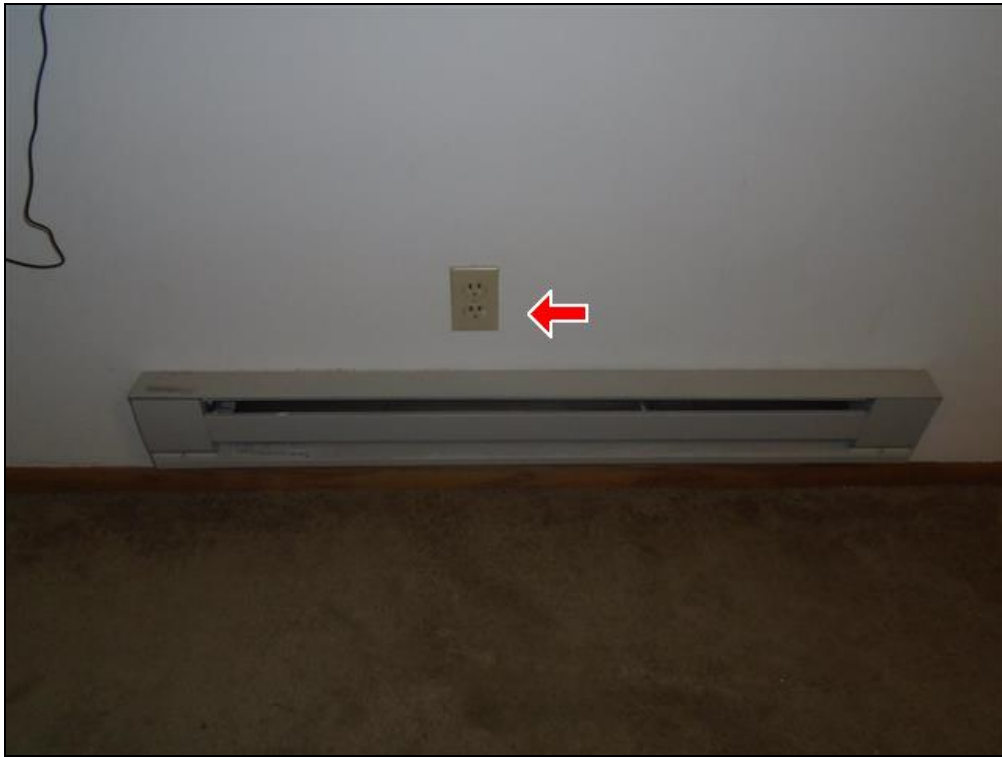
6.7 Item 1(Picture)

Outlets over baseboard heaters can damage the electrical. I recommend removal of the outlet or discontinue use.

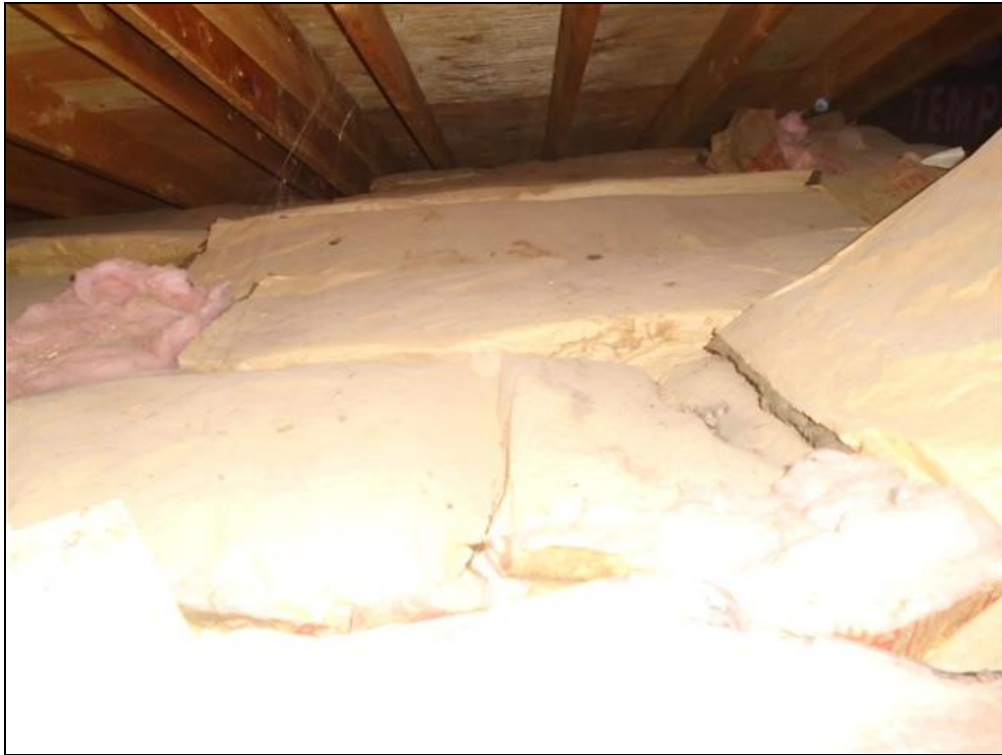
9.0 Item 1(Picture)

(2) Several of the insulating batts are installed with the flammable paper facing exposed. This is a fire hazard. Re-install the batts correctly or remove the paper facing material.
