# Inspection Report Home Buyer

7243 E Monte Vista Rd 456 Yellow Brick Rd. AZ 85257

**Liberty Inspection Service**

<b>Date:</b> 9/10/2018	<b>Time:</b> 12:00 PM	Report ID: Sample Report 2
Property: 7243 E Monte Vista Rd 456 Yellow Brick Rd. AZ 85257	Customer: Home Buyer	Real Estate Professional: Sample Agent

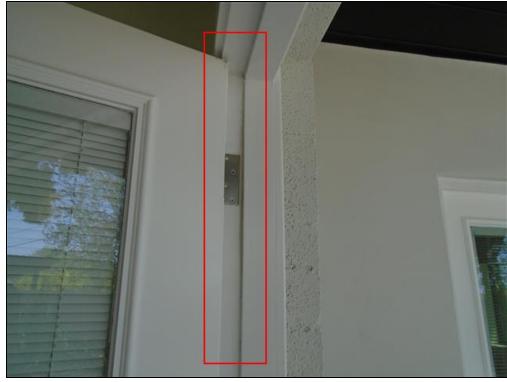
2.2 Item 2(Picture)

(1) The master bedroom and dining room exterior doors weather stripping have been removed. I recommend the addition of weather stripping.

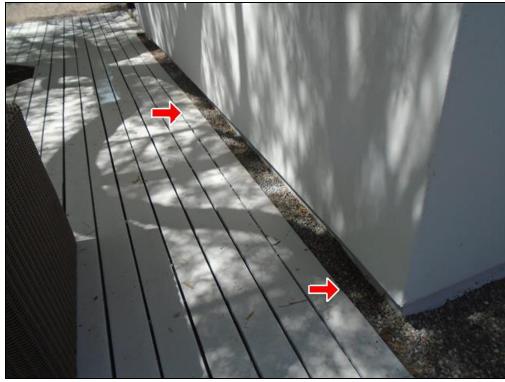
2.9 Item 6(Picture)

(1) The grade is sloped toward the house on all sides of the house. This will direct surface water into the soil adjacent to the foundation and cause water damage to the foundation concrete. Adjust the grade to direct surface water away from the foundation to prevent water damage.

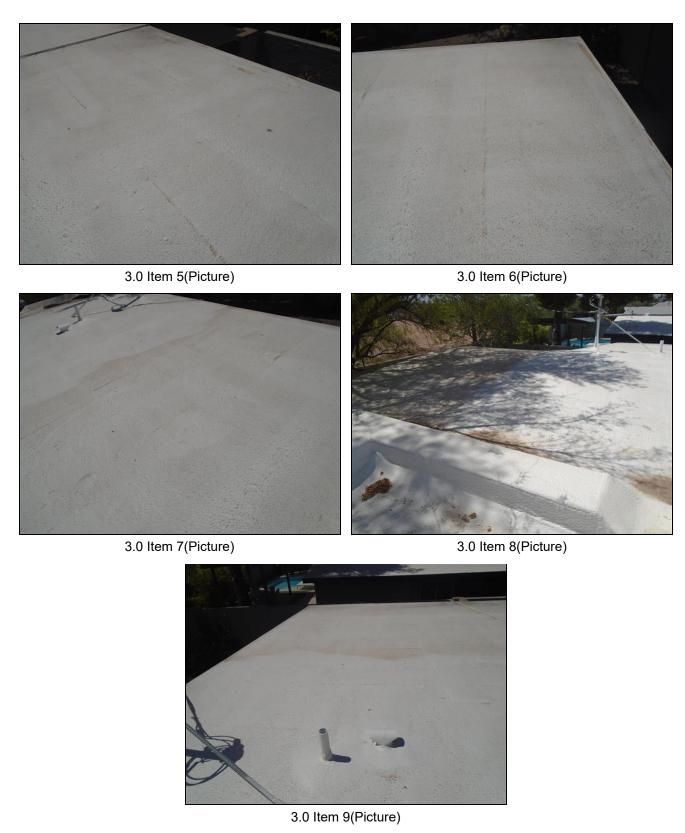
(2) There is evidence of ponding in low places on the roof. The roof sealant is a water based product that will rehydrate and fail to protect the foam if wet for too long. If the water does not evaporate in 48 hours I recommend evaluation by a licensed roofer and remedy as needed.

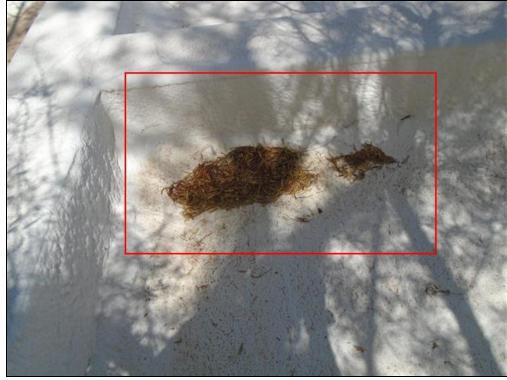
3.1 Item 2(Picture)

- (1) Overall the roof drainage system is in satisfactory condition.
- (2) Remove the leaf litter from the flat roof surfaces to improve water flow.

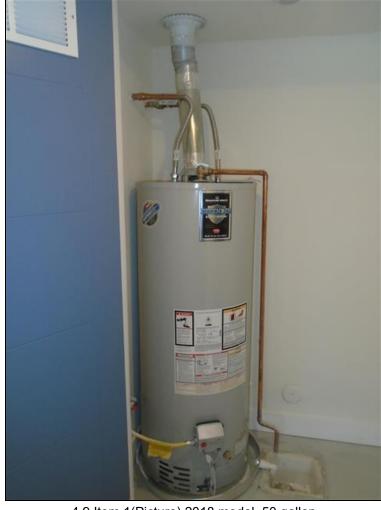
The water heater is in satisfactory condition and operational. The service life of a water heater in Arizona is 8-12 years.

4.9 Item 1(Picture) 2018 model, 50 gallon

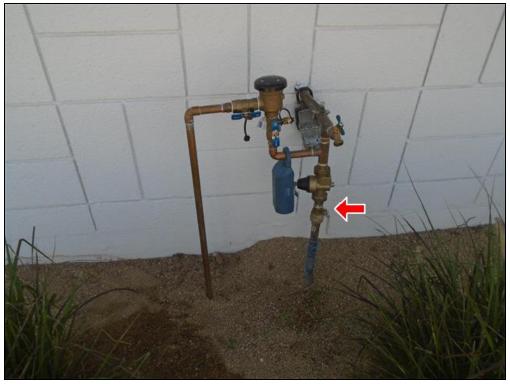
4.14 Item 1(Picture)

The main water shut off valve is located on the front of the house.

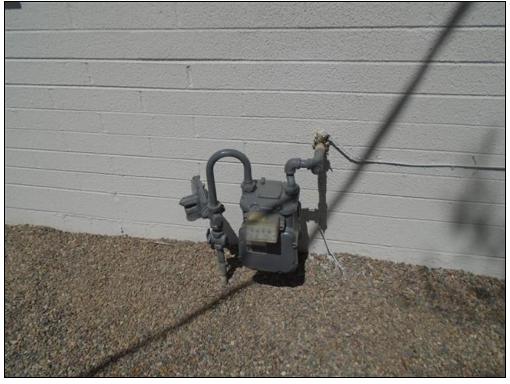
4.16 Item 1(Picture)

Located on the back of the house.

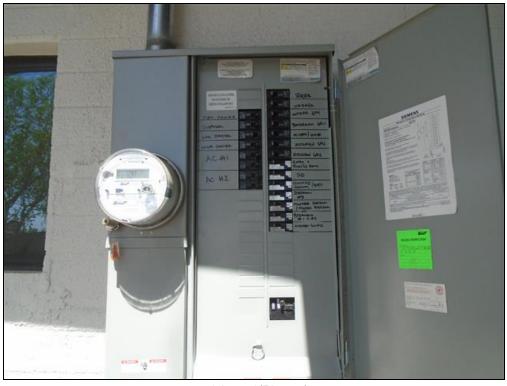
5.0 Item 1(Picture)

The main disconnect and distribution panels are located on the back of the house.

The main and distribution panels are in satisfactory condition.

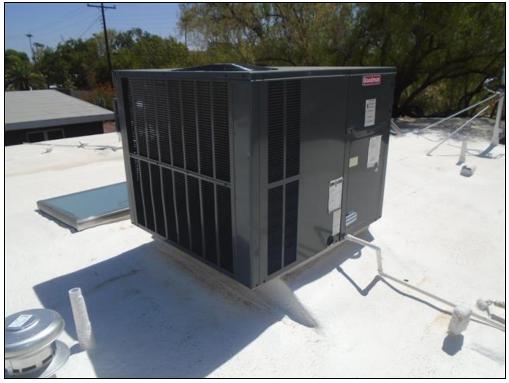
The visible portions of the cooling equipment are in satisfactory condition and operational.

7.0 Item 1(Picture) 2017 model, 5 ton (estimated)

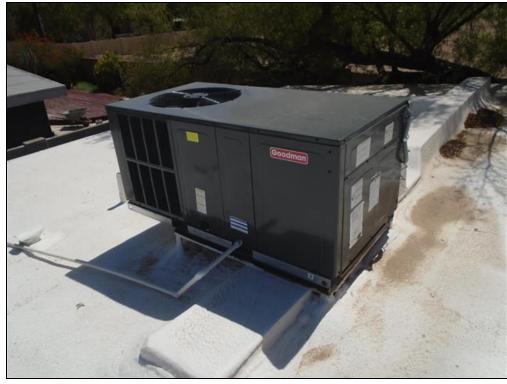
7.0 Item 2(Picture) 2018 model, 2 ton (estimated)

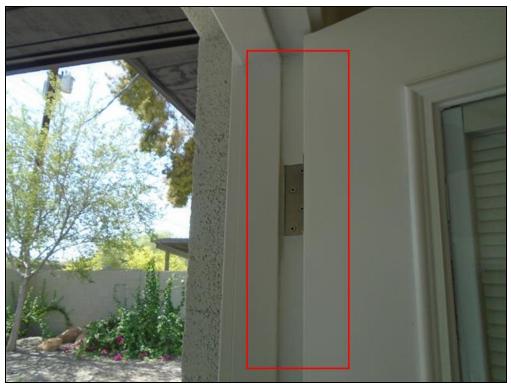
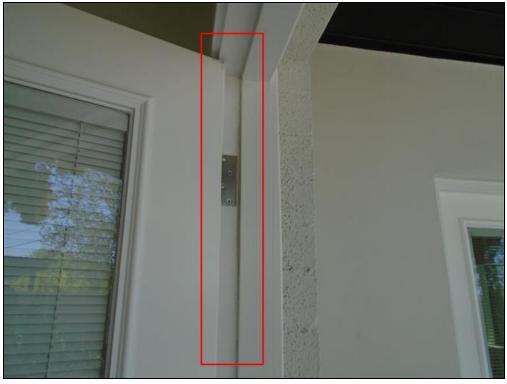
(1) The master bedroom and dining room exterior doors weather stripping have been removed. I recommend the addition of weather stripping.

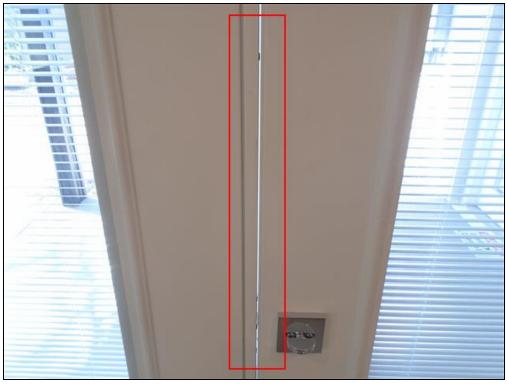
2.2 Item 5(Picture)

(3) There is daylight visible between the master bedroom exterior doors, remedy as needed.

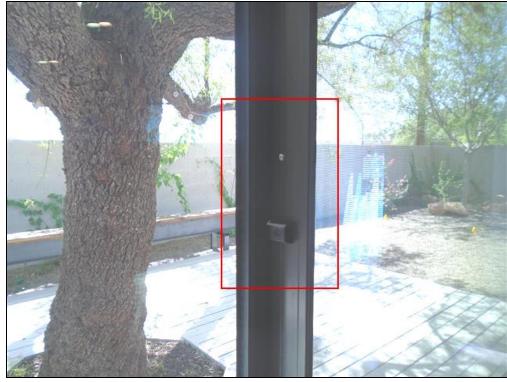
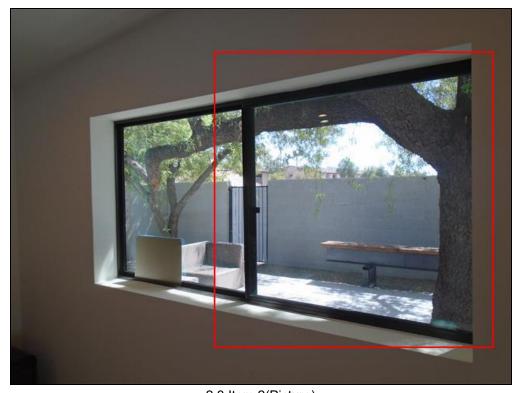
(2) The master bedroom rear window lock has been removed and the window does not open. I recommend replacement of the lock and adjustment of the window to operate as intended.

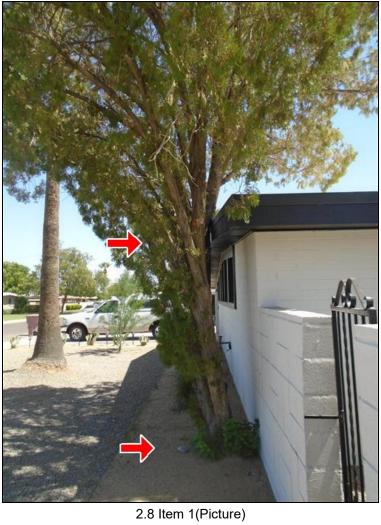
There is a large tree growing in close proximity to the house. This could damage the foundation. Also, tree limbs/ vegetation in contact with the exterior and roof can cause damage to the roof and wall cladding, as well as provide access for rodents. I recommend removal of the tree to prevent damage to the foundation, house, and roof.

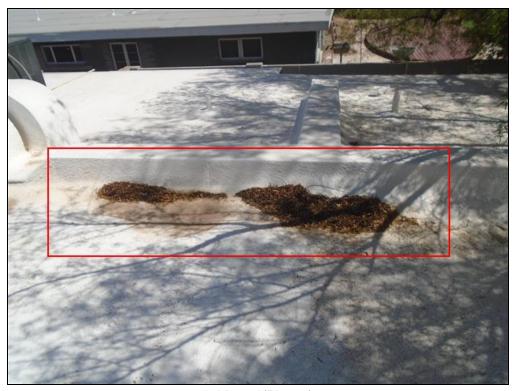
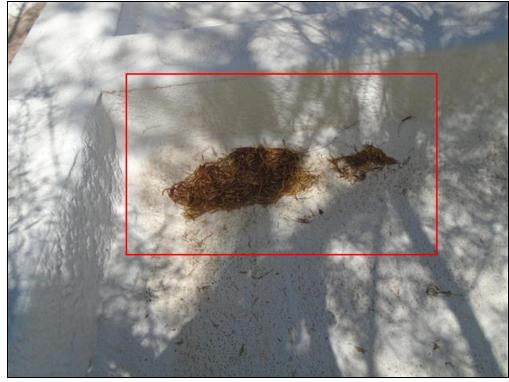
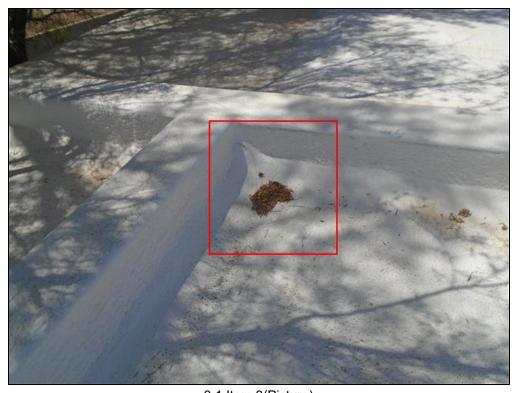
- (1) Overall the roof drainage system is in satisfactory condition.
- (2) Remove the leaf litter from the flat roof surfaces to improve water flow.

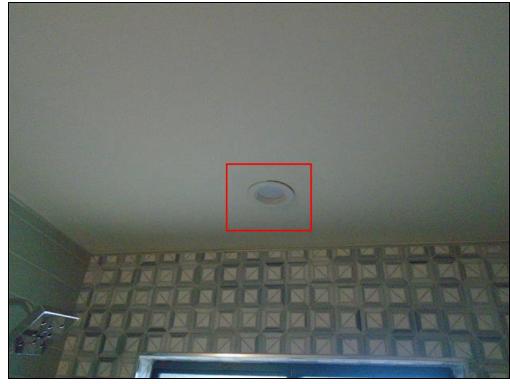
5.6 Item 1(Picture)

(2) The hallway guest bathroom recessed can light is not secured to the ceiling, remedy as needed.
